# Fire Risk Assessment

## Scott House

**Langdale Road  
Great Barr, B43 5RD**

**Date Completed: 07/11/2025**

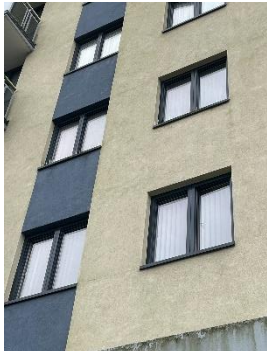
- Alumasc mineral wool render (Fire Classification A2)

Other than some slight damage to render (trivial) There have been no changes in the condition of the external walls since the previous FRA.

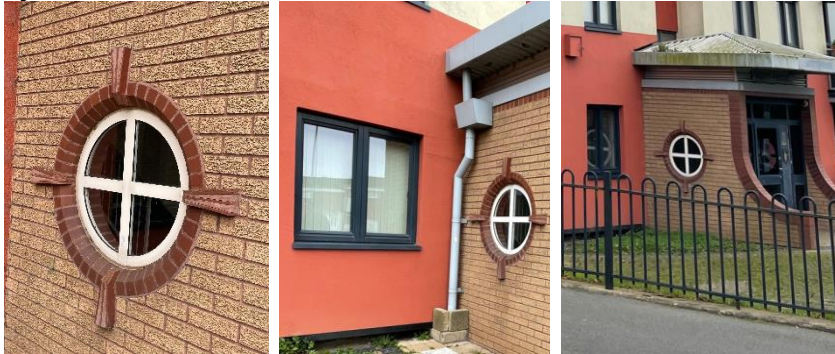
considered as part of a future works programme such as installing 60 minute fire resistant glazing, bricking up the window, or installing sprinkler system to the flats.

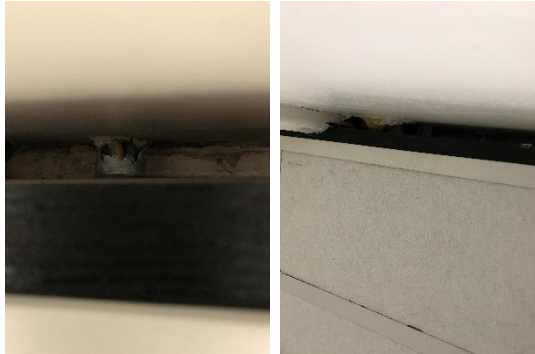
- 16) Compartmentation above the false ceiling on the ground floor could not be determined and further investigation should be conducted. Limited accessed was made into the false ceiling.**
