# Fire Risk Assessment

## Lancaster House

**1-120, Oldbury Rd,  
Rowley Regis, B65 0QF**

**Date Completed: 02/04/2025**

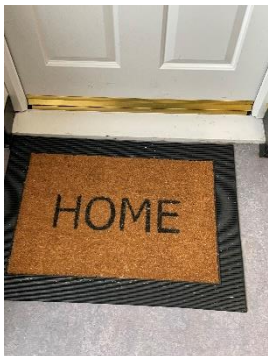
- 15) Individual floor mats were noted outside some flats. Fire rating of the mats is unknown but deemed to be of low risk.

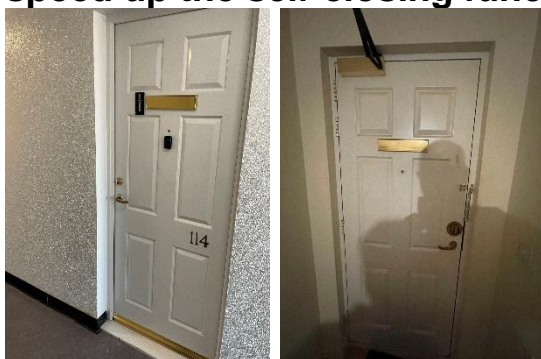
- a) **Flat 114 – Self-closing service requires adjustment to speed up the self-closing function.**

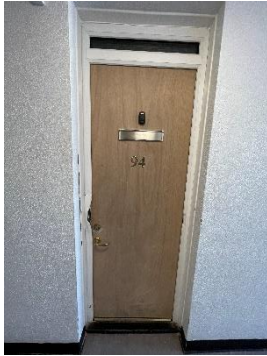
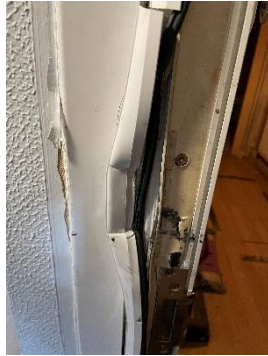
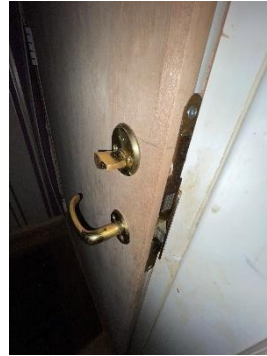
- c) Flat 94 – Door is a timber FD30 temporary replacement following a forced entry. *Measurements will be taken for a replacement FD30s doors set during a survey booked for 11/04/25. SMBC contractor Lutley Windows will complete the work – Job Number 16452783*

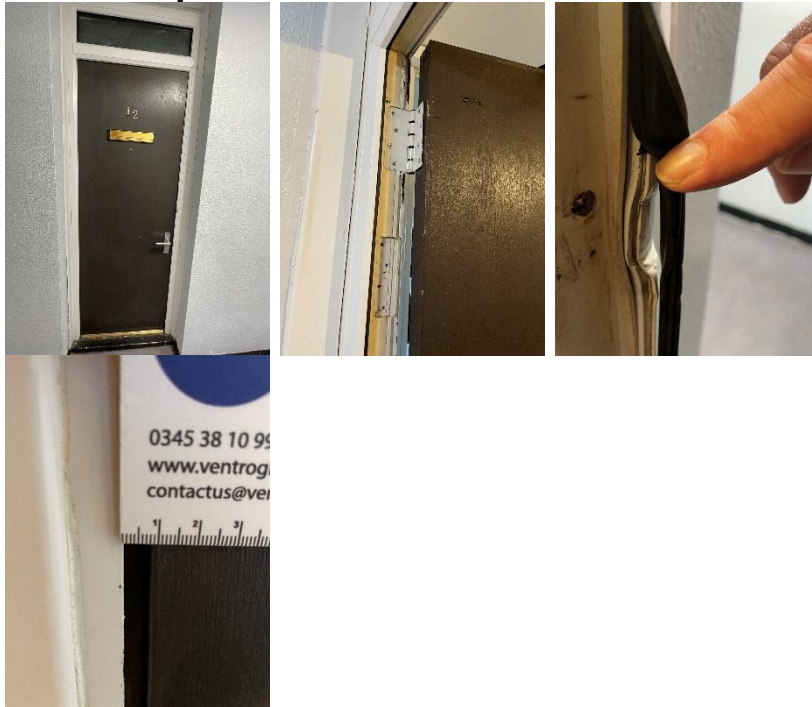
- e) Flat 12 – Door leaf is timber FD30 door that has been installed as a replacement door within the previous Permadoor frame. **The door has been installed with 3 hinges. There is a small area of the frame without intumescent where a 4<sup>th</sup> hinge was previously fitted. Damage is evident to the lock side of the frame where forced entry tools have previously been used. There's an 8mm gap between the door leaf and latch side of the frame. Replacement FD30s door and frame set required.**

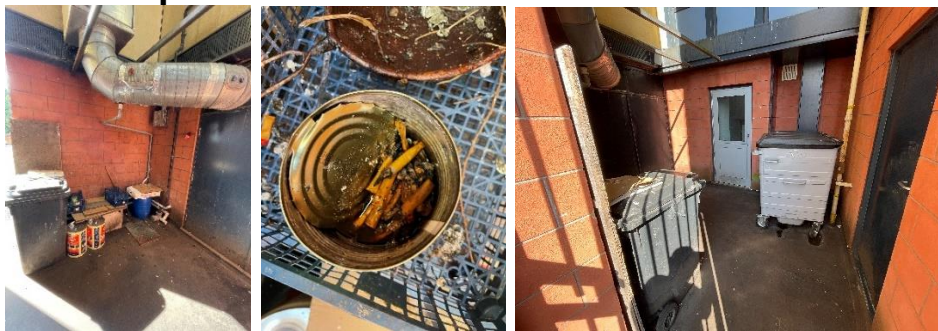
In conclusion, the likelihood of a fire is at a medium level of risk prior to the implementation of the action plan because of the potential fire hazards that have been highlighted within the risk assessment, including the retail waste containers that continue to be stored against the rear of the building.

- 7) **A mixture of 9 metal and plastic waste containers for the retail units are stored against the rear of the building with no consideration for safe distances.**

**A suitable area should be identified where all waste containers can be stored safely at a horizontal distance of 6 metres from the building as per the recommended guidance of the Confederation of Fire Protection Associations Europe (CFPA-E).**
