# Fire Risk Assessment

## Lancaster House

**1-120, Oldbury Rd,  
Rowley Regis, B65 0QF.**

**Date Completed: 01/04/2026**

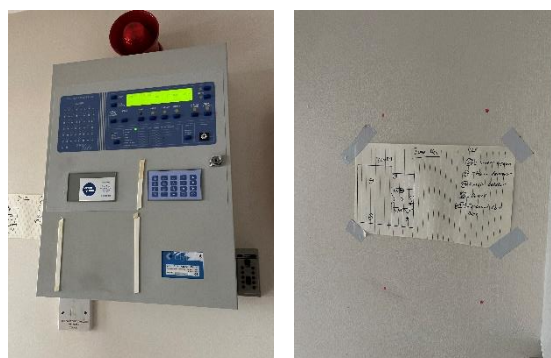
- 5) The server room on the lower ground floor has an automatic fire alarm system that appears to conform to BS5839. There are detector heads, sounders, a manual call point and a fire alarm control panel. This panel indicates that the alarm system is zoned, however, only a temporary zone plan is present. BS 5839-1:2025 states that zone plans are required on every system of any size to be compliant. It is required that a suitably compliant zone plan is provided near the fire alarm control panel. See action 8/5.

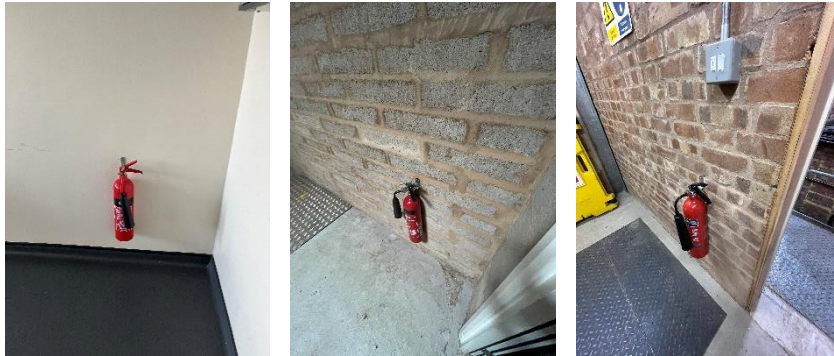
- 5) **A foam fire extinguisher is present in the lower ground floor common area. The presence of fire extinguishers in the common areas of residential high rise blocks is discouraged as it may encourage untrained residents to firefight instead of alerting the fire service and evacuating the block. The assessor requires this foam extinguisher to be removed. It could be re-sited in the fire Rapid Response Teams store on the lower ground floor. See action 11/5.**

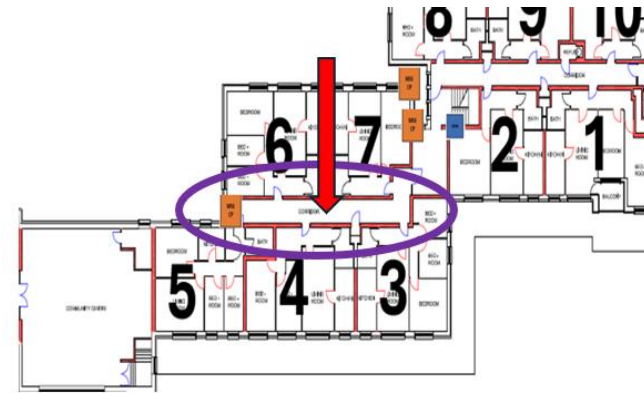
The dead-end corridors in the 1st & 2nd floor wings form part of the means of escape. These corridors have travel distances more than 15m. Considering the construction date of the building (1965), additional control measures have been put in place to include automatic opening vents and replacement FD30s composite fire doors to flat entrances. Additional cross corridor fire doors to prevent smoke spread should be considered in the next program of block refurbishment.
