# Fire Risk Assessment

## Sheapcoate House

**Beaconview Road, West Bromwich,  
B71 3PP**

**Date Completed: 14/02/2025**

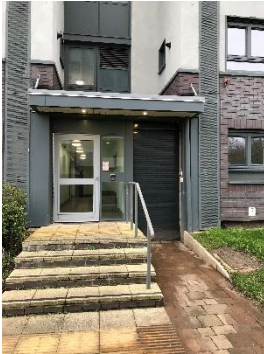
- 6) It was noted that some balconies may have had combustible materials in the form of hanging washing this is deemed acceptable risk due to the likelihood of a fire starting in this area being low and combined with the temporary nature of the activity.

*Under no circumstances should netting or screening be attached to balconies as they can support fire spread across the external of the building. Other options should be explored*

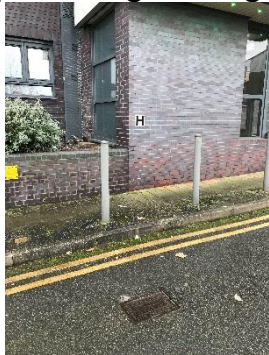
- 10) Gas was noted to be external, secured behind corrugated panelling, with gas isolation points located on the orientation plan.

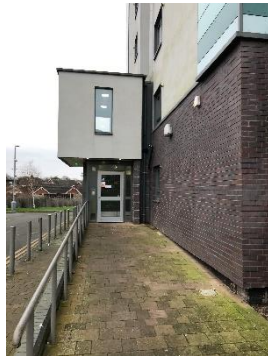
- 11) Noted there is a communal viewing Pod on the first floor above the Main access point to the block.

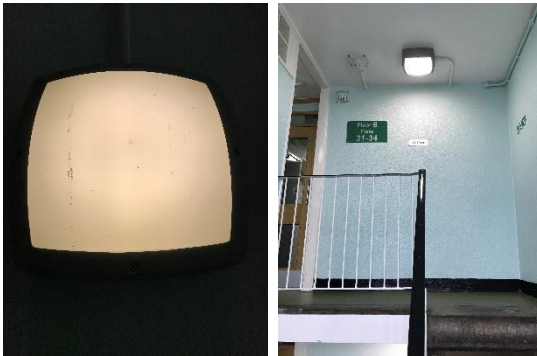
- 1) The premises has a sufficient emergency lighting in accordance with BS 5266 and has test points strategically located.
- 2) The units are provided to the communal landings, stairs and lift motor room.

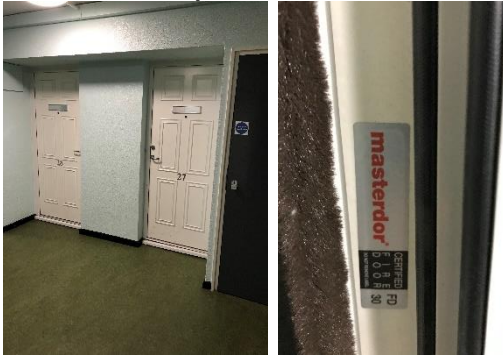
- 9) Individual flat doors are a combination of 44mm Manse Masterdoor FD30s composite or nominal timber fire door construction.

*It is accepted that, in older blocks, fire doors, particularly flat entrance doors, do not meet current test standards for FD30S doors. However, these doors may still be acceptable if the doors remain in good condition, and they met the relevant standards at the time of construction of the block*

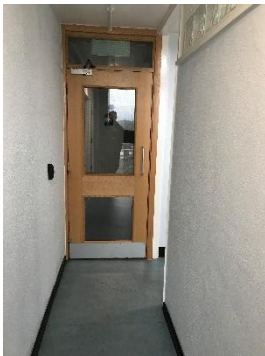
- 10) Corridors / staircases are protected by use of 44mm nominal FD30s fire doors with vision panels.

Some nominal communal landing doors are starting to show signs of general wear and tear due to age. Consideration should be given to upgrade with certified FD30s door sets & combination frames with future improvement works.

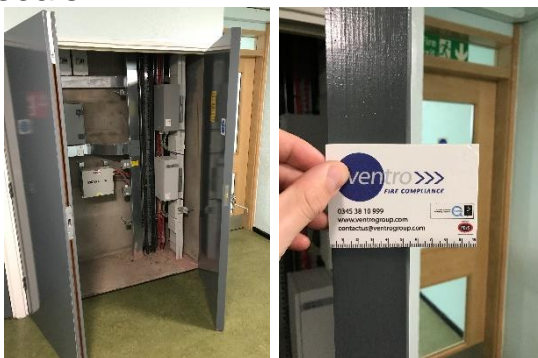
- 11) Cupboard doors within the communal areas such as residents meter cupboards/ electrical riser's cupboards are nominal 54mm FD60 timber fire door sets with intumescent strips, cold smoke seals.

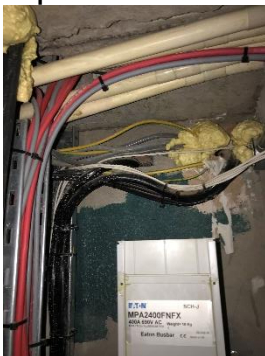
- 12) The use of expanding foam was present within the communal cupboards around cabling as part of the fire stopping knowing that intumescent pads and a concrete slab is present and this foam is only used as an enhancement it is deemed acceptable. This should be enhanced as part of future works to the building and replaced with intumescent mastic to improve fire stopping

The use of expanding foam was present within the communal cupboards around cabling as part of the fire stopping knowing that intumescent pads and a concrete slab is present and this foam is only used as an enhancement it is deemed tolerable. This should be enhanced as part of future works to the building and replaced with intumescent mastic to improve fire stopping.

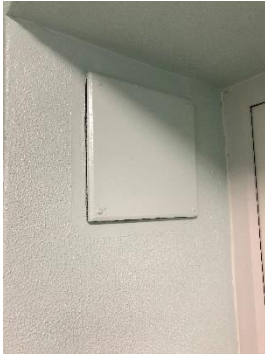
- 13) Access panels to stop taps are fixed to masonry and bedded on Intumescent material and secured behind nominal timber doors within the communal areas.

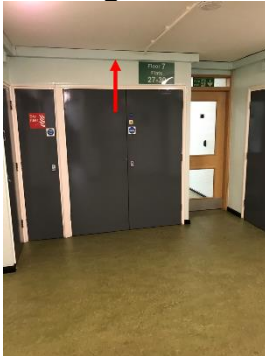
- 14) It was noted that metal trunking had been utilised to house cabling in communal areas.

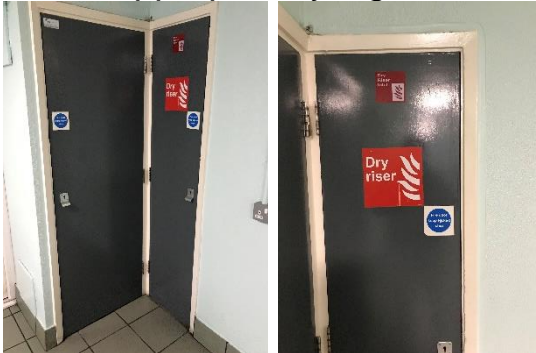
- 1) The dry riser inlet cupboard is located in the ground floor lift lobby and is appropriately signed.

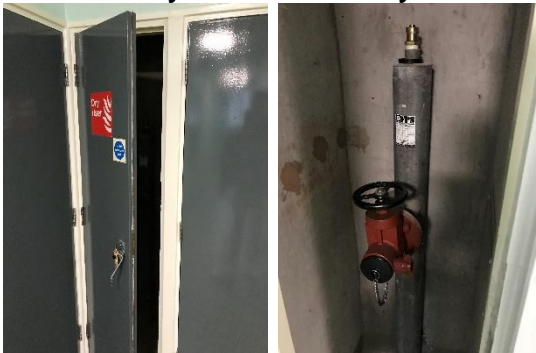
- 2) The riser outlets are available on each floor lobby (ground – 8<sup>th</sup>) these are protected via nominal 44mm 30-minute fire doors secured by suited 54 key & mortice locks.

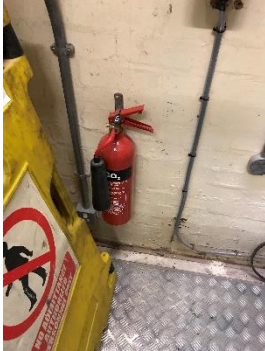
- 5) Portable fire extinguisher (CO2) is provided to the lift motor room. Maintenance contracts in place for maintenance of the extinguisher. The frequency for the maintenance checks are once of each calendar year last check was conducted October 2024.
