# Fire Risk Assessment

## Sheapecoate House

**Beaconview Road, West Bromwich,  
B71 3PP**

**Date Completed: 12<sup>th</sup> February 2026**

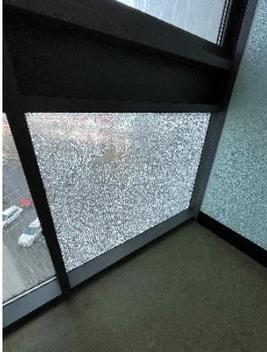
- 15) The inner pane of a double glazed window was noted as shattered between the 5<sup>th</sup> and 6<sup>th</sup> floors of the protected stairwell. The required repair has been reported, and a protection film has been applied as a temporary measure.

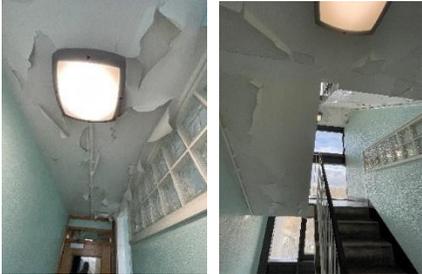
Question/ Ref No	Required Action	Supporting photograph	Priority	Timescale and Person Responsible	Date Completed
7/9	Remove and replace all flaking paint from multiple areas in the protected stairwell and several chute rooms. Re-paint with suitable euro class B-S3,d2 product.

P3	Within 3-6 Months Repairs

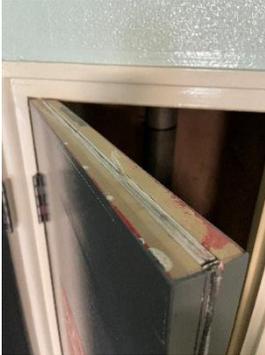
10/17	Replace damaged cold smoke seal to head of 1 <sup>st</sup> floor dry riser cupboard. Door may need to be rehung to accommodate.

P2	Within 1-3 Months Fire Rapid Response	
14/5	Remove adhesive tape and re-fix trunking cover with suitable fixings adjacent flat 10.
