Fire Risk Assessment

Stanton House

**Beaconview Road, West Bromwich,
B71 3PW**

Date Completed: 4th March 2026

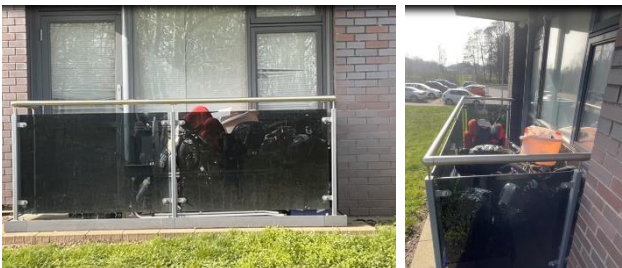
2) Flat 36 has excessive fire loading to balcony with a number of believed combustible items.

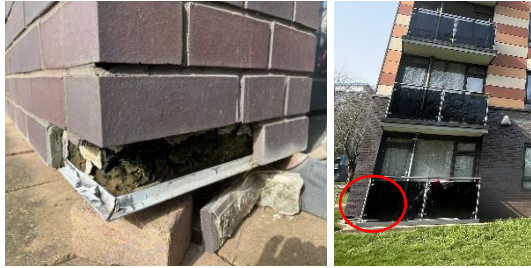
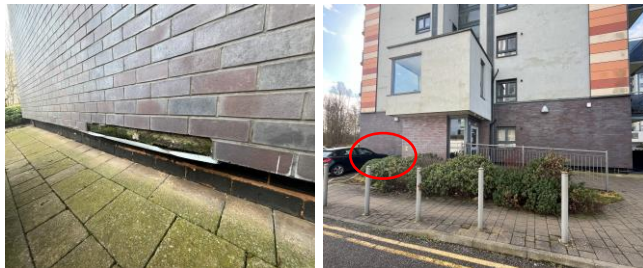
- 3) External wall on the ground floor level has missing Ibstock brick from the left/north and east elevation of the building. *Email sent on 23/03/2026 to Repairs*

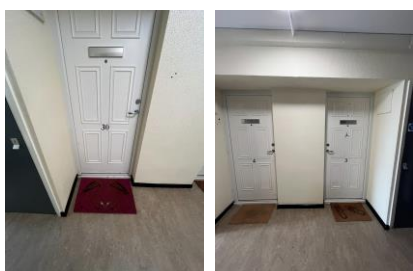
- 4) **Condition of door mat to flat 34 is deemed as poor due to the edges being lifted which could potentially cause a trip hazard.**

7/4	Flat 34 front door mat required to be removed or replaced by resident due to poor condition

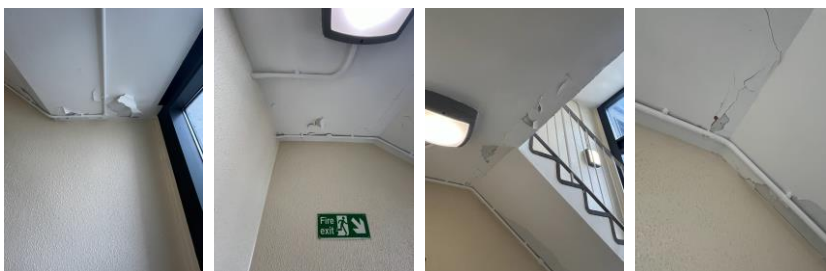
5th & 6th floor stairs

- 10) The surface coatings applied within the communal areas comprise Torrex Flameshield Ultimate 2015, which is Class 0 rated. However, the coating to the ceilings is flaking in multiple locations throughout the protected stairwell. **These areas should be prepared by removing the defective coating and subsequently redecorated using a suitable fire-rated product.**

Removal and replacement of all flaking paint from in the protected stairwell to floors 5/6,6/7,7/8. Re-paint with suitable euro class B-S3, d2 product.

P2	Within 1-3 Months Housing Manager	
7/10	Remove and replace all flaking paint from multiple areas in the protected stairwell Re-paint with suitable euro class B-S3, d2 product.

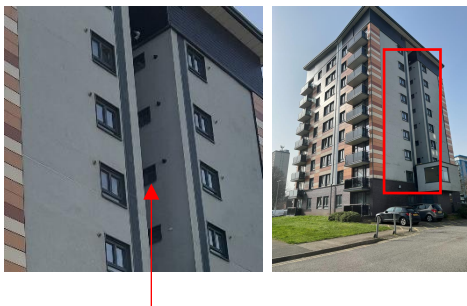
- 18) Glazing to kitchen windows within flats has been identified within 1.8 m of the staircase. As a result, the implementation of a sprinkler roll-out programme should be considered as part of any future refurbishment works. (*Recommended Observations*)

Kitchen windows near protective staircase

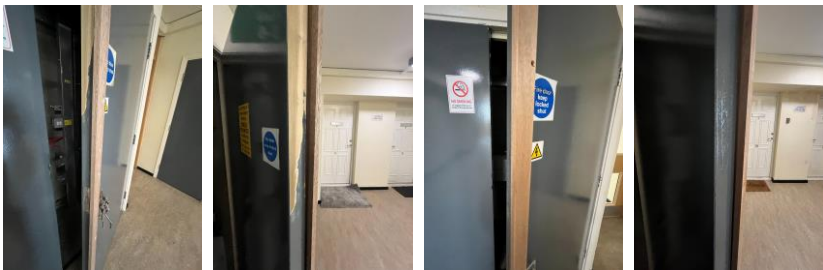
- 16) The dry riser cupboards are installed with FD30s (44mm) nominal doors electrical cupboards are secured with locked nominal FD60s (54mm) fire doors. The electrical risers on the 1st and 4th floor have had an additional hardwood strip added to the front of the doors, it is recommended that on any future refurbishment of the block that the doors be upgrade to certified fire doors. (*Recommended Observations*).

First and 4th floor additional timber strip added to the electrical riser doors

The electrical risers on the 1st and 4th floor have had an additional hardwood strip added to the front of the doors, it is recommended that on any future refurbishment of the block that the doors be upgraded to certified fire doors.

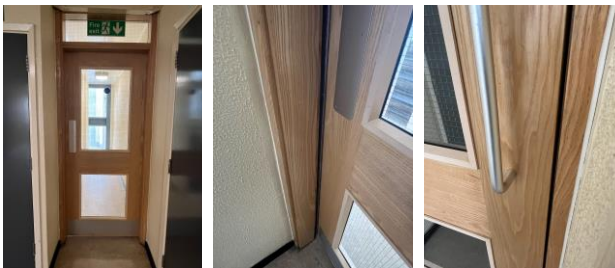
23) Nominal FD30s fire door located on the communal landing on the 5th floor has excessive gap at the bottom of the door due to the angle of the floor.

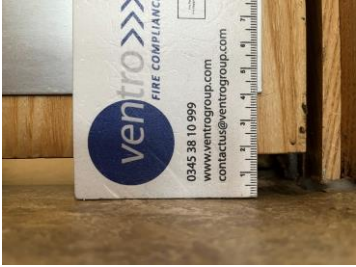
P3	Within 3-6 Months Repairs	
10/21	Excessive gap at the bottom of communal fire door on 2 nd floor. Requires a drop-down seal installed
