# Fire Risk Assessment

## Stanton House

**Beaconview Road, West Bromwich,  
B71 3PW**

**Date Completed:** 04/03/2025

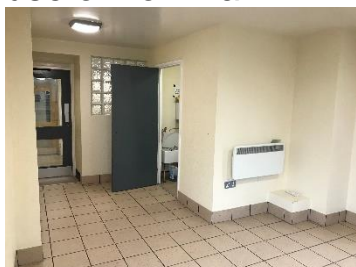
There is a “viewing pod” located on the 1<sup>st</sup> floor this is secured with the use of nominal 44mm timber FD30s doors secured with a suited key.

- 15) Communal viewing pod located on the first floor secured with a 44mm timber nominal door with intumescent strips, cold smoke seals and vision panels is secured with a type 38 mortice lock that residents have access to this room remains relatively sterile with the cleaners cupboard also being within this area noted the cleaners cupboard is missing the addition of combined intumescent strips and smoke seals as this is a nominal door and the area being regularly accessed by cleaning / caretaking teams the element of risk is tolerable however with future improvements to the block it should be considered that this door is upgraded to a FD30s.

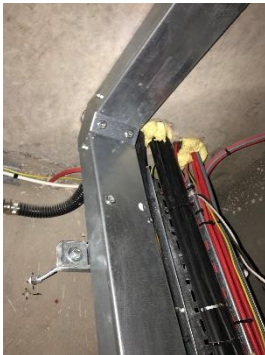
- 12) Leftover residue from expanding foam was observed within the communal cupboards. Fire-stopping enhancements have been implemented, and the presence of intumescent pads and a concrete slab ensures the overall effectiveness of the fire protection measures. As a result, the remaining foam is considered acceptable. However, this should be further improved as part of the routine maintenance carried out by the Fire Rapid Response Team.

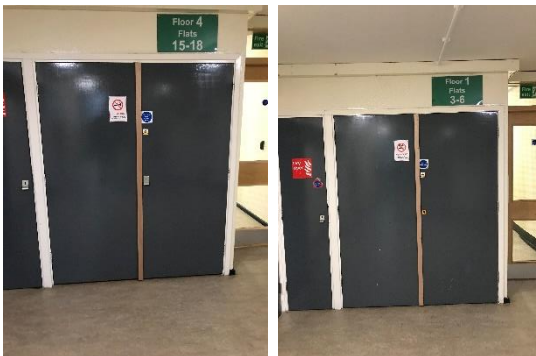
- 15) It was noted that a timber strip had been installed to the electrical installations cupboards on the 1<sup>st</sup> and 4<sup>th</sup> floors, as these are 54mm nominal timber doors and this strip has been added with the intention of upgrading the resistance to smoke/flame this is deemed tolerable however with future upgrades to the block some consideration should be made to upgrading the doors to fully certified FD30s doors.

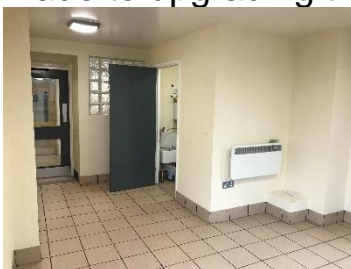
- 16) The store cupboard located within the 1<sup>st</sup> floor viewing pod is missing any intumescent strips and cold smoke seals, due to this door being a 44mm nominal FD30 timber door the regular checks by cleaning and caretaking services, additional nominal door protecting the viewing pod from the means of escape and level of risk being minimal this is deemed as tolerable however however with future upgrades to the block some consideration should be made to upgrading the doors to fully certified FD30s door.

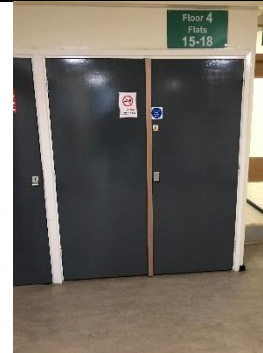
A timber strip had been installed to the electrical installations cupboards on the 4<sup>th</sup> floor, as these are 54mm nominal timber doors and this strip has been added with the intention of upgrading the resistance to smoke/flame this is deemed acceptable however with future enhancements considerations should be made to install combined intumescent strip and cold smoke seals.
