# Fire Risk Assessment

## Harry Price House

Hartlebury Rd, Oldbury,  
B69 1EQ

**Date Completed:** 15/05/2025.

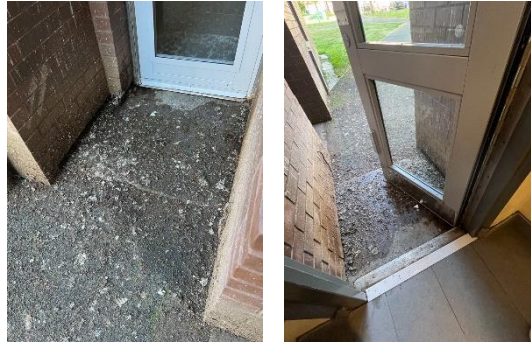
- 9) The escape routes from both rear fire exits are covered in pigeon excrement creating a potential slip hazard. These areas should be cleaned. Email sent to Estates Services manager. 20.05.25.

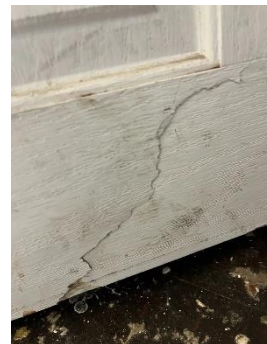
e) **Flat 16 - Entrance door is a nominal 30-minute fire door with combined intumescent strips / cold smoke seals and a self-closing device. However, there is damage to the door leaf and door frame, requiring repair. See Action 7/20/e.**

Question/ Ref No	Required Action	Supporting photograph	Priority	Timescale and Person Responsible	Date Completed
7/20/e	Flat 16 - Entrance door. There is damage to the door leaf and door frame, requiring repair.	 	P2	Within 1-3 months Fire Rapid Response

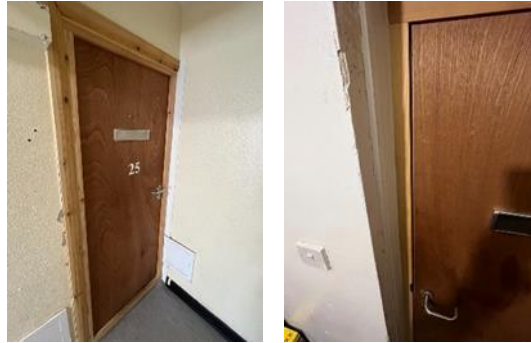
- f) **Flat 25 - Entrance door is a timber 30-minute fire door with combined intumescent strips / cold smoke seals and self-closing device. This door has an excessive leaf side gap requiring adjustment. See Action 7/20 (f)**

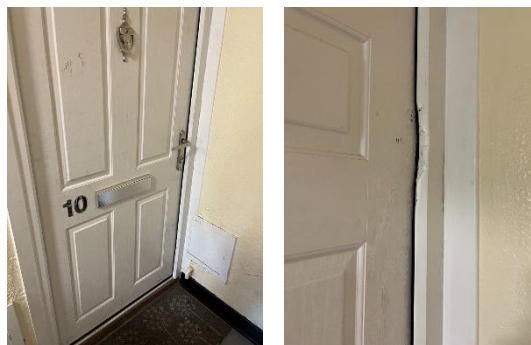
- g) **Flat 10 (not accessed) - Entrance door is a nominal 30-minute fire door with combined intumescent strips / cold smoke seals and a self-closing device. However, there is damage to the door frame, requiring repair. See Action 7/20(g).**

P2	Within 1-3 months Fire Rapid Response	
7/20/g	Flat 10 - Entrance door. There is damage to the door frame, requiring repair. This flat was not accessed at the time of the FRA,

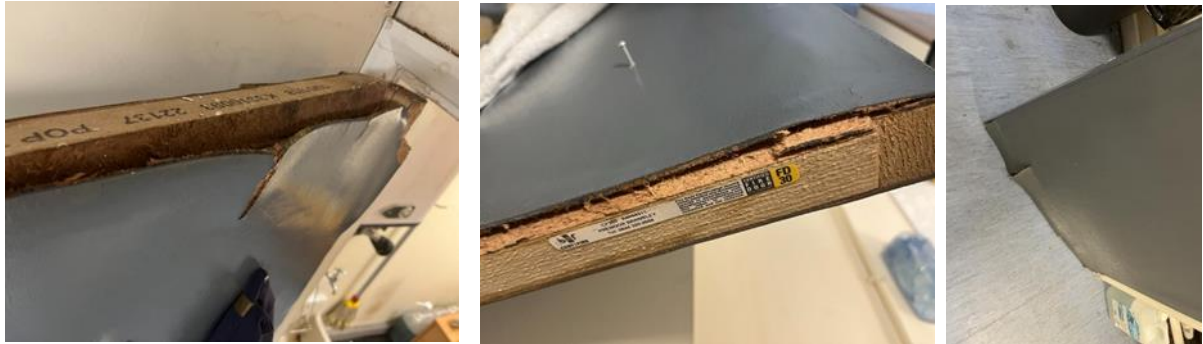
- 4) All communal fire doors are subject to a 12-week check by the Fire Safety Rapid Response Team. **At the time of the FRA the fire door in the caretaker's room was found to have a damaged door leaf requiring repair. See action 10/4.**

P2	Within 1-3 months Fire Rapid Response	
10/4	The fire door in the caretaker's room was found to have a damaged door leaf requiring repair.

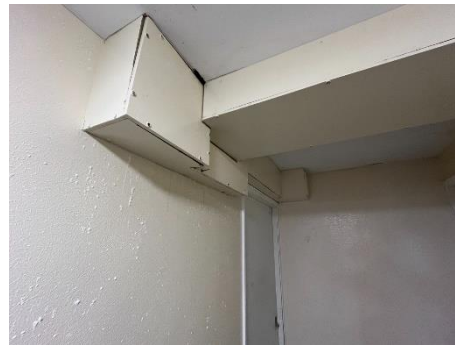
- 8) The fire stopping / compartmentation is subject to a 12-week check by the Fire Safety Rapid Response Team.
- 9) **There is timber panelling requiring removal to check for compartment breaches and reinstating with materials offering 60 mins of fire resistance in the following areas: Storeroom off main entrance lobby, Caretakers room, corridor to ground floor void flats and the ceiling of the corridor near flats 66,67 and 68 on floor 11. See action 10/9.**

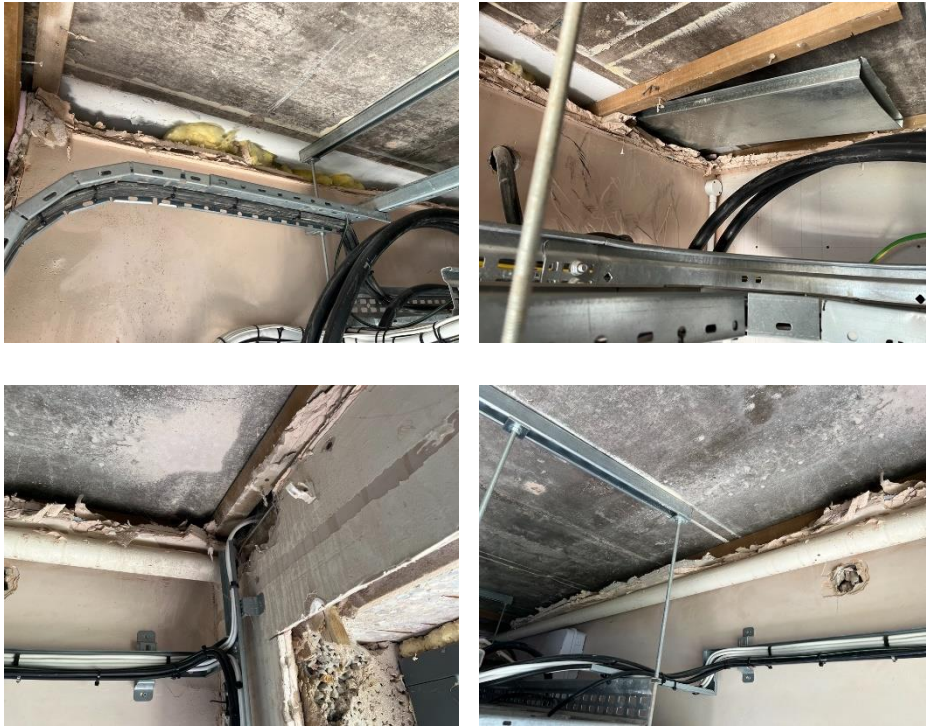
- 10) Fire stopping is inadequate in the main incoming electrical plant room (also containing the emergency lighting back up power supply) around cable penetrations, the ceiling and where the walls met the ceiling. This area requires adequate fire stopping to be fitted by a competent provider. See action 10/10.

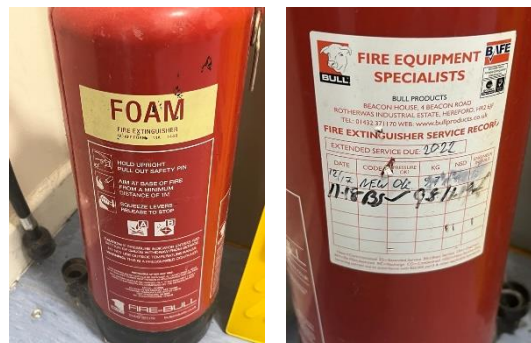
- 6) There is an empty, out of date foam extinguisher in the caretaker's room, this extinguisher is required to be removed. Email sent to Estate Services Manager. 20.05.25.
