Fire Risk Assessment

Harry Price House

**Hartlebury Road, Oldbury
B69 1EQ**

Date Completed: 23rd September 2022

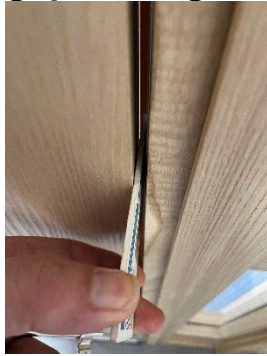
A. 11th floor - Communal door adjacent flat 66 excessive gap to hinge side.

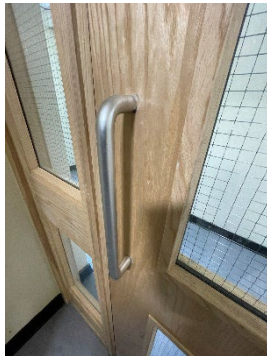
B. 9th floor - Handle to communal door adjacent flat 54 is loose.

07/6b	9 th floor – communal door adjacent flat 54, tighten loose door handle.	 	P2	Within 1-3 months of assessment date. Fire Rapid Response JM9636287	06/10/2022
07/6c	8 th floor – communal door to stairwell correct excessive gap to handle side.

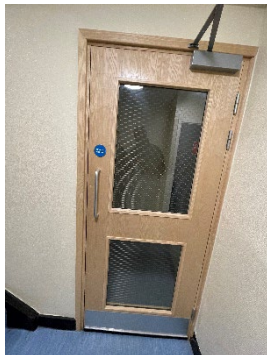
C. 8th floor - Communal door to stairwell excessive gap to handle side.

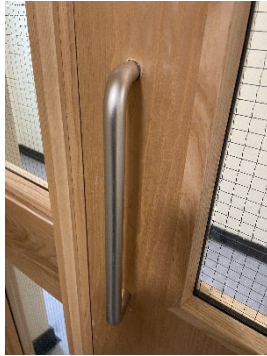
D. 8th floor – Handle to communal door adjacent flat 48 is loose.

P2	Within 1-3 months of assessment date. Fire Rapid Response JM9636295	06/10/2022
07/6d	8 th floor - communal door adjacent flat 48, tighten door handle.

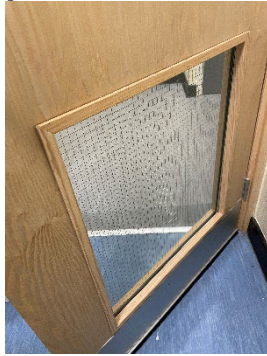
E. 6th floor – communal door to stairwell glazing to bottom panel is loose and moves behind beading.

07/6e	6 th floor – communal door to stairwell secure loose glazing within lower panel.

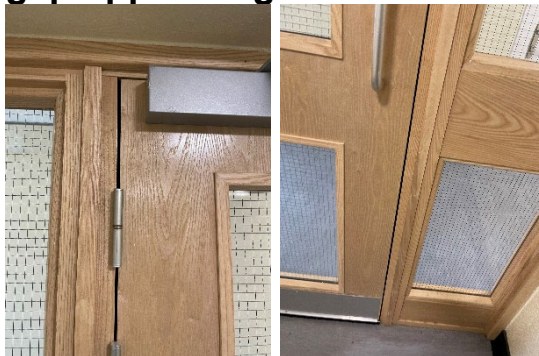
F. 5th floor – Communal door adjacent flat 27 has excessive gap upper hinge side and lower handle side.

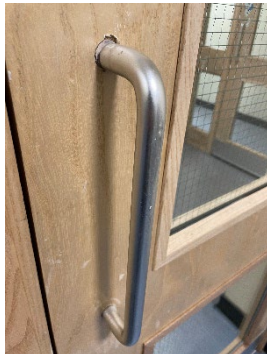
G. 2nd floor - Handle to stairwell door adjacent is loose.

07/6g	2 nd floor – tighten loose handle to stairwell door.

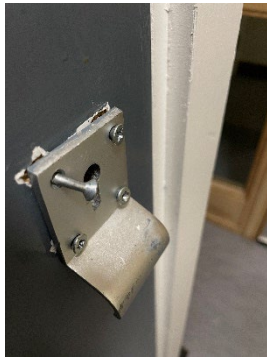
A. 12th floor riser cupboard – lock cover to be secured.

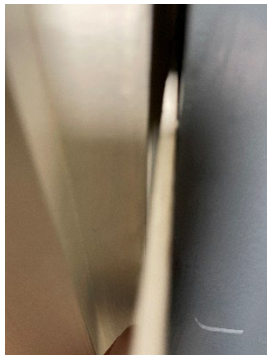
B. 10th floor riser cupboard excessive gap on hinge side.

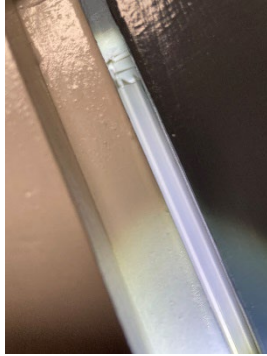
C. 7th floor riser cupboard excessive gap on hinge side.

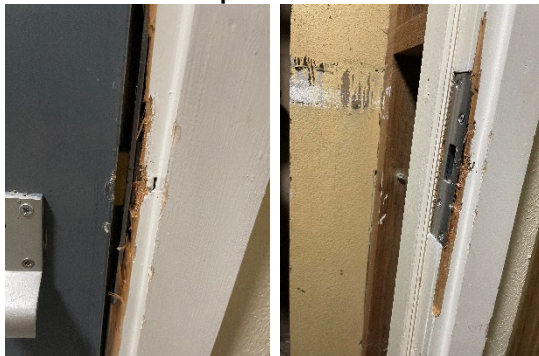
D. 1st floor riser cupboard has signs of forced entry however damage is minimum and is limited to the architrave. Door secures and provides sufficient compartmentation.

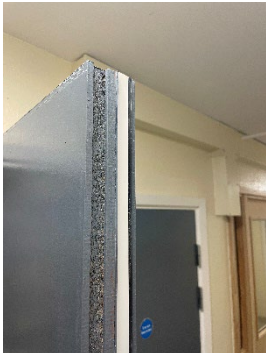
16) Service cupboard doors are FD30s rated, secured with type 54 suited mortice locks. 1st floor service cupboard with double doors is missing an intumescent strip.

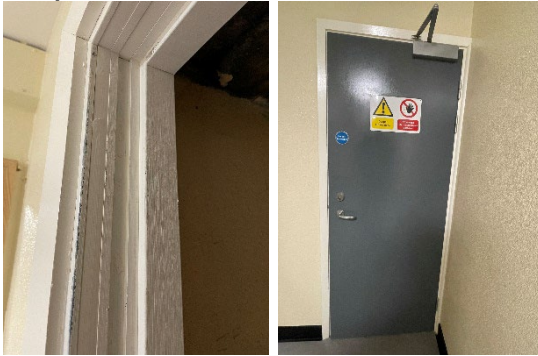
- 17) The lift motor room FD60s rated door is missing an intumescent strip on lock side.

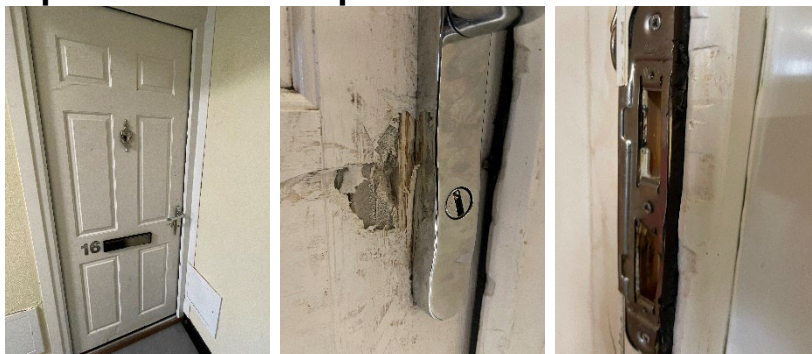
B. Flat 16 has signs of forced entry resulting in damage to door and frame around lock. Door does appear to form appropriate compartmentation however would recommend repairs to damaged surface or full door replacement if not possible.

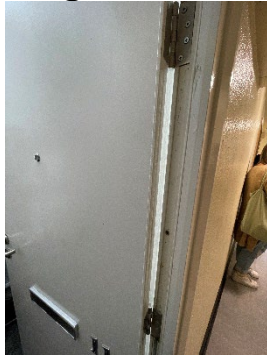
C. Flat 11 requires intumescent strip / cold smoke seal to hinge side.

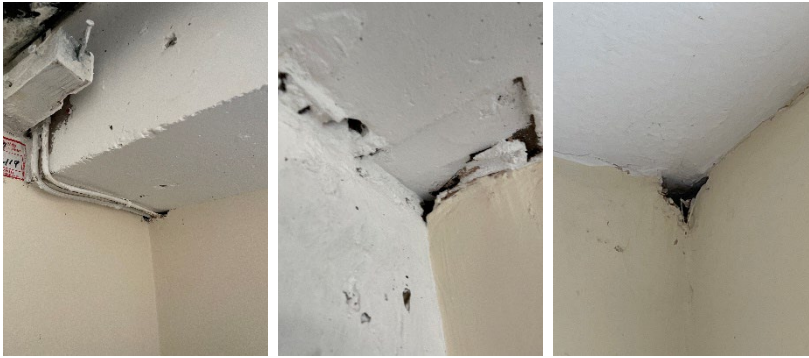
- 9) Caretakers office / ground floor 3 small holes at ceiling level on wall that adjoins server room to be fire stopped with intumescent mastic.

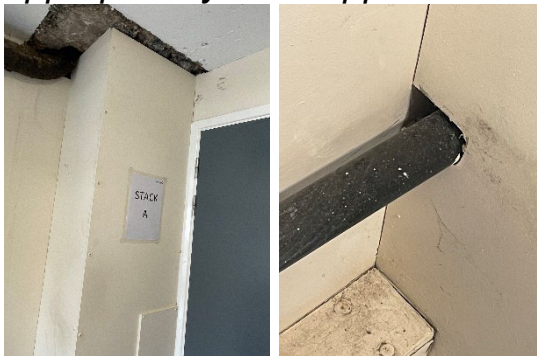
- 10) Caretakers office / ground floor – Fire stop gaps to “stack A” around top of boxing and where waste pipe enters from sink. Boxing removed 14/10/22 to reveal the internals were appropriately fire stopped.**

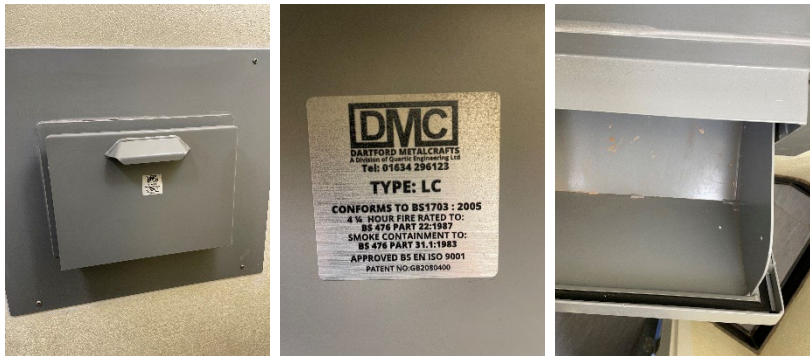
12) 23/02/23 - Refuse hoppers to all floors have been replaced with Dartford Metalcrafts Type LC – Conforming to BS1703: 2005

Smoke containment to BS476 part 31.1: 1983.
