# **Fire Risk Assessment**

## **St Clements House 1-36**

**Hallam Street, West Bromwich,  
B71 4HB.**

**Date Completed: 09/03/2026**

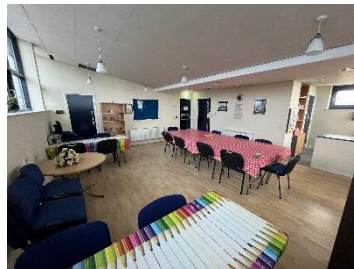
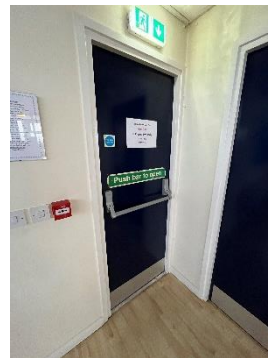
- 17) Flat front door inspections were not carried out by the fire risk assessor as the SMBC Fire rapid response team now undertake surveys of flat entrance doors. Records are recorded electronically by SMBC.
- 18) **The means of escape from the top floor communal room is facilitated by two exit doors each exiting onto either the front or rear escape stairwell. The communal room can be accessed by disabled persons using the platform lift from the 7<sup>th</sup> and 8<sup>th</sup> floor. There are no refuge facilities, no evac chair and no trained permanent staff.**

**The communal room is currently believed to be only used by the Tenants and Residents Association. A service level agreement is required to be drawn up to control access to the communal room, agree terms of use and to formalise fire safety procedures. See action 7/18.**

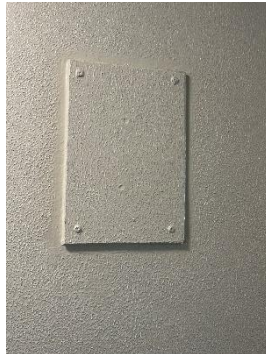
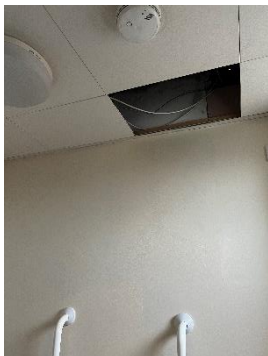
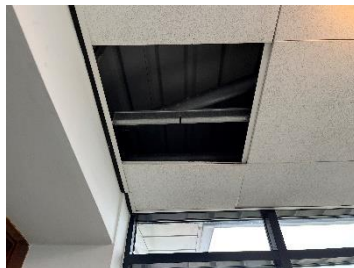
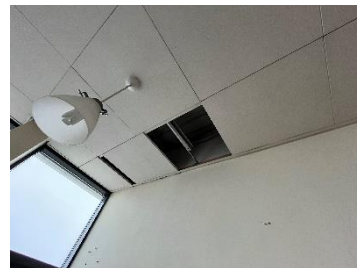
- 13) **Suspended ceiling panels are missing in the following areas: communal room, communal room toilet and at the top of the rear stairwell near the communal room entrance. Missing ceiling tiles can prevent or slow down smoke reaching detector heads. All missing ceiling tiles are required to be replaced. See action 10/13.**

10/13	Suspended ceiling panels are missing in the following areas: communal room, communal room toilet and at the top of the rear stairwell near the communal room entrance. All missing ceiling tiles are required to be replaced.

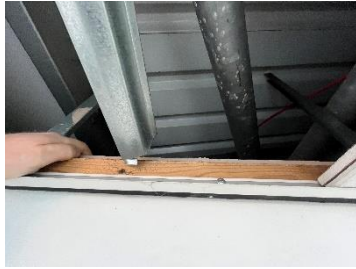
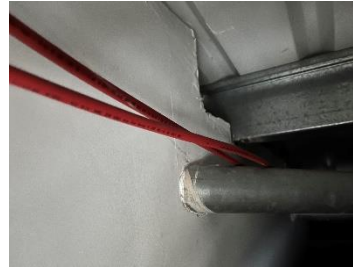
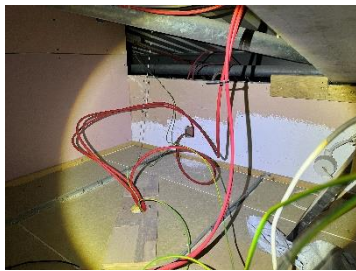
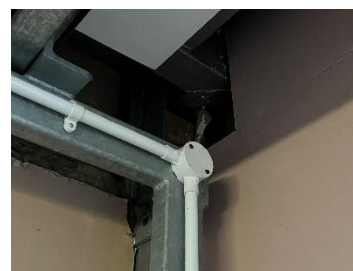
- 14) **Compartmentation above and around the communal room and on the outer side of both protected stairwells on the top floor is unsatisfactory and requires major rectification. It is recommended that the compartmentation above and around the communal room and on the outer side of both protected stairwells on the top floor and the disabled lift shaft receives major rectification by a suitably trained person. See action 10/14.**

P2	Fire Rapid Response 1 – 3 months.	
10/14	It is recommended that the compartmentation above and around the communal room and on the outer side of both protected stairwells on the top floor and the disabled lift shaft receives major rectification by a suitably trained person.

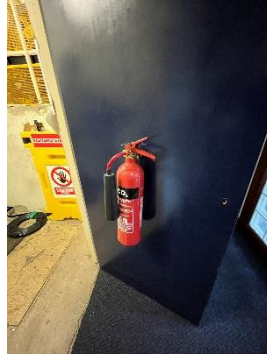
- 4) A portable fire CO2 fire extinguisher is provided in the lift motor room. A contract is in place for maintenance of the extinguisher. The frequency for the maintenance checks is once (October) each calendar year. There is no extinguisher information sign. A CO2 extinguisher information sign is required to be fitted. See action 11/4.
