# Fire Risk Assessment

## Astbury Court

**Hereford Road, Oldbury,  
B68 0QG**

**Date Completed: 11/04/25.**

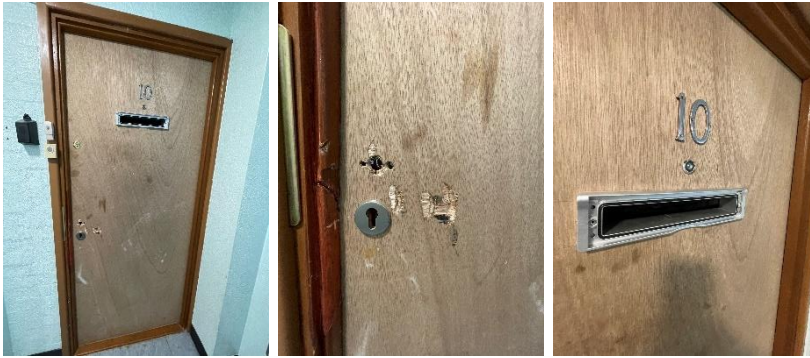
- 17) Individual flat doors are nominal FD30s rated timber fire doors sets predominantly manufactured by Russell Doors.
- 18) Flat 10 entrance door was noted as missing an outer letterbox plate, has superficial damage to the leaf, and two holes where mortice locks have been removed. Attempts to inspect the door from both sides were not possible due to the occupier not being home. A replacement FD30S door set has previously been requested & approved (SMBC job number JM-13853737). However, this was also noted within the FRA dated May 2024. It is essential that access is gained to this flat to in order to replace the damaged door set with a certified FD30S fire door set.**
-

Question/ Ref No	Required Action	Supporting photograph	Priority	Timescale and Person Responsible	Date Completed
7/18	Flat 10 Entrance door damaged and requires replacement FD30S. <i>This job was previously raised over 12 months ago JM13853737 but remains unresolved.</i>	 	P3	Within 3-6 months Asset Management

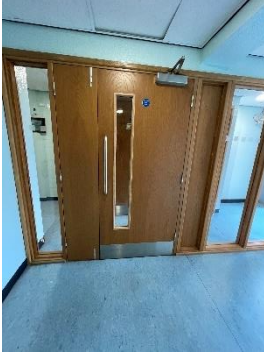
- 7) A ground and 7<sup>th</sup> floor lobby door both show small signs of staining within the vision panel. This does not adversely affect the doors integrity or ability to see through the panel. The doors are regularly monitored as part of the 12-weekley communal door checks.

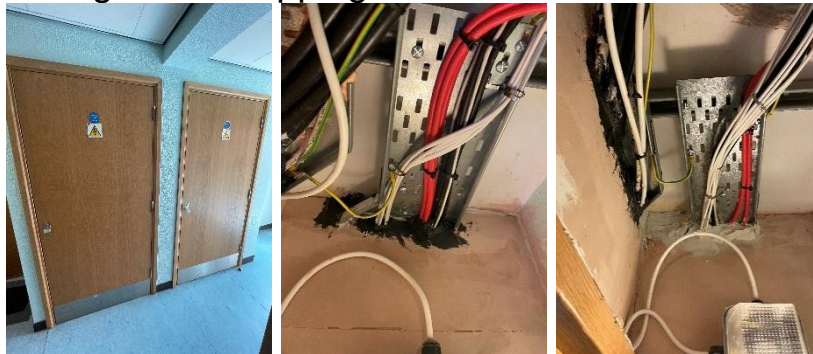
- 14) 4<sup>th</sup> floor service cupboard by flat 25 requires replacement section of combined intumescent strip / cold smoke seal.

P2	Within 1-3 months Fire Rapid Response	
10/14	4 <sup>th</sup> floor service cupboard door by flat 25 – replace missing section of intumescent strip / cold smoke seal.

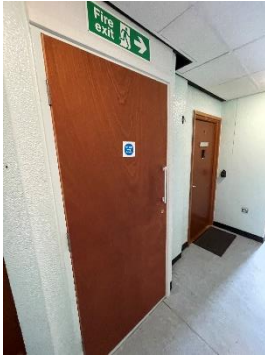
- 16) **2<sup>nd</sup> floor cupboard by flats 14 and 15 requires door handle re-fixing. The handle has been placed in the adjacent service cupboard.**

P2	Within 1-3 months Fire Rapid Response	
10/16	2 <sup>nd</sup> floor cupboard by flats 14 & 15 – refit door handle. Handle placed in adjacent storage cupboard.
