# Fire Risk Assessment

## Astbury Court

**Hereford Road, Oldbury,  
B68 0QG**

**Date Completed: 26<sup>th</sup> May 2022**

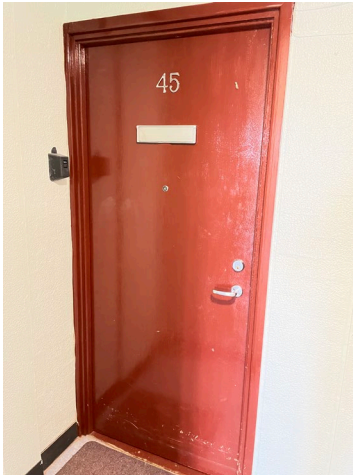
- 14) The surface coatings to the communal areas are Class 0 rated.
- 15) A number of flats have floor mats adjacent to front door which could cause a trip hazard – fire rating unknown.
- 16) Individual flat doors are FD30s rated. Access was gained to a sample of properties as part of the risk assessment to ensure the doors have not been tampered with by residents etc. Flats sampled were 3, 31, 40 & 45. It was not possible to sample any further flats at the time of the visit.

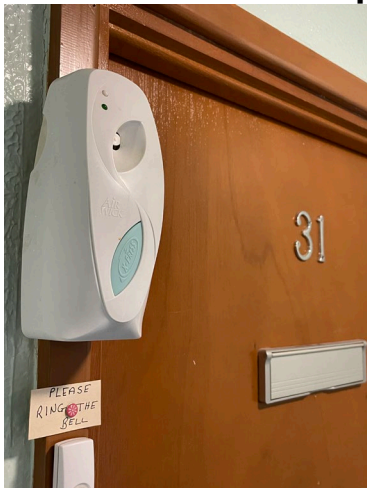
- 17) The building has sufficient passive controls that provide effective compartmentation in order to support a Stay Put-Unless Policy. Therefore, residents are advised to remain in their flat unless the fire directly affects them.
- 18) **The vinyl flooring leading to the rear final exit door on the ground floor is damaged and could cause a trip hazard.**
- 19) **Battery powered aerosol air freshening device to be removed from means of escape outside flat 31 on the 5<sup>th</sup> floor.**

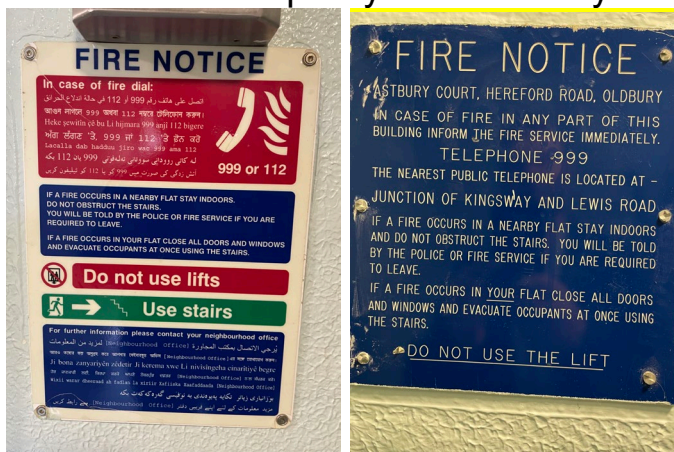
- 2) Fire Action Notices are displayed throughout the building on each floor; however, these are currently under review as they do not state the current policy which is Stay Put, Unless.

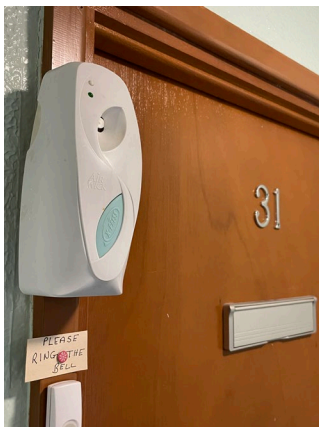
07/19	Remove battery powered aerosol air freshener o/s flat 31.

3	Housing Office Manager June 2022	21/06/2022
10/08	7 <sup>th</sup> floor - FD30s communal door excessive gaps / Cold Smoke Seal to be corrected near to flat 43.	No photograph	3	Fire rapid response team June 2022 JM8793414	07/06/2022
10/09	7 <sup>th</sup> floor - FD30s communal door excessive gaps to Cold Smoke Seal to be corrected near to flat 46	No photograph	3	Fire rapid response team June 2022 JM8793434	07/06/2022
10/10	7 <sup>th</sup> floor – FD60s door to bin shut room excessive gap to Cold Smoke Seal to be corrected.	No photograph	3	Fire rapid response team June 2022 JM8793454	08/06/2022
