Fire Risk Assessment

Russell House

**Holyhead Road,
Wednesbury, WS10 7BA**

Date Completed: 05/11/2025.

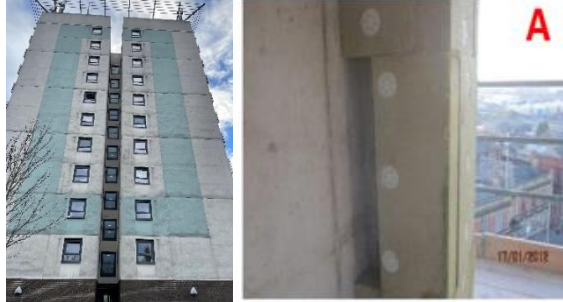
- Rockwool Insulated Render to gable walls. Fire Classification A2. Please see historic photo A taken 17/01/2012 indicating rockwool insulation behind.

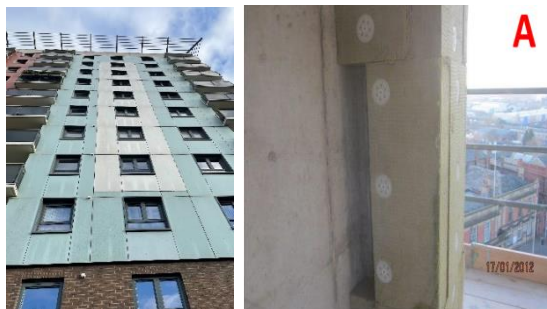
- High Pressure Laminate Panel. Front and rear façade. Fire classification B-S2, D0. Please see historic photo A taken 17/01/2012 indicating rockwool insulation behind.

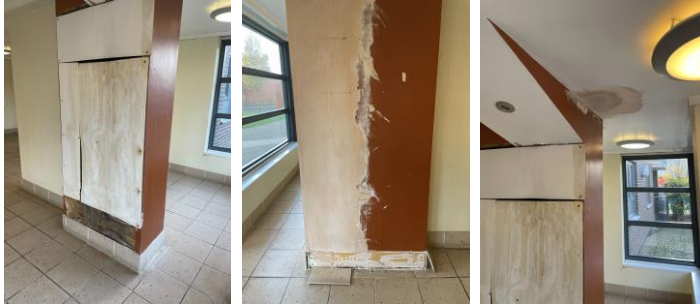
- 16) It was noted on the ground floor that some repairs have been carried out and bare plaster exposed. Further repairs are required to existing panels and the surface areas sealed with an appropriate finish and decoration required.

Question/ Ref No	Required Action	Supporting photograph	Priority	Timescale and Person Responsible	Date Completed
07/16	Carry out further repairs to existing panels and the surface areas sealed with an appropriate finish, then redecorate.

P3	Repairs 3-6 Months

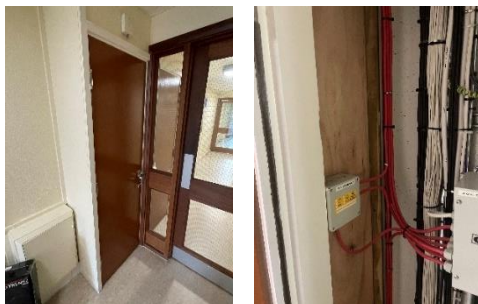
- 18) Service cupboards located within the corridors are 44mm nominal fire doors with intumescent strips and cold smoke seals secured with type 54 suited mortice locks. Service cupboards are FD30s rated.

Please note the newly constructed service cupboards (done as part of the 2012 refurbishment) are constructed from timber studding, plywood overlaid with 9mm Supalux. The plywood has been used to support all the internal fixtures, as Supalux is, by nature, quite brittle.

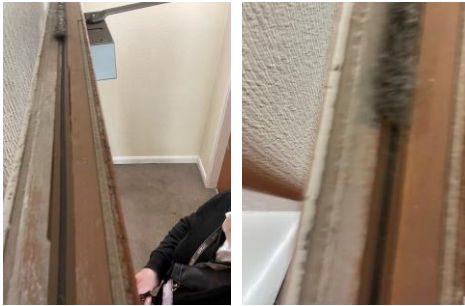
- 24) At the time of the assessment access was not gained by the fire risk assessor to properties to establish whether or not entrance doors have been tampered with by residents etc.
- 25) Replace combined cold smoke seal and intumescent strip in the community room door on the ground floor.**

- 26) Replace or repair top hinge in the ground floor community room door.**

07/25	Community room door top edge - replace combined cold smoke seal and intumescent strip.

P3	Fire Rapid Team 3-6 Months	
07/26	Replace or repair top hinge in the ground floor community room door.

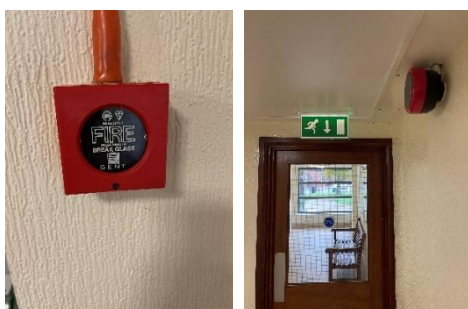
- 2) The main Fire Alarm control panel is located within the lift lobby area. At the time of the fire risk assessment the panel was not showing any detail on the screen. It has been clarified by the Electrical team that the communal alarm system has been decommissioned. This will avoid any conflict with the STAY PUT UNLESS Policy.
- 3) Break glass points are located on each floor adjacent to the stairs fire screen door throughout the premises. It should be noted that some obsolete break glass call points on the ground floor have been isolated and capped with a red blank. Sounders are also located on each floor level.

- 4) When any refurbishments are carried out within this building all existing and decommissioned equipment associated with the communal fire alarm system should be removed in its entirety.

- 5) This point has been raised for the last three years. An independent fire alarm system specifically for the community room on the ground floor should be installed.

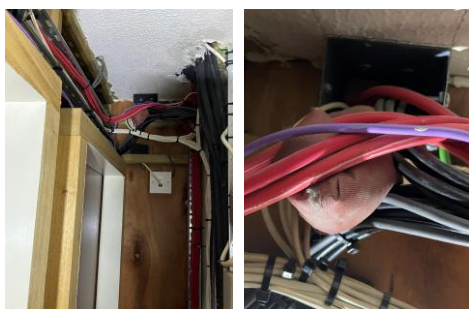
- 6) **On the 6th floor in the service cupboard, the intumescent pillows have become dislodged and need to be re seated or replaced with an alternative FR product.**

10/06	On the 6 th floor in the service cupboard, the intumescent pillows have become dislodged and need to be re seated or replaced with an alternative FR product.

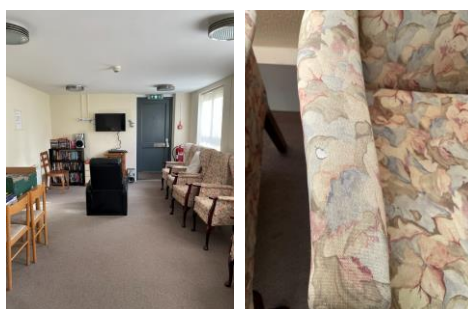
- 2) Hot working is not normally carried out. If essential maintenance requires the use of hot work processes, then corporate policies and procedures are to be followed.
- 3) Portable electrical equipment used as part of the Caretaking / Cleaning regime is subject to annual PAT Testing. This information is held by the Estate Services Manager Bryan Low.
- 4) **On the ground floor in the community room, it was noted that at least one armchair had tears in the fabric. These items should be taken out of service and disposed of.**

- 5) When purchased, armchairs did meet regulations set out within the furniture and furnishings (Fire Safety) regulations. **However, a system needs to be introduced whereby furnished items are checked at frequent intervals to ensure they are fit for purpose.**

P3	Fire Rapid Team 3-6 Months.	
14/04	On the ground floor in the community room, it was noted that at least one armchair had tears in the fabric. These items should be taken out of service and disposed of.

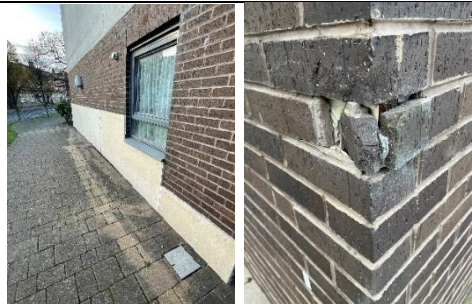
Observations		
As part of any future works programme consideration should be given to the installation of sprinkler systems in this LPS building.	No Image	
It was noted that some communal doors on various landings has excess gaps at the threshold of the door. As part of any future refurbishment consideration should be given to either replace these doors, doorsets, or install a drop down seals.	No Image	
Foam insulation behind brick slips. Management aware of situation. Combustibility rating unknown. Rectification works presently being discussed and should provide for an “A” rated insulation.
