Fire Risk Assessment

Neale House

**Glover Street,
West Bromwich, B70 6DZ**

Date Completed: 05/12/2025

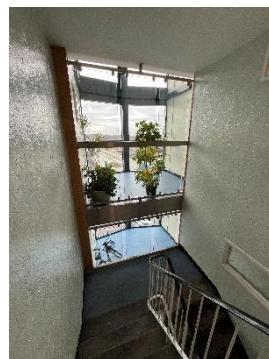
- 9) The building, on all floors, has an extended landing / atrium type space off the communal stairs. Potted house plants are displayed on some floors within the extended landings of the staircase. The plants do not cause an obstruction or present a fire risk within the escape route. Therefore, the risk is deemed to be low.

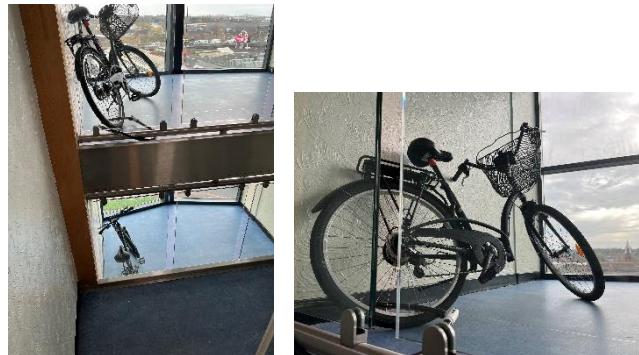
- 10) Bicycles were seen to be stored on the extended landings on the 7th and 6th floors. It is noted that these bicycles may not cause an obstacle to escape, however their presence may encourage other residents to use the common areas for storage. It is required that these bicycles are removed from the common area. See action 7/10.**

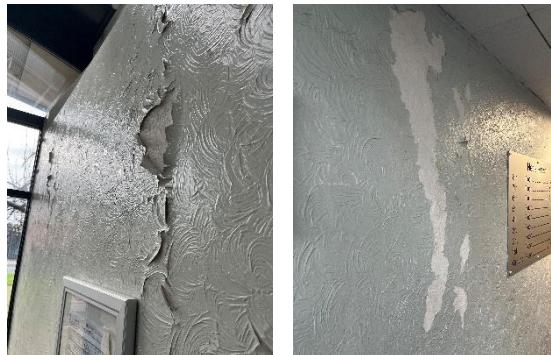
15) The surface coatings to the communal areas are Euro Class B-s3, d2 rated. It was noted that surface coatings in the ground floor lobby are peeling off the surface of the walls in some areas. This paint should be scraped off and repainted an appropriately rated material. See Action 7/15.

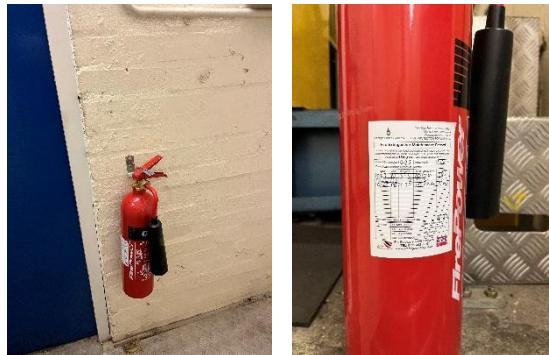
- 5) A portable fire extinguisher (CO2) is provided in the lift motor room. Maintenance contracts are in place for maintenance of the extinguisher. The frequency for the maintenance checks is once (October) of each calendar year. The CO2 extinguisher is missing its information notice, a suitable CO2 extinguisher information notice is required to be fitted. See action 11/5.

11/5	<p>The CO2 extinguisher in the lift motor room is missing an information notice. A suitable CO2 extinguisher information notice is required to be fitted.</p>
