# Fire Risk Assessment

## Hamstead House

**Coniston Crescent,  
Great Barr, B43 5NT**

**Date Completed: 06/11/2025**

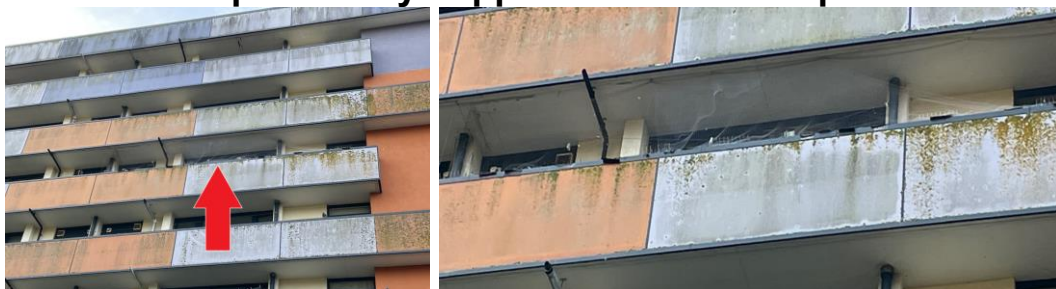
6. Flat 64 has installed a netting type material to the balcony which could potentially support the external spread of flame.

| Question/<br>Ref No | Required Action | Supporting photograph | Priority | Timescale<br>and Person<br>Responsible | Date<br>Completed |
|---|---|---|---|---|---|
| 6.6 | Flat 64 – to remove<br>netting / mesh type<br>material installed to<br>balcony. | | P3 | Within 3-6<br>months<br>Housing<br>Manager | |

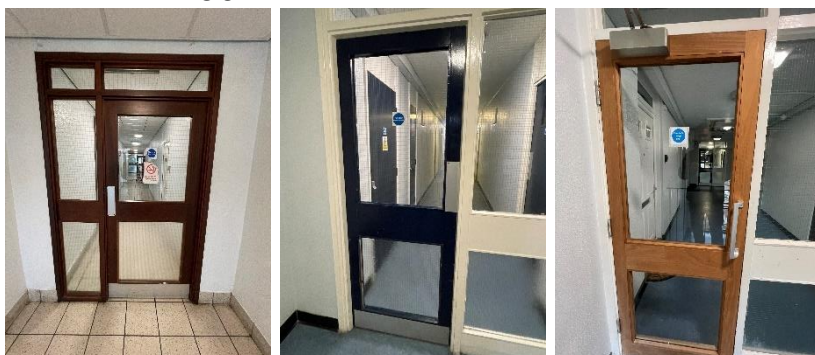
- 9) The communal cross corridor FD30s fire door is missing a lower vision panel. Replacement glass has been ordered, see job card below.

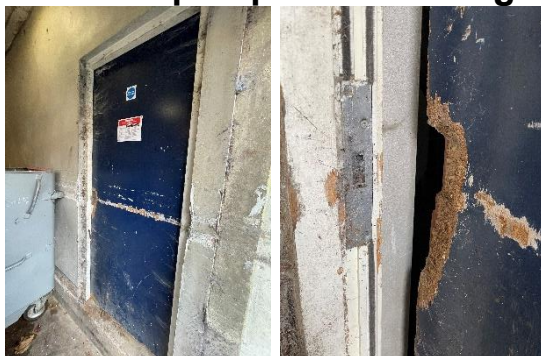
- 15) The door to the electrical intake room accessed via the bin store is a nominal FD60s timber fire door. **This door is damaged and requires replacement. The replacement door should be installed with a metal strip to prevent damage during the movement of bins.**

| 10/15 | FD60 service cupboard door in bin store damaged / to be replaced incorporating 54 suited mortice lock and metal protective strip to prevent damage from bins. | | P3 | Within 3-6 Months.<br>Fire Rapid Team | |

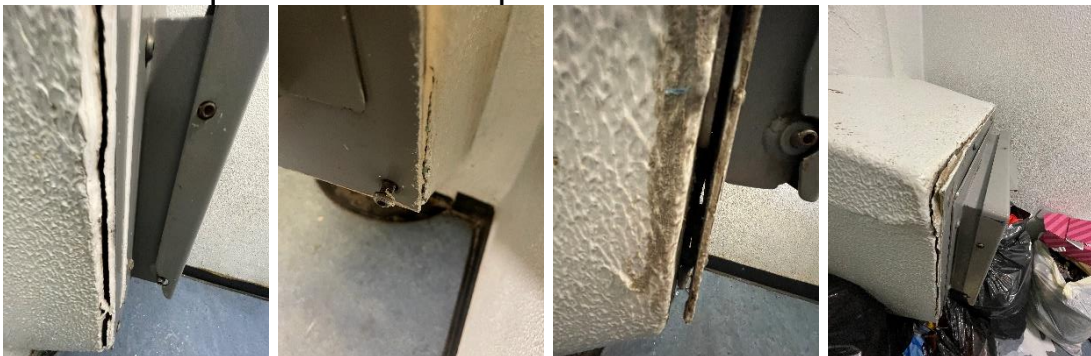
- 20) Flats 36, 61 & 66 have been recently surveyed for replacement entrance doors.
- 21) Seals around chute hoppers on several floors have failed and therefore require attention / repair.

- a) 10<sup>th</sup> floor hopper seal cracked / gaps / draught.**
- b) 7<sup>th</sup> floor hopper seal cracked / gaps / draught / securing bolt partially out.**
- c) 6<sup>th</sup> floor hopper is loose, seal cracked / gaps / draught**
- d) 5<sup>th</sup> floor hopper is loose, seal cracked / gaps / draught**
- e) 4<sup>th</sup> floor hopper is loose, seal cracked / gaps / draught**
- f) 3<sup>rd</sup> floor hopper seal cracked / gaps / draught.**
- g) 2<sup>nd</sup> floor hopper seal is cracked**
- h) 1<sup>st</sup> floor hopper seal is cracked / gaps / draught.**

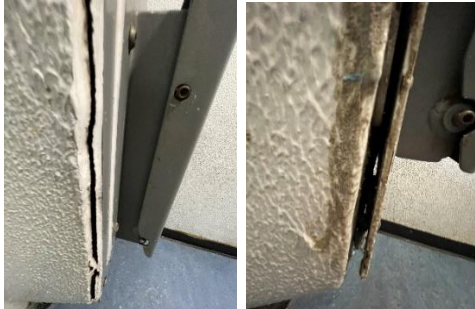
| 10/21a | 10 <sup>th</sup> floor hopper requires attention to rectify cracked seal / gaps / draught.<br><br><i>Generic image from the block</i> | | P3 | Within 3-6 Months<br>Repairs | |

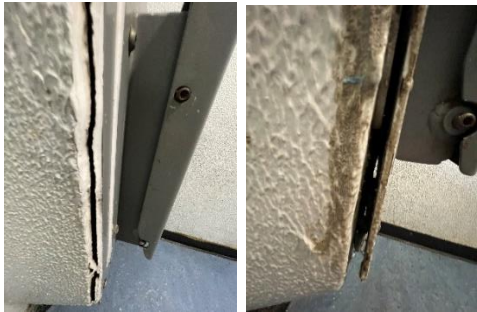
| 10/21f | <p>3<sup>rd</sup> floor hopper<br/>requires attention to<br/>rectify - cracked seal<br/>/ gaps / draught.</p> <p><i>Generic image from the block</i></p> | | P3 | Within 3-6<br>Months<br>Repairs | |

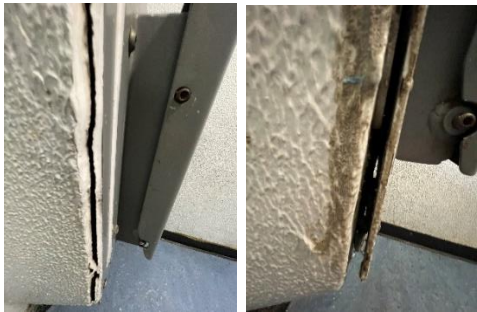
| 10/21g | <p>2<sup>nd</sup> floor hopper<br/>requires attention to<br/>rectify cracked seal.</p> <p><i>Generic image from the block</i></p> | | P3 | Within 3-6<br>Months<br>Repairs | |

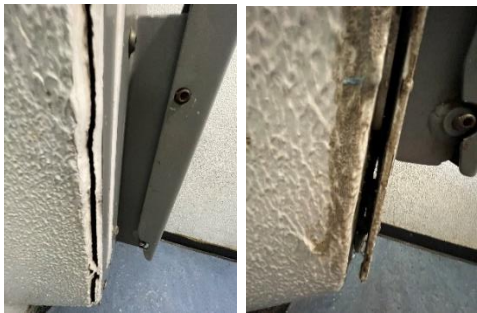
| 10/21h | <p>1<sup>st</sup> hopper requires<br/>attention to rectify -<br/>cracked seal / gaps /<br/>draught.</p> <p><i>Generic image from the block</i></p> | | P3 | Within 3-6<br>Months<br>Repairs | |
