Fire Risk Assessment

Hackwood House

**Hartlebury Road, Oldbury
B69 1EG**

Date Completed: 20/09/2022

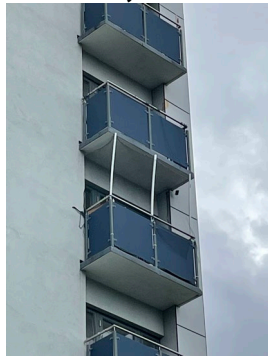
A. Flat 33, 6th floor has netting installed to balcony.

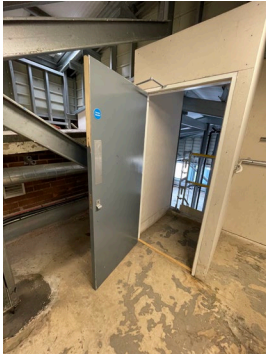
- 22) Door to upper roof area found to be unlocked and cannot be secured. Door is accessed via hopped ladder from lower roof area.**

3	P2 Within 1-3 months of assessment date. Housing Manager	15/11/2022
07/22	Access door to upper roof requires attention to ensure it can be secured by lock.

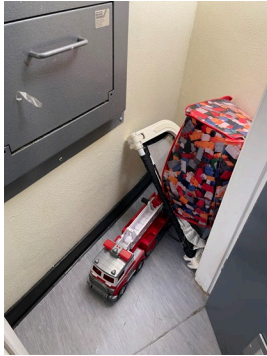
- 25) 11th floor chute room combustible items have been discarded.**

3	P2 Within 1-3 months of assessment date. Fire Rapid Response JM9598274	30/09/2022
07/25	Items to be removed from chute room

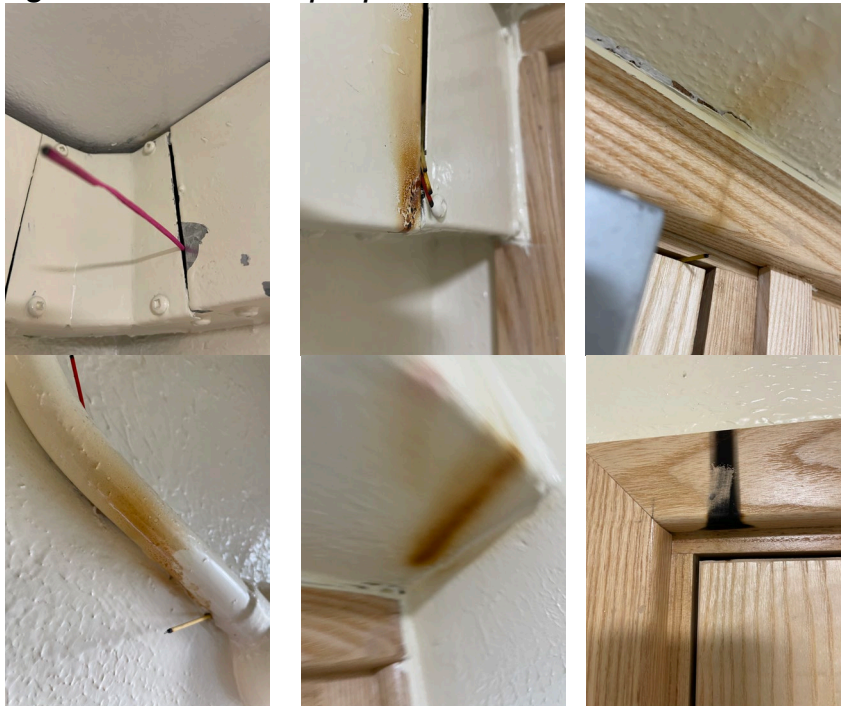
- 26) Evidence of scorching throughout the 10th floor on various surfaces. Scorching is caused by incense sticks that have been lit and wedged into various crevices. Over 20 incense sticks were found during this assessment. At the time of the visit all incense sticks were extinguished.**

22/09/22 Issue discussed on site with local housing officer who agreed to visit the properties on this floor.

07/26	Residents on the 10 th floor to be informed not burn incense sticks within any communal areas. Incense sticks are an ignition source and there is evidence of scorching to multiple surfaces. Also remove & dispose all remaining incense sticks from this area.

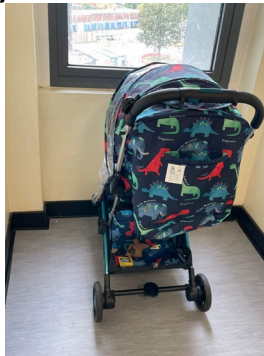
- 28) Pushchair left in the communal area on the 9th floor.**

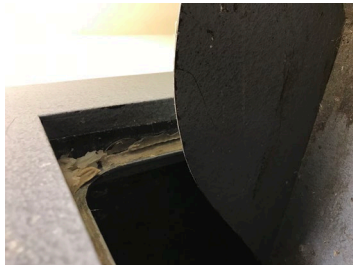
- 29) 10th floor seal missing from rubbish chute. *23/02/23 Hoppers to all floors have been replaced / upgraded ([Refer to Section 10](#))*.**

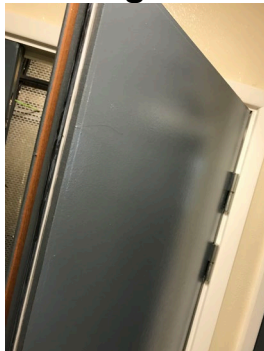
- 30) Service cupboard double doors on 8th floor adjacent flat 45 missing an intumescent strip**

fi 07/30	Intumescent strip to be replaced in service cupboard door on 8 th floor adjacent flat 45

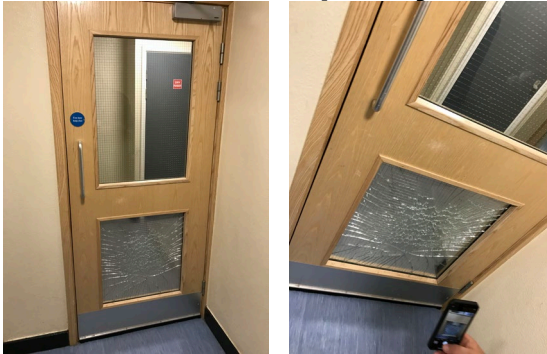
- 31) Vision panel within communal stairwell door on 7th floor has been broken. Temporary fix to secure glass is evident.**

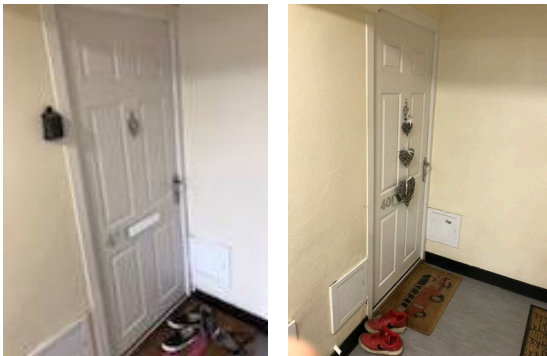
- 32) Several pairs of shoes left in communal area outside flats 40, 43 and 44 on 7th floor.**

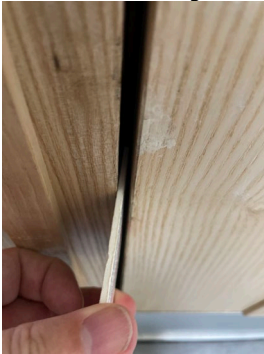
- 35) Excessive gap to lower leading-edge communal door on the 4th floor adjacent flat 24.

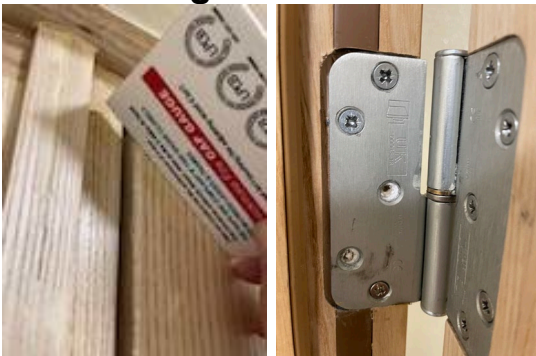
- 36) Communal door by flat 12 on the 2nd floor has an excessive gap on the leading edge resulting in the door not closing flush in the frame it is noted there is also 2 screws missing from the middle hinge.

07/36	2 nd floor adjacent flat 12 - communal door excessive gap on leading edge to be rectified and missing screws to centre hinge to be replaced.

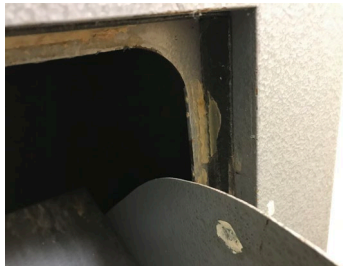
- 37) 1st floor rubbish chute, seal is missing. *23/02/23 Hoppers to all floors have been replaced / upgraded [\(Refer to Section 10\)](#).*

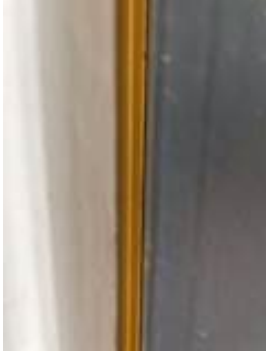
- 38) First floor communal chute room door has an excessive gap on the leading-edge, light is visible through the gap.**

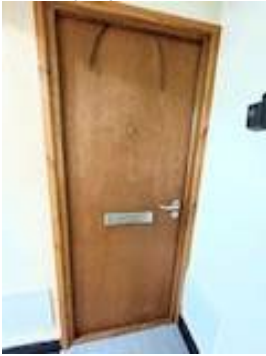
- 39) 2nd floor, flat 13 – It was noted that the draught seal has come away (door actioned in 10/5a).**

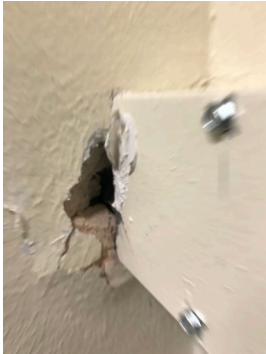
- 40) Hole in between wall and conduit on the 2nd to 3rd floor staircase to be fire stopped.**

3	P2 Within 1-3 months of assessment date. Fire Rapid Response JM9598816	30/09/2022
07/40	2 nd to 3 rd floor stairwell – apply suitable firestopping material to hole in wall against conduit.

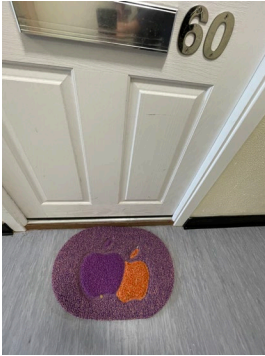
- 41) It is noted throughout the premise there are door mats outside flats. The fire rating of the doormats is unknown.

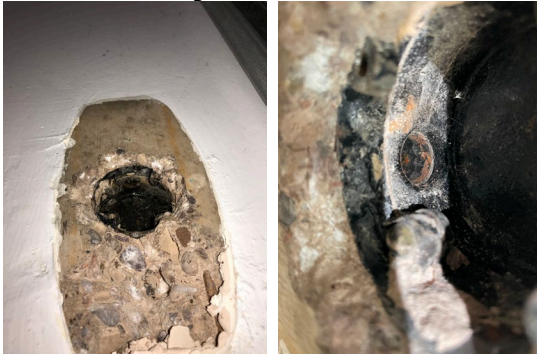
- 9) Hole in ceiling of external electrical / server room to be fire stopped. There are 2 additional holes within this hole running horizontally.

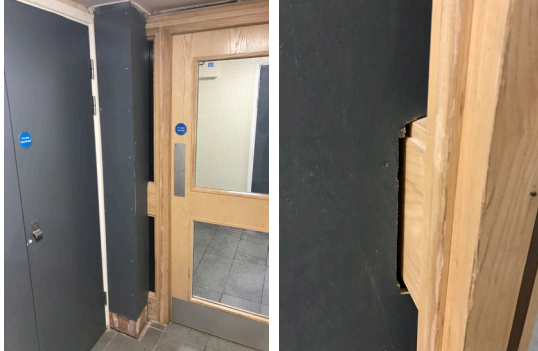
- 10) The boxing adjacent the ground floor service cupboard is insufficiently fire-stopped around communal door frame.

10/10	Boxing adjacent ground floor service cupboard requires fire-stopping around gaps against communal door frame with suitable material.

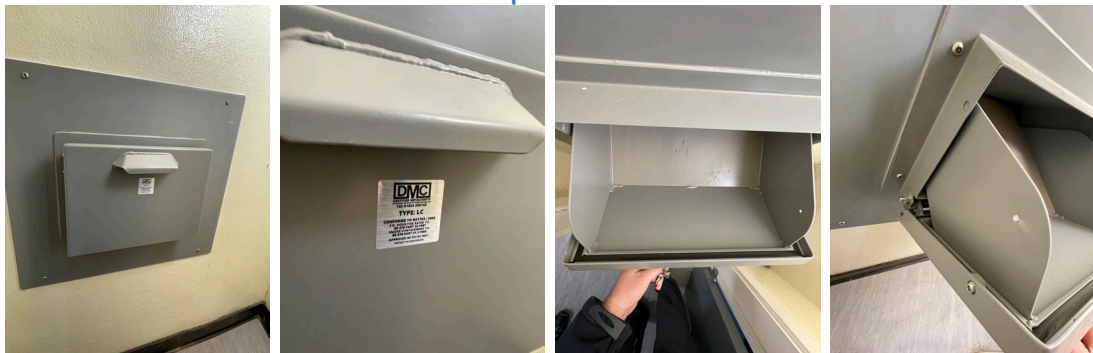
- 11) 23/02/23 - Refuse hoppers to all floors have been replaced with Dartford Metalcrafts Type LC – Conforming to BS1703: 2005

Smoke containment to BS476 part 31.1: 1983.

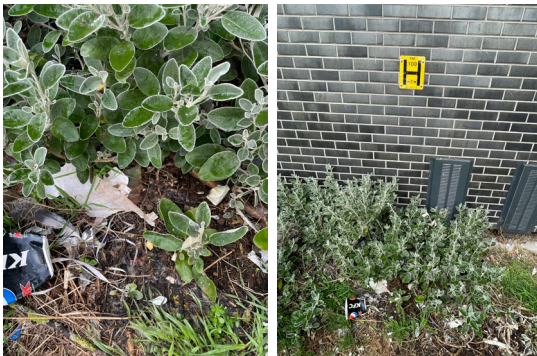
- 7) **Vegetation covering hydrant on the left hand side of the main entrance should be trimmed back so that hydrant is easily accessible.**

2	P2 Within 1-3 months of assessment date. Fire Rapid Response JM9598885	03/10/2022
11/7	Clear vegetation that has overgrown the fire hydrant to the righthand side of the main entrance.

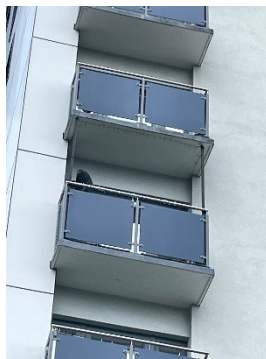
06/3b	Flat 34, 6 th floor – removed netting installed to balcony.

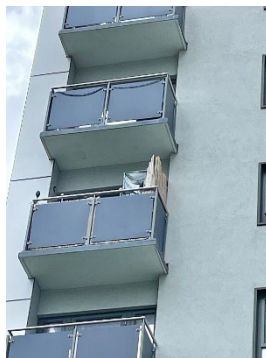
3	P2 Within 1-3 months of assessment date. Housing Manager	15/11/2022
06/3c	Flat 34, 6 th floor – remove wicker screening to balcony.

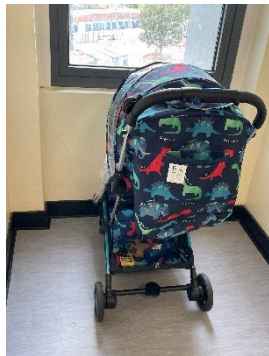
3	P1 Within 10 days of assessment date. Housing Manager	15/11/2022
07/28	9 th Floor - Removal of pushchair from communal area outside flats 54,55,56.

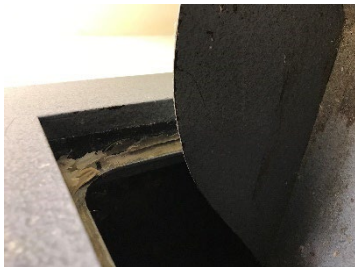
2	P2 Within 1-3 months of assessment date. Housing Manager	15/11/2022
07/29	Bin chute seal to be replaced on 10 th floor

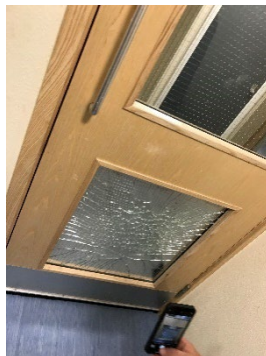
2	P2 Within 1-3 months of assessment date. Fire Rapid Response JM9598393	03/10/2022
07/31	Vision panel within communal door on 7 th floor to be replaced

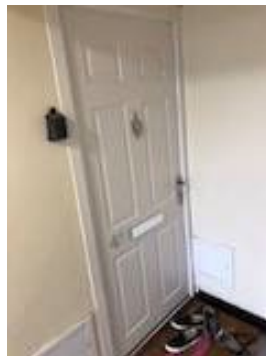
3	P1 Within 10 days of assessment date. Repairs Glazing	28/09/2022
07/32	Removal of footwear stored in communal corridor outside flats 40, 43, 44 on 7 th floor.

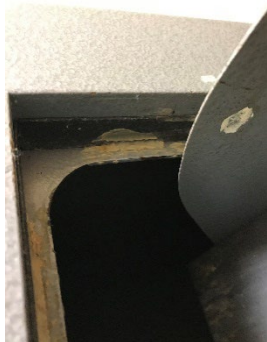
3	P2 Within 1-3 months of assessment date. Fire Rapid Response JM9598486	30/09/2022
07/37	Intumescent seal that is missing from the bin chute in the 1 st floor chute room to be installed.
