# Fire Risk Assessment

## Hackwood House

Hartlebury Rd, Oldbury,  
B69 1EG

**Date Completed:** 09/05/2025.

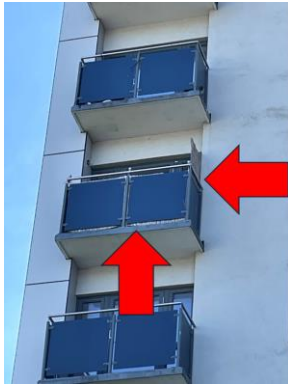
- 6) Flat 36 / 8<sup>th</sup> Floor – Installed 2 x timber based screening across balcony which has the potential to support the surface spread of flame.**
-

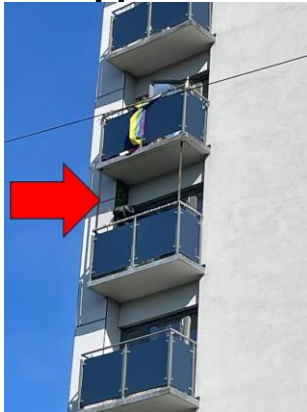
- 7) Flat 34 / 6<sup>th</sup> floor – Installed netting to balcony has the potential to support the surface spread of flame.**

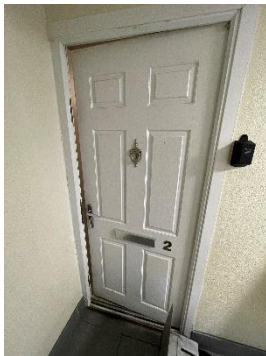
- a) **Flat 2 door – Requires adjustment as failing to reliably overcome the latch.**

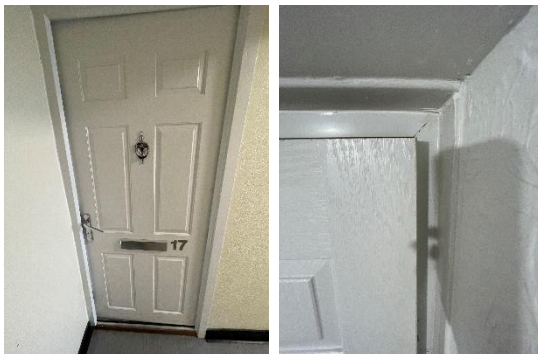
- b) **Flat 17 door - Requires adjustment as failing to reliably overcome the latch / door leaf binds on leading edge.**

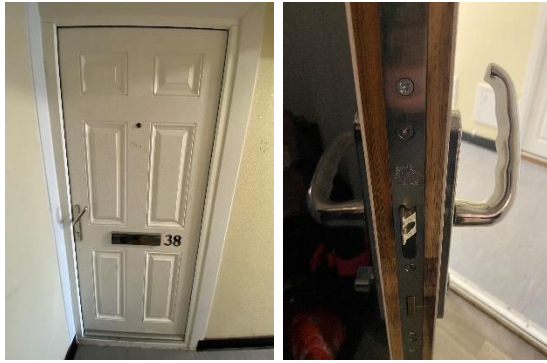
- c) **Flat 38 door – Requires adjustment as failing to reliably overcome the latch. Also sticking door handle requires attention.**

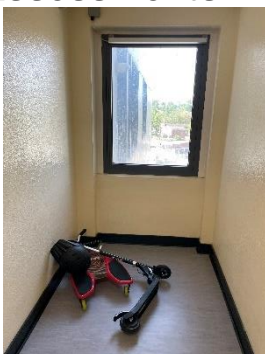
**9<sup>th</sup> floor corridor adjacent flats 54, 55, 56 – 2 x children's scooters in communal area should be removed to maintain a sterile environment. It has been noted that items have been recorded in the same location in two previous fire risk assessments.**

7/18	Remove scooters from communal corridor adjacent flats 54,55,56.	 	P2	Within 1-3 months Housing Manager	
8/3	Flat 58 – Combined Heat / CO detector low backup battery sound is audible.	<div> <div><b>Ei3028 Report</b> May 9, 2025, 11:38 am</div> <div> <div>ALARM AGE2 years 226 days</div> <div>REPLACEMENT DUESep 2033</div> </div> <div> <div>MAINS POWER STATUSOFF</div> <div>TIMES MAINS POWER OFF LAST TIME198.0 days46</div> </div> <div> <div>ALARM ON FOR1 year 239 days</div> <div>BATTERY

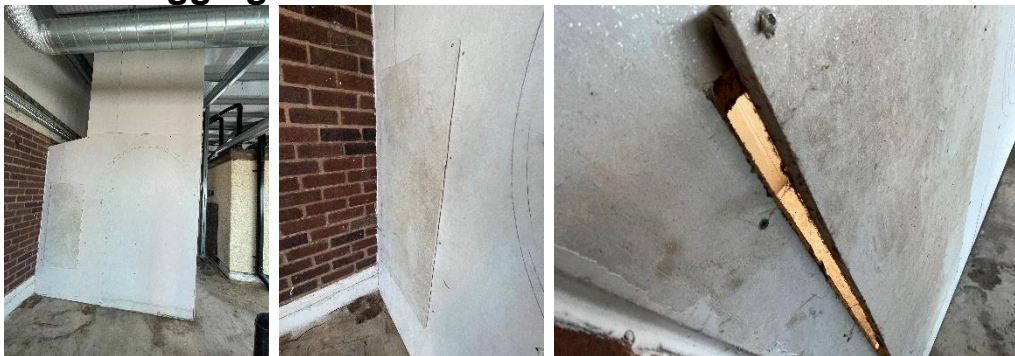
It has been acknowledged that the automatic opening vent shaft in the roof void requires attention due to an access panel which has not been sufficiently installed following repair thus creating a small gap between the shaft and the roof void. This could potentially lead to some smoke logging within the roof void however, this is a controlled area with effective compartmentation between the roof void, flats and communal areas. A relatively simple repair will quickly resolve the issue.

- 8) **12<sup>th</sup> floor Automatic Opening Vent smoke shaft in roof void, adjacent flat 70. The shaft has previously been accessed to facilitate repair to the AOV however, the access panel hasn't been suitably reinstated. This could potentially cause some smoke logging to this side of the roof void in the event of a fire.**

10/8	12 <sup>th</sup> floor roof void adjacent flat 70 – Re-fit or replace AOV shaft panel to prevent the leakage of smoke into the roof void.

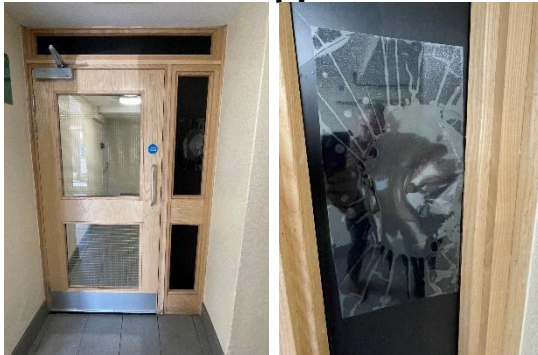
- 10) Cracked glazing to ground floor communal door near flats 1 & 2 to be replaced with suitable fire resistant glass. Protective film has been applied as a temporary repair.**

P2	Within 1-3 months Rapid Fire Team	
10/10	Ground floor communal door adjacent flats 1 & 2 – Replace damaged fire resistant glazing within fire door frame.

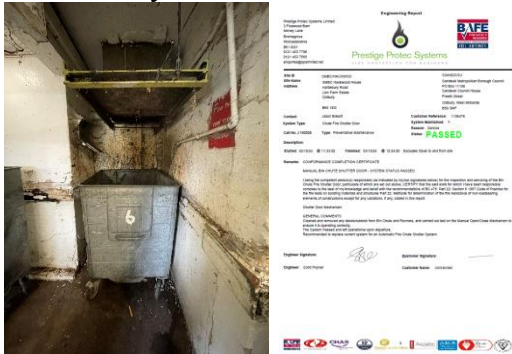
- 7) There is a closure plate installed to the refuse chute. The system is manually operated only with no automatic function and is serviced 6-monthly. Observation recorded in section 19.

<b>Observations</b>	
Recommend the manual chute closure plate to the bin store is replaced with a suitable automatically (fusible link) closing fire closure plate.

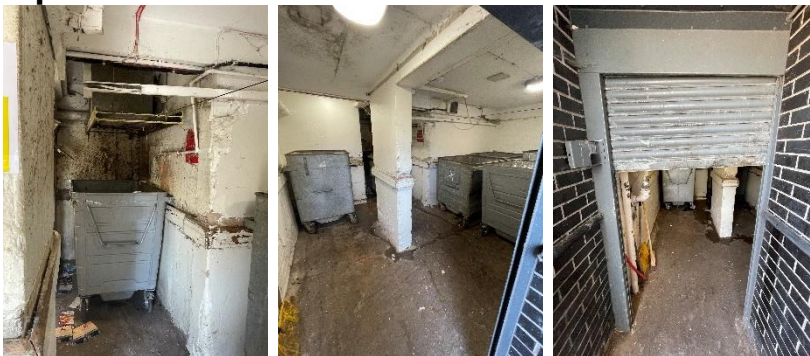
- 3) **Refuse containers are located in the bin store at ground level. The roller shutter door was noted as defective and requires repair. The bin store should be secured.**

P4	<p>Programmed Work Electrical Compliance Manager.</p>	
15/3	<p>Bin store roller shutter door defective and requires repair. (Also reported by caretaker).</p>
