# Fire Risk Assessment

## Thompson Gardens

**1-89, Hales Lane,  
Smethwick, B67 6RX**

**Date of Inspection: 16<sup>th</sup> September 2026**

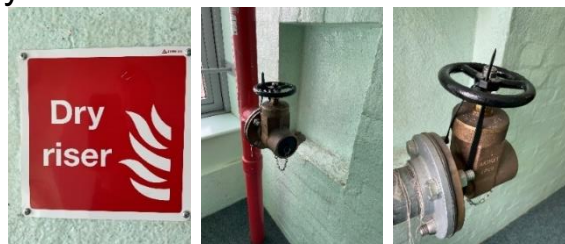
Dry riser outlets are available on each floor lobby. Each outlet is secured in the off position by cable tie.

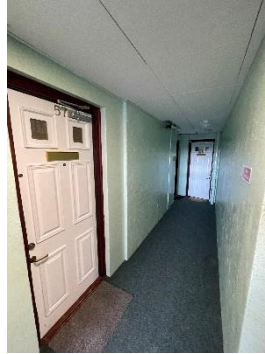
- 14) Individual floor mats were noted outside some flats. Fire rating of the mats is unknown but deemed to be a trivial risk.

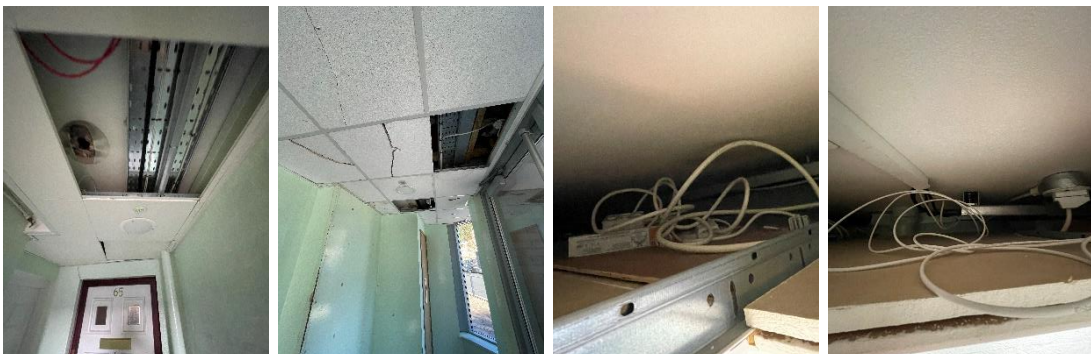
- 16) Multiple damaged and displaced suspended ceiling tiles were identified throughout the building's communal areas on a number of floors. The damaged ceiling sections expose building services and loose cabling located within the ceiling void. While no immediate signs of fire damage or electrical defects were observed, the condition of the false ceiling system detracts from the standard of fire safety management and may increase the likelihood of damage to building services.

The exposed cabling and open ceiling voids may also hinder effective inspection and maintenance activities and could lead to unauthorised interference with electrical installations.

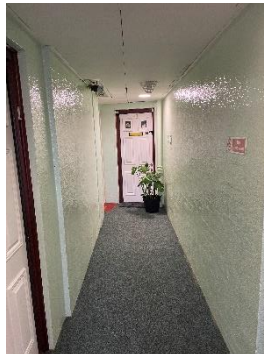
- 19) No significant accumulation of combustible materials was identified at the time of the fire risk assessment. However, it should be noted that fly-tipping has been an ongoing issue within the building, with items periodically being left in communal areas and adjacent to final exit routes. This matter is managed through the combined efforts of the Building Safety Team, Housing Management, Caretaking Services, and Waste Management, who work collaboratively to remove such items promptly and minimise the associated fire risk and obstruction to means of escape.

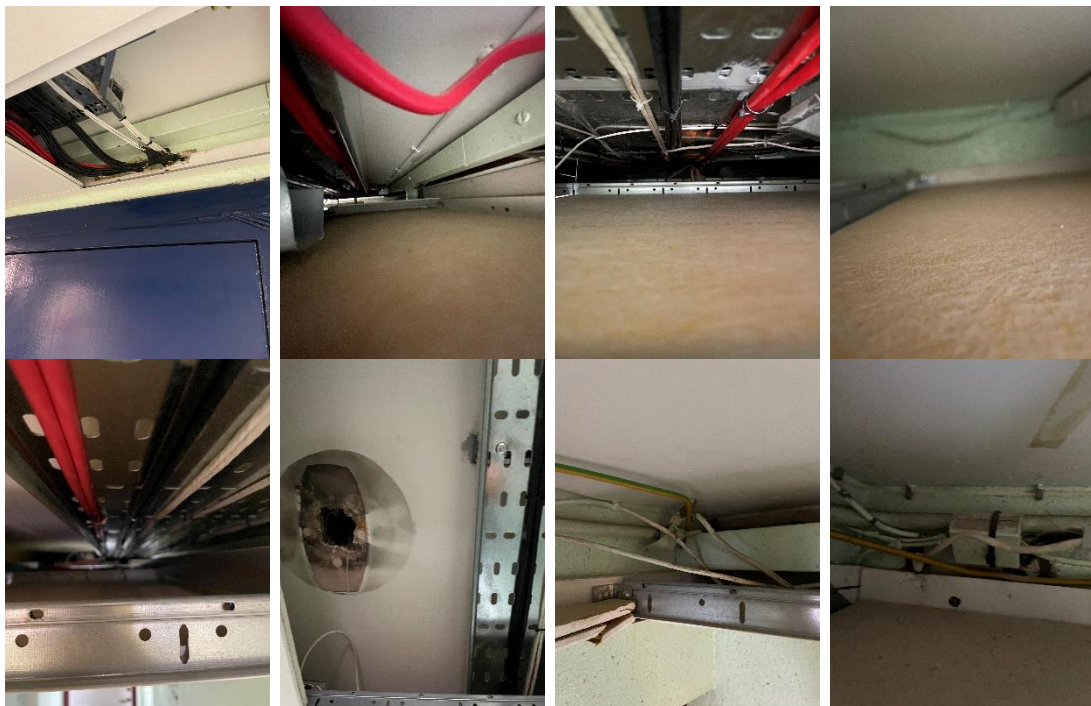
- 15) The corridors / staircases are protected by use of self-closing notional or nominal 44mm fire doors with combined intumescent strips / cold smoke seals and vision panels consisting of Georgian wired glazing. It was noted that some general wear and tear/ superficial damage could be seen on some of the communal doors within the block however this will not affect the doors performance.
- 16) A sample-based inspection of the suspended ceiling voids was undertaken at strategically selected locations throughout the building, including areas above communal doors, flat entrance doors, and service cupboards, to assess the condition of compartmentation and fire-stopping measures. No deficiencies relating to fire stopping or compartmentation were identified within the areas inspected.

However, evidence of historic lighting removals was noted in several locations, where openings remain within the ceiling and appear to penetrate the floor slab above. The full extent, depth, and construction detail of these openings could not be determined during the visual inspection, and it was therefore not possible to confirm whether compartmentation has been adversely affected.
