Fire Risk Assessment

Thompson Gardens

**1-89, Hales Lane,
Smethwick, B67 6RX**

Date Completed: 23/09/2025.

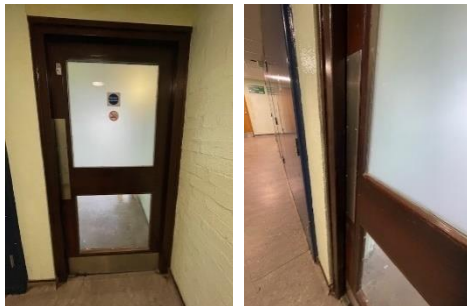
- 23) The Staircase door on the ground floor, outside flat 3, by the rear access door needs the self-closer adjusting. The door is not closing correctly.**

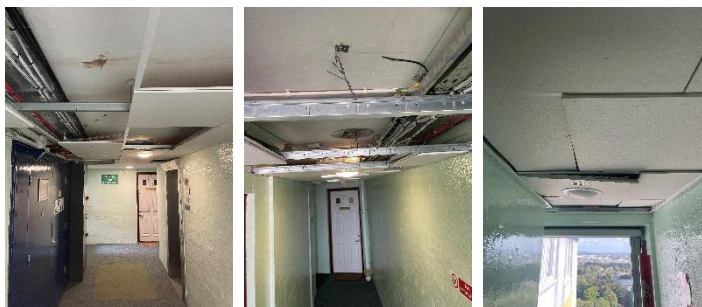
- 24) Numerous ceiling tiles were noted as missing from the suspended ceilings within lobbies on floors P/14th, O/13th, N/12th, L/10th, K/9th, G/6th, F/5th, D/3rd, B/1st & Ground floor. The missing tiles revealed that electrical cabling above was secured to cables trays utilising a combination of metal and plastic fastenings.

- 25) As set out above, ceiling tiles should be reinstated to protect the cabling above from any potential fire or other ignition sources, it's recognised that the missing tiles of from a sterile area and good practice dictates that tiles are replaced.**

P2	Within 1-3 months Fire Rapid Response	
07/25	Replace missing ceiling tiles within lobbies on floors P/14 th , O/13 th , N/12 th , L/10 th , K/9 th , G/6 th , F/5 th , D/3 rd & B/1 st & Grd floor.

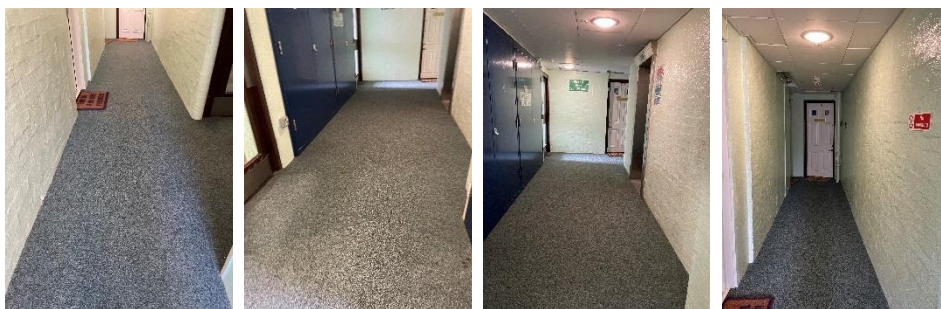
- 27) At the time of the assessment, it was noted that landing floors were fitted with carpet. It should be confirmed that carpets have been procured in accordance with BS 5287: 1988 specification for assessment and labelling of textile floor coverings and & BS 4790 Fire Test to Textile Floor Coverings.

These carpets have been procured by SMBC utilising third party approved contractors. Therefore, it is understood that carpets fitted meet the approved standard.

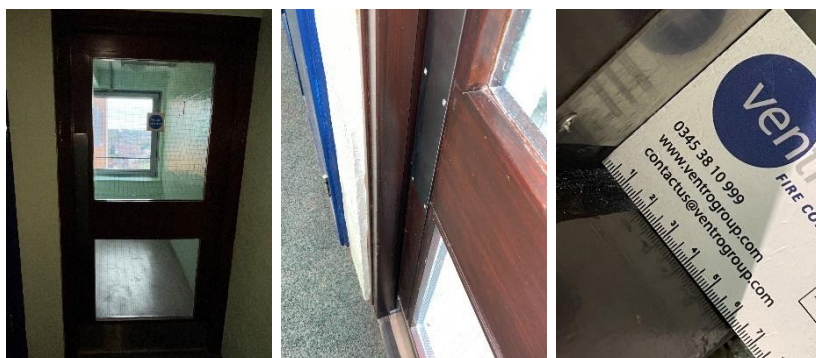
- 7) It has been recognised that all of the landing / staircase notional doors in this block have been upgraded with combined intumescent strips & cold smoke seals to enhance their original design. There were minor shortcomings that have been identified, and actions have been created for corrective works or replacement.
- 8) **Floor L (10) – Communal door to stairwell by flat 63, leaf is warped and requires replacement. This is a newly fitted door, unfortunately it is a poor fit & bounces off the door frame.**

P2	Within 1-3 months Asset Management	
10/08	Floor L (10) – Communal door to stairwell by flat 63, leaf is warped and requires replacement. This is a newly fitted door, unfortunately it is a poor fit & bounces off the door frame.	Discussed with the Fire Rapid Response team at site.	P2	Within 1-3 months Fire Rapid Response

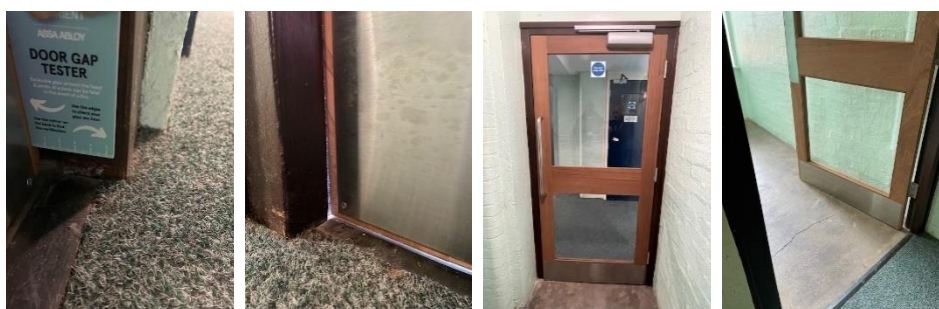
- 9) **Floor J (8) – Communal door to stairwell by flat 51, leaf is warped and requires complete replacement.**
- 10) **Floor H (7) – Communal door to stairwell by flat 42, leaf is warped. This is a newly fitted door, it is a poor fit & sits approx. 25mm off the door frame.**
-

- 11) Floor G (6) – Communal door to stairwell by flat 36, leaf is warped. This is a newly fitted door, but it is a poor fit.
- 12) Floor F (5) – Communal door to stairwell by flat 30, leaf is warped. This is a newly fitted door, it is a poor fit.
- 13) Floor C (2) – Communal door to stairwell by flat 15, leaf is warped. This is a newly fitted door, it is a poor fit, you can see daylight at the base of the door.
- 14) Floor B (1) – Communal door to stairwell by flat 9, leaf is warped. This is a newly fitted door, but it is a poor fit.
- 15) Floor D (3) - Staircase door outside flat 21, the footplate on the lower door needs to be realigned, this will ensure the door closes correctly.

10/09	Floor J (8) – communal door to stairwell by flat 51, leaf is warped and requires complete replacement.	Discussed with the Fire Rapid Response team at site.	P2	Within 1-3 months Fire Rapid Response	
10/10	Floor H (7) – Communal door to stairwell by flat 42, leaf is warped. This is a newly fitted door, it is a poor fit & sits approx. 25mm off the door frame.	Discussed with the Fire Rapid Response team at site.	P2	Within 1-3 months Fire Rapid Response	
10/11	Floor G (6) – communal door to stairwell by flat 36, leaf is warped. This is a newly fitted door, but it is a poor fit.	Discussed with the Fire Rapid Response team at site.	P2	Within 1-3 months Fire Rapid Response	
10/12	Floor F (5) – communal door to stairwell by flat 30, leaf is warped. This is a newly fitted door, it is a poor fit.	Discussed with the Fire Rapid Response team at site.	P2	Within 1-3 months Fire Rapid Response

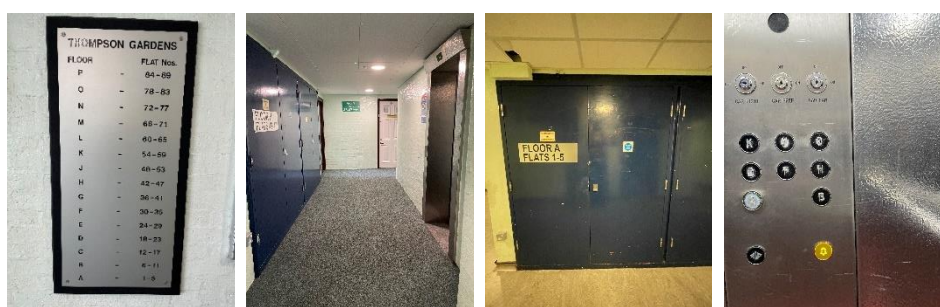
- 7) Following the previous Fire Risk Assessment in August 2024, the issue of inconsistent signage was raised by the assessor. For example, inconsistencies with terminology with the elevator call buttons, AOV Repeater panel, and the signage in the main entrance lobby using letters rather than numbers.

An onsite meeting has taken place between SMBC and WMFS who have clarified that the current signage is acceptable and will not cause any confusion to responding operational fire crews in an emergency.
