Fire Risk Assessment

St Mary's House 1-64

**Summer Street, West Bromwich,
B71 4HZ.**

Date Completed: 11/03/2026

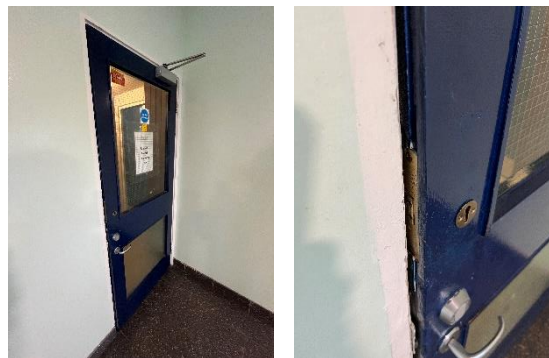
- 6) **The leaf of the communal fire door leading into the caretaker's area fails to close into its frame correctly and requires adjustment. See action 7/6.**

Question/ Ref No	Required Action	Supporting photograph	Priority	Timescale and Person Responsible	Date Completed
7/6	The leaf of the communal fire door leading into the caretaker's area fails to close into its frame correctly. The door requires adjustment to close correctly.

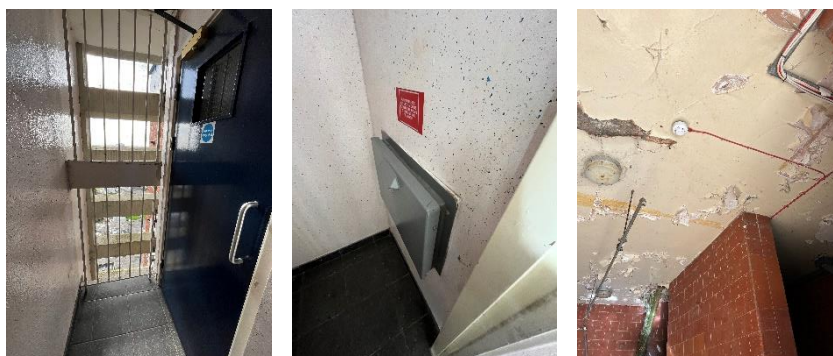
- 11) Refuse chute hoppers are available on each floor, protected by FD30s doors. The chute system is connected to the bin store at the rear of the building. Peeling paint is present on ceiling of the bin store. This peeling paint should be removed, and fresh class 0 or equivalent spec paint should be applied. See action 7/11.**

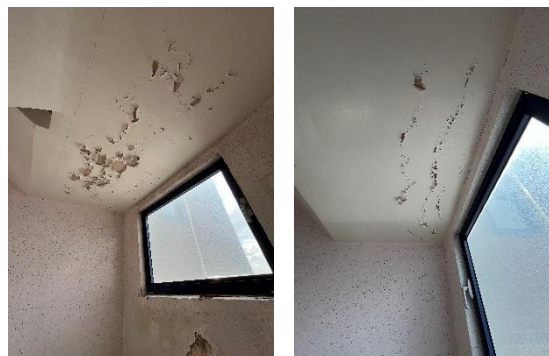
- 14) The surface coatings to the communal areas are Class 0. Peeling paint is present on ceiling of the half landings between floors 15/14, 14/13, 11/10, 6/7 and 2/1. This peeling paint should be removed, and fresh class 0 or equivalent spec paint should be applied. See action 7/14.**

P2	Repairs 1 – 3 months.	
7/14	Peeling paint is present on ceiling of the half landings between floors 15/14, 14/13, 11/10, 6/7 and 2/1. This peeling paint should be removed, and fresh class 0 or equivalent spec paint should be applied.

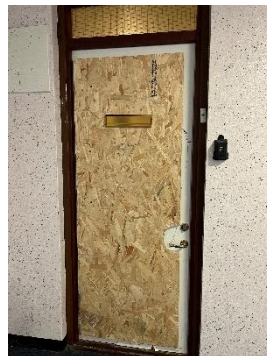
- 17) Flat 57 front door on the 15th floor is damaged. A replacement flat front door is required to be fitted. See action 7/17.**

P2	Repairs 1 – 3 months.	
7/17	Flat 57 front door on the 15 th floor is damaged. A replacement flat front door is required to be fitted.

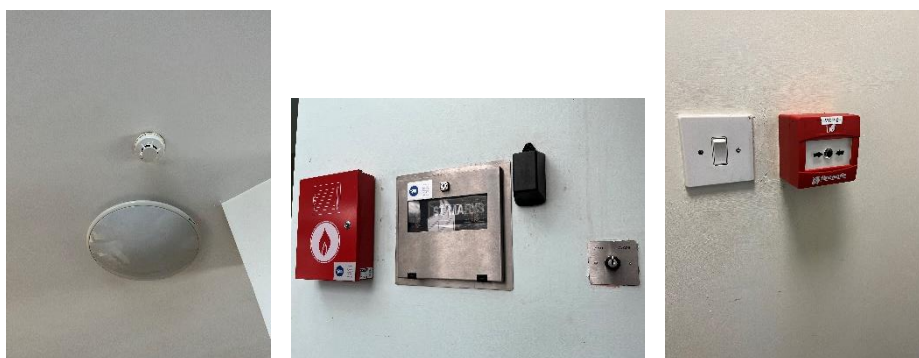
- 1) Early warning is limited to hard wire or battery smoke alarms within each of the resident's flats. The equipment is subjected to a cyclical test by the resident.
- 2) **The communal room on the ground floor has an automatic fire alarm system that appears to conform to BS5839. There are detector heads, sounders and manual call points. The fire alarm control panel is sited on a wall in the main entrance foyer. This panel indicates that the alarm system is zoned, however there is no zone plan present. It is required that a zone plan is provided near the fire alarm control panel. See action 8/2.**

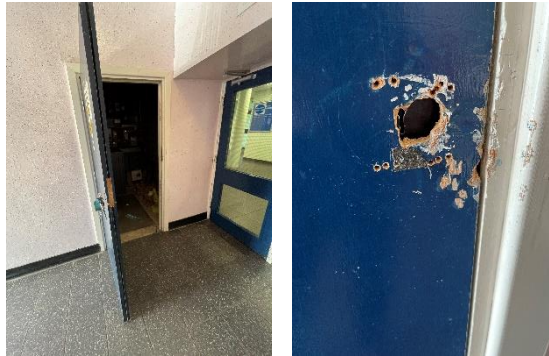
- 8) The main electrical cupboard on the ground floor has damage around the lock and a missing escutcheon plate. These defects are required to be rectified. See action 10/8

<p>P2</p>	<p>Electrical 1 – 3 months.</p>	
<p>10/8</p>	<p>The main electrical cupboard on the ground floor has damage around the lock and a missing escutcheon plate. These defects are required to be rectified.</p>

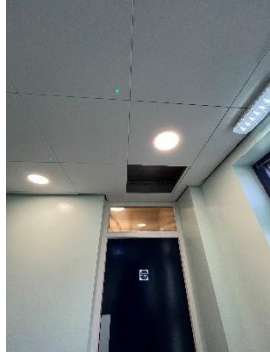
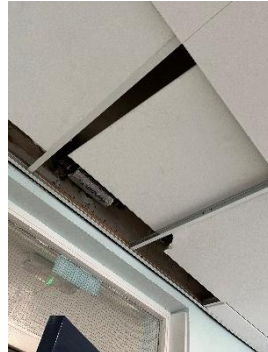
- 14) **Suspended ceiling panels are missing in the ground floor foyer areas. All missing ceiling tiles are required to be replaced. See action 10/14.**

<p>P2</p>	<p>Fire Rapid Response 1 – 3 months.</p>	
<p>10/14</p>	<p>Suspended ceiling panels are missing in the ground floor foyer areas. All missing ceiling tiles are required to be replaced.</p>

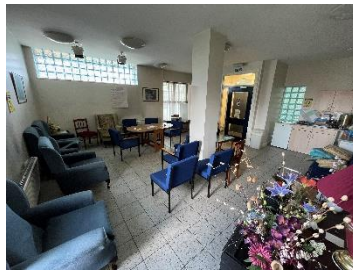
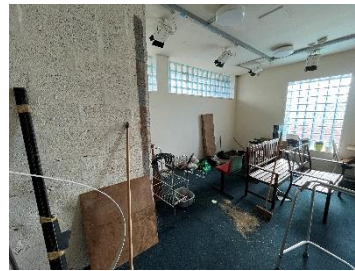
- 9) **The communal room and storeroom opposite on the ground floor have large amounts of combustible storage within them. This amount of combustible storage is required to be significantly reduced and an improvement in housekeeping is required. See action 14/9.**
