Fire Risk Assessment

Heronville House

**Sedgley Rd East,
Tipton, DY4 7TX**

Date Completed: 13/12/2022

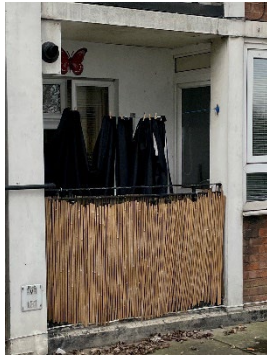
A. Flat 62 (ground floor) has wicker screening to balcony which could potentially support the surface spread of fire.

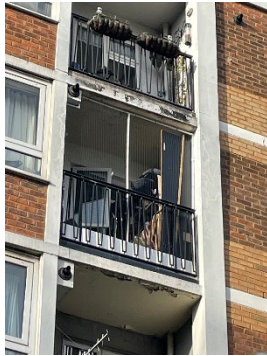
- D. Flat 106 (4th floor) has installed what appears to be netting or mesh to the balcony. There also appears to be a number of items that may be combustible present on the balcony such as a timber door or worktop and cardboard alongside other unknown materials, all of which could potentially support the surface spread of fire.**

P2	Within 1 to 3 months of action plan date. Housing Manager	15/05/2023
06/03d	Flat 106 – remove installed netting/mesh & excessive combustible items on balcony.

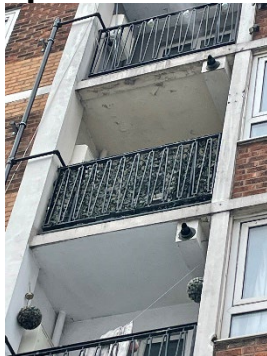
- E. Flat 102 (4th floor) has installed decorative screening to the balcony which could potentially support the surface spread of fire.**

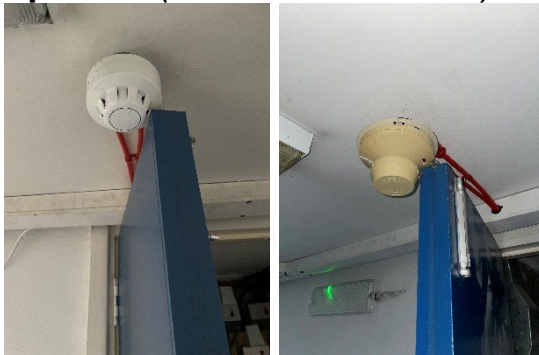
- 10) The left-hand door to the service cupboards on 4th and 5th floors foul on the automatic ventilation detector head when opened. *(Resolved 02/01/23)*

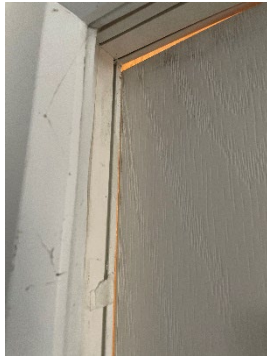
Flat 74 – entrance door doesn't reliably self-close into frame. Door binds on upper corner against frame.

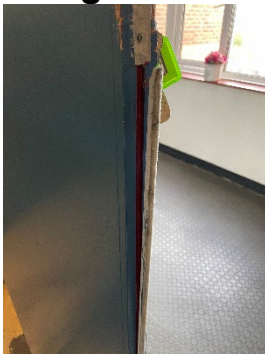
- 22) 5th floor service cupboard by flat 112 – Combined intumescent strip / cold smoke seal is loose and requires fixing within R/H door.**

P2	Within 1 to 3 months of action plan date. Fire Rapid Response. JM:10081185	12/01/2023
07/22	5 th floor by flat 112 – combined intumescent strip / cold smoke seal requires fixing to door / hangs loose.

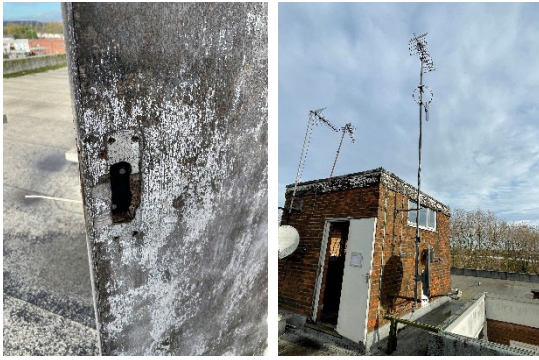
- 23) External handle to roof access door is detached from door.**

P2	Within 1 to 3 months of action plan date. Fire Rapid Response. JM:10081245	11/01/2022
07/23	Reinstate external handle to roof access door.

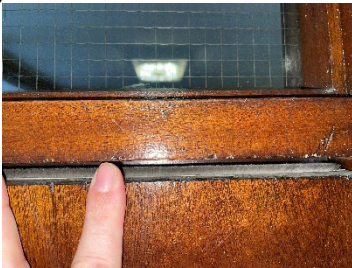
27) 4th floor communal door to stairs has excessive gap.

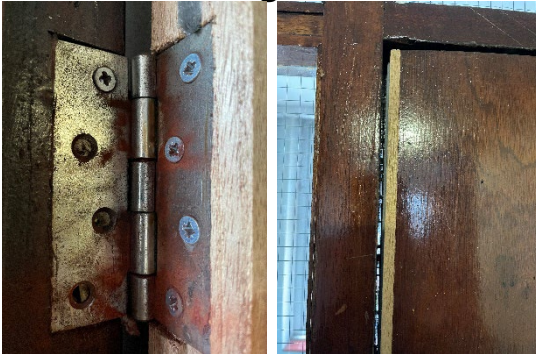
28) 4th floor by flat 100 - communal door has excessive gaps and screws missing from each hinge.

P2	Within 1 to 3 months of action plan date. Fire Rapid Response. JM:10622271	19/04/2023
07/28	4 th floor by flat 100 – communal door has excessive gaps adjustment or possible re-lipping required. Also replace missing screws to hinges.

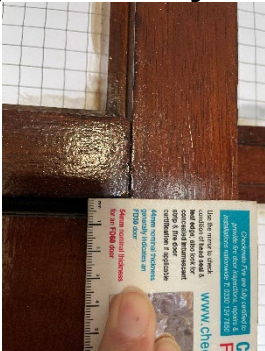
29) 4th floor by flat 108 - communal door has excessive gaps.

P2	Within 1 to 3 months of action plan date. Fire Rapid Response. JM:10622295	19/04/2023
07/29	4 th floor by flat 108 - communal door has excessive gaps adjustment or possible re-lipping required

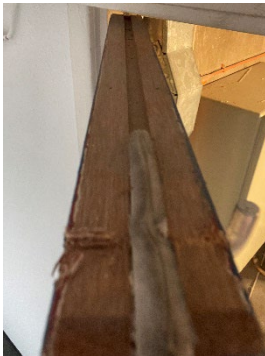
- 30) 4th floor by flat 104 – combined intumescent strip / cold smoke seal part missing from head on service cupboard head.

07/30	4 th floor by flat 104 – service cupboard door replace missing intumescent / cold smoke strip on head of door.

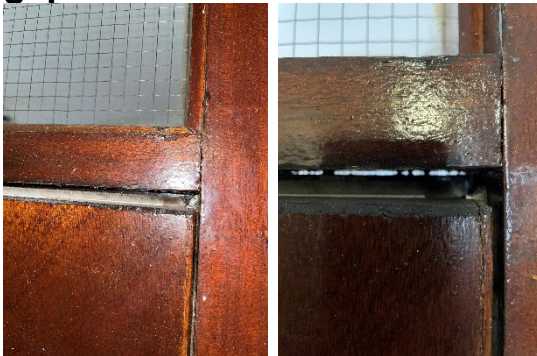
- 31) 3rd floor by flat 98 – communal door has excessive gaps also gap between rebate and frame.

P2	Within 1 to 3 months of action plan date. Fire Rapid Response. JM:10081351	12/01/2023
07/31	3 rd floor by flat 98 – communal door has excessive gaps adjustment or possible re-lipping required

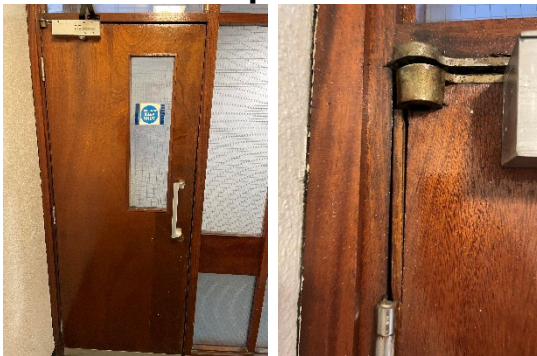
- 34) 2nd floor communal door to stairs has excessive gaps, also noted was a split within the timber.**

P2	Within 1 to 3 months of action plan date. Housing Manager	14/03/2023
07/34	2 nd floor communal door to stairs has excessive gaps and split above hinge, Adjustment / repair or possible replacement required

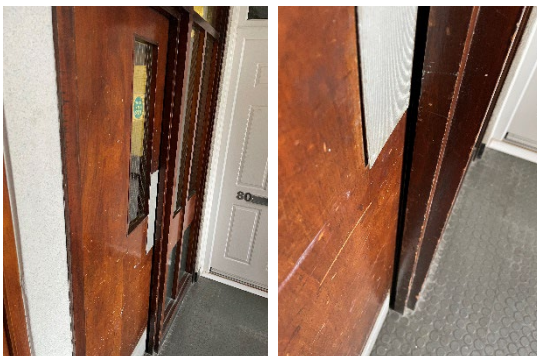
- 35) 2nd floor by flat 80 – communal door doesn't fully close into frame.**

P2	Within 1 to 3 months of action plan date. Fire Rapid Response. JM:10081405 JM:10622425	12/01/2023
07/35	2 nd floor by flat 80 – communal door doesn't fully close into frame. Door requires adjustment / repair or replacement.

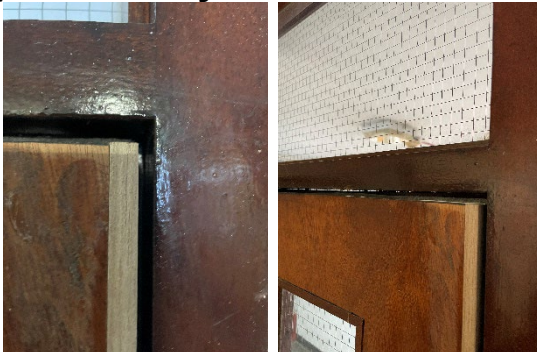
- 36) 2nd floor by flat 88 – communal door has excessive gaps.**

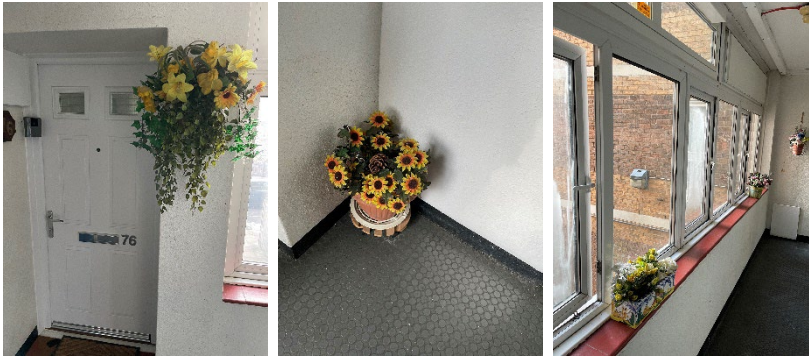
- 37) 1st floor – artificial plants in communal corridor outside flat 76.**
-

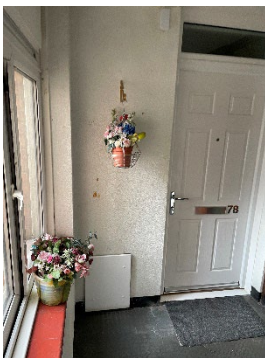
38) 1st floor – artificial plants in communal corridor outside flat 78.

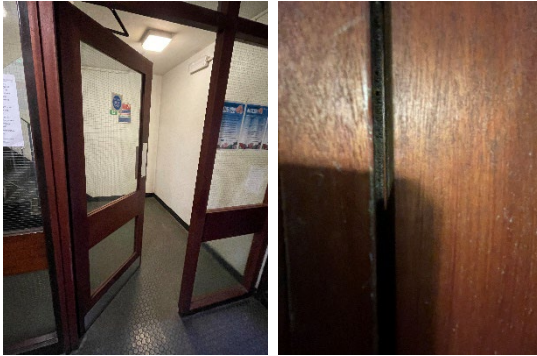
- 40) Ground floor – communal door to stairs has excessive gaps, also door binds on floor which can prevent closure.**

07/40	Ground floor communal door to stairs has excessive gaps and binds on floor. Adjustment or repair required

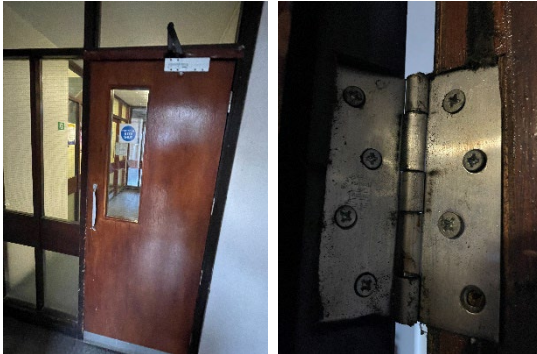
- 41) Ground floor by flat 68 – communal door binds on leading edge and doesn't fully close into frame. Top hinge is slightly deformed and there is a screw missing from a hinge.**

P2	Within 1 to 3 months of action plan date. Fire Rapid Response. JM:10081456	12/01/2023
07/41	Ground floor by flat 68 – communal door binds on leading edge / doesn't fully close into frame / adjustment required. Replace missing screw to hinge.

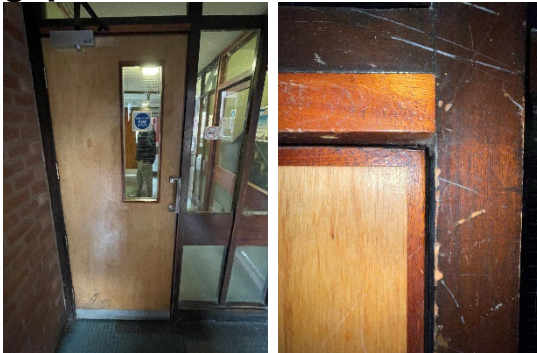
- 42) Ground floor by flat 60 – communal door has excessive gaps.**
