Fire Risk Assessment

Heronville House

**Sedgley Rd East,
Tipton, DY4 7TX**

Date Completed: 23/06/2025

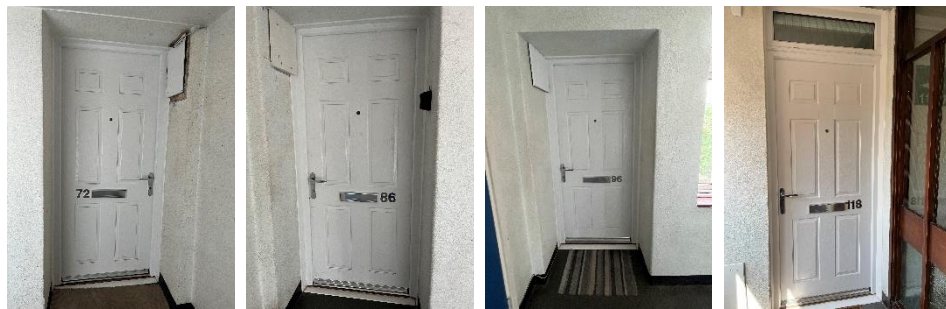
- 20) Individual flat doors are FD30s rated composite doors sets manufactured by IG Doors, except flat 70, which appears to be a nominal FD30s flush fit timber door.

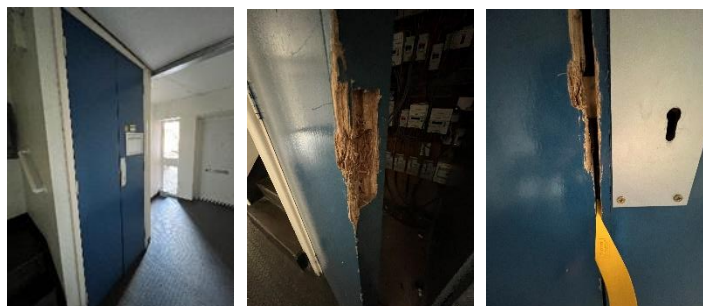
- 6) **Service cupboards consist of notional FD30s timber doors and are secured with suited cylinder locks. A key is stored within the Firefighters white box. Residents have been provided with a key for those service cupboards with double doors for access to their electricity meters. The ground floor main electrical service cupboard has an excessive gap between the door leaves and damage around the lock, requiring repair. See Action 10/06.**

P3	Fire Rapid Response 3 – 6 months.	
10/06	The ground floor main electrical service cupboard has an excessive gap between the door leaves and damage around the lock, requiring repair.

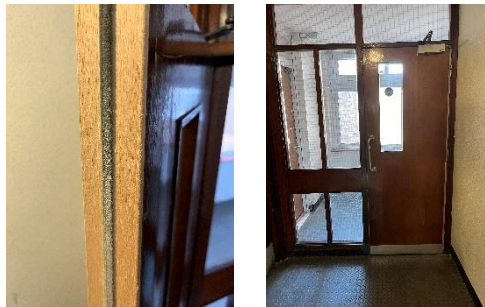
- 10) It was noted that the notional hardwood fire screens with Georgian wired glazing that protect staircases only provided 30 mins fire resistance. When any future refurbishments take place, this should be upgraded to a minimum of 60 mins.

Observations	
Some notional communal landing doors show signs of wear and tear due to age. Consideration should be given to upgrade with certified FD30s door sets, combination frames / screens as part of any future refurbishment works.

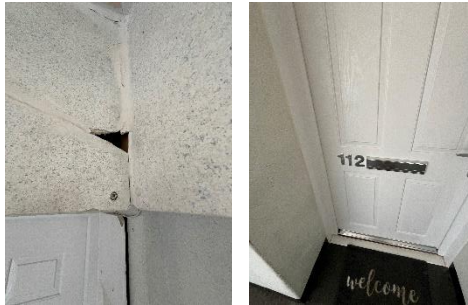
- 12) There is service ducting on all floors at high level. Ducting was noted to be damaged, requiring repair, near flat 112. See actions 10/12.**

10/12	Ducting was noted to be damaged, requiring repair or replacement, near flat 112.
