# Fire Risk Assessment

## Paget House

**Sedgley Rd East,  
Tipton, DY4 7TU**

**Date Completed: 06/01/23**

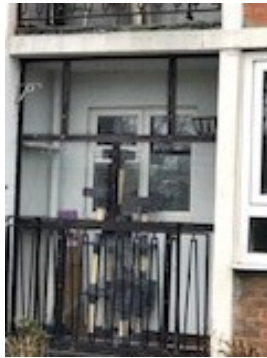
- a) **timber and wire full height screen built onto balcony. On the Ground floor flat 122. Resolved 23/02/23**

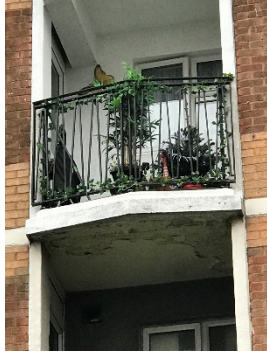
**e) Plastic screen attached to the 4<sup>th</sup> floor balcony of flat 166**

*Resolved 23/02/23*

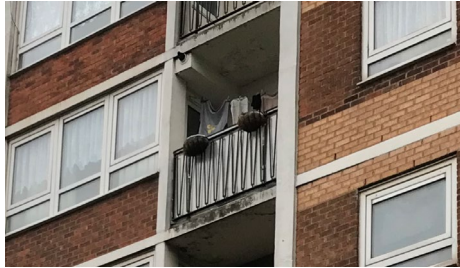
**f) Mesh and timber trellis attached to the 5<sup>th</sup> floor balcony of flat 174**

*Resolved 23/02/23*

P2	1-3 months Housing Manager	23/02/2023
06/04f	Remove mesh and timber trellis attached to the 5 <sup>th</sup> floor balcony flat 174

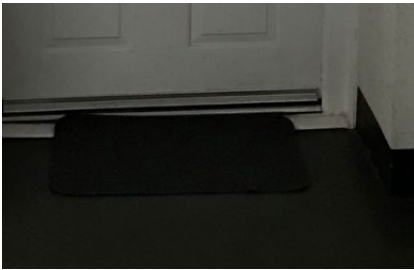
**17)** The fire rating of individual door mats outside flat entrance doors is unknown.

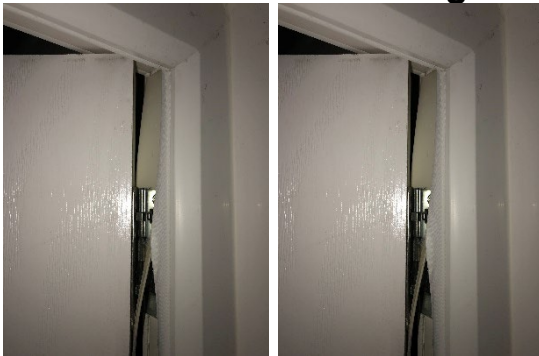
- a) Flat 178 has a batwing attached to the frame of the door
- b) Damage to door seal, issues when opening and closing door issue with closing door correctly into frame.**

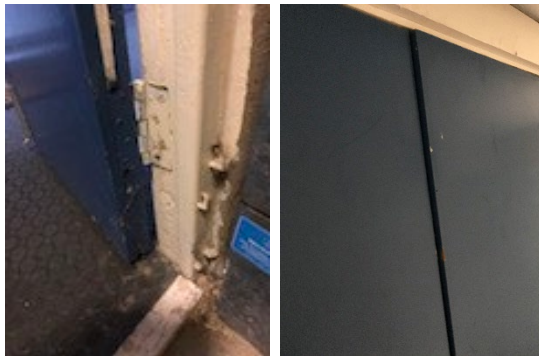
- 21) 5th floor service cupboard does not align properly with the service cupboard door next to it is also missing small portion of cold smoke seal at the bottom edge of the door.**

07/21	5 <sup>th</sup> floor service cupboard needs properly aligning and replace small portion of missing intumescent strip and cold smoke seal from bottom edge of floor

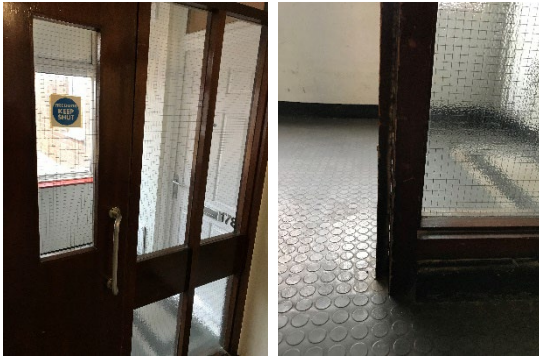
- 22) There are excessive gaps around the edges of the door and frame on the 5<sup>th</sup> floor communal door closest to flat 178 light is also visible through frame of the door, and the door handle is loosened.**

07/22	<p>5<sup>th</sup> floor communal door nearest flat 178 has excessive gaps where adjustment required</p> <p>Also, adjust Gap in frame where light is visible through, and tighten loose door handle</p>

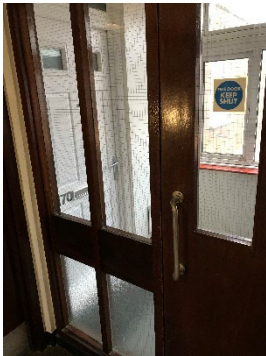
- 23) There are excessive gaps around the edges of the door and frame on the 5<sup>th</sup> floor communal door closest to flat 170 light is also visible through frame of the door, and the door handle is loosened.**

P2	<p>1-3 months Fire Rapid Response JM10627733</p>	19/04/2023
07/23	<p>5<sup>th</sup> floor communal door nearest flat 170 has excessive gaps where adjustment is required</p> <p>Also adjust frame where light is visible and tighten loose door handle</p>

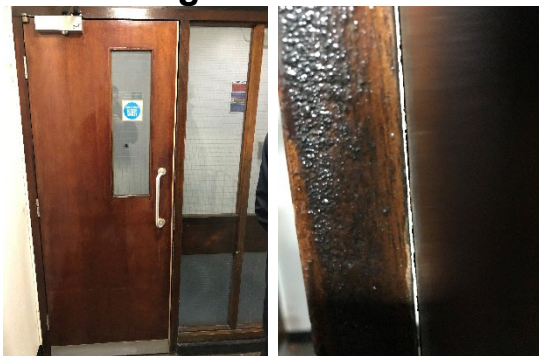
- 24) The communal door leading to stairs on the fourth floor has obvious light breaches in the frame.**

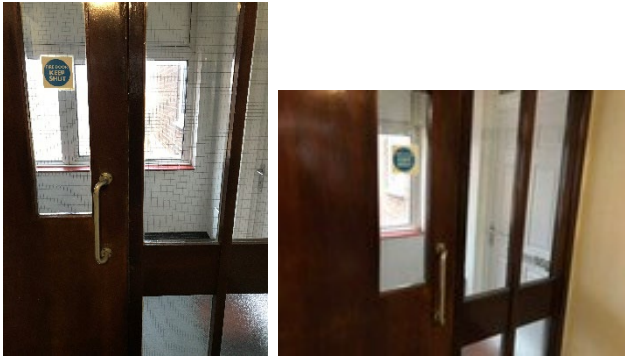
- 25) There are excessive gaps the frame on the 4<sup>th</sup> floor communal door closest to flat 168 light is also visible through frame of the door, and the door handle is loosened.**

P2	1-3 months Fire Rapid Response JM10627757	19/04/2023
07/25	4 <sup>th</sup> floor communal door nearest flat 168 adjust frame of door where light is visible and tighten loose door handle

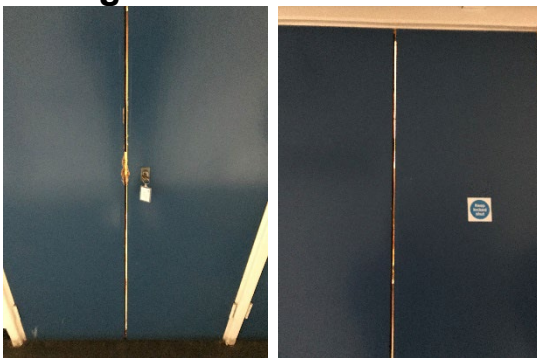
- 26) large gaps between service cupboard doors light is visible through double doors closest to flat 164**

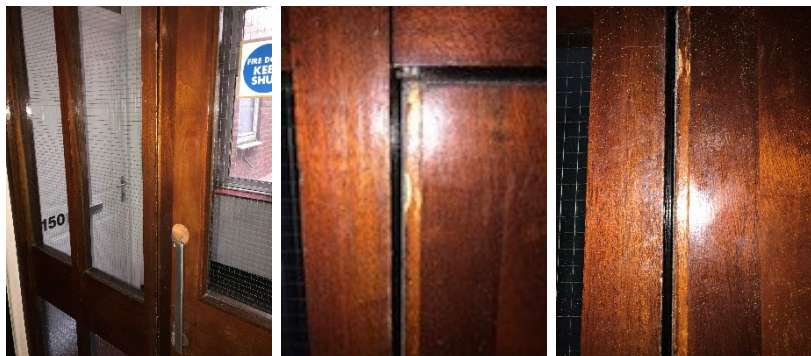
- 27) There are excessive gaps around the edges of the door and frame on the 3<sup>rd</sup> floor communal door closest to flat 150 cold smoke seal nowhere near the frame.**

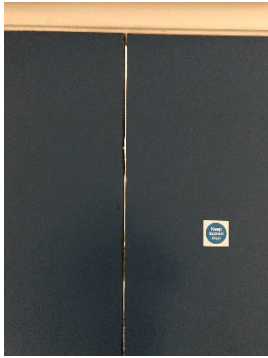
- 29) large gaps between service cupboard doors on the 2<sup>nd</sup> floor light is visible through double doors these doors cannot be secured due to damage around the lock**

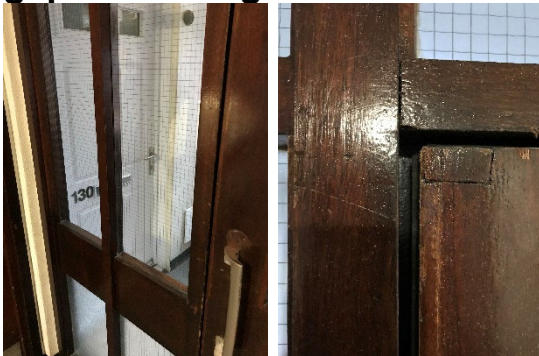
**31) communal door closest to flat 130 on the 1<sup>st</sup> floor has large gaps between cold smoke seals and door frame, also large gaps where light can be seen between frame.**

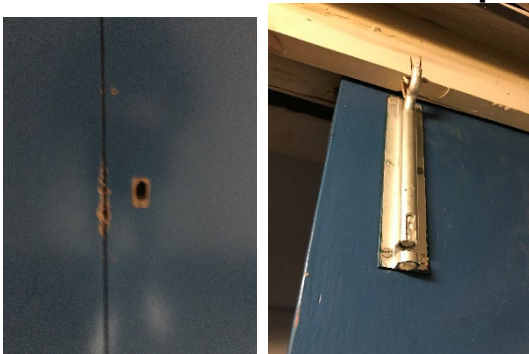
**32) lock is missing to service cupboard doors on the first floor nearest flat 132. Secure bolt lock is also broken to the left-hand side of the service cupboard doors**

07/32	1 <sup>st</sup> floor service cupboard doors nearest flat 132 lock missing and needs replacing also bolt lock to the left-hand side of the cupboard doors is broken and in need of replacement

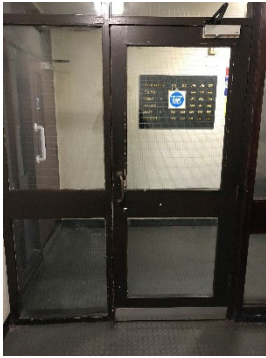
**33) excessive gaps to the communal door entering the stairwell on the ground floor**

P2	1-3 months Fire Rapid Response JM10627899	19/04/2023
07/33	Excessive gaps to communal door entering stairwell on the ground floor

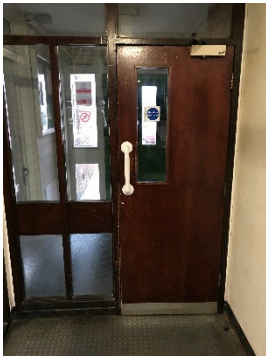
- 34) Excessive gaps on the ground floor communal door entering the communal area (door with large white handle)**

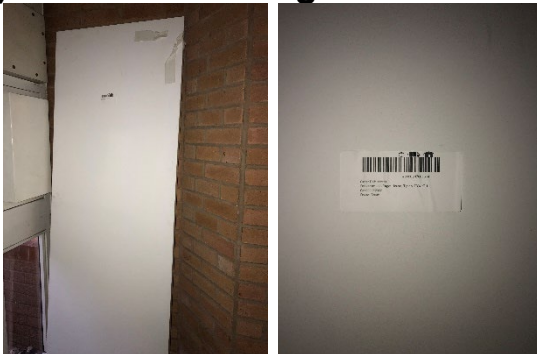
- 35) Door left in the ground floor communal area labelled for 178**

P2	1-3 months Fire Rapid Response JM10627917	19/04/2023
07/35	Remove Door to flat 178 left on ground floor
