Fire Risk Assessment

Paget House

**Sedgley Rd East,
Tipton, DY4 7TU**

Date Completed: 16/06/2025

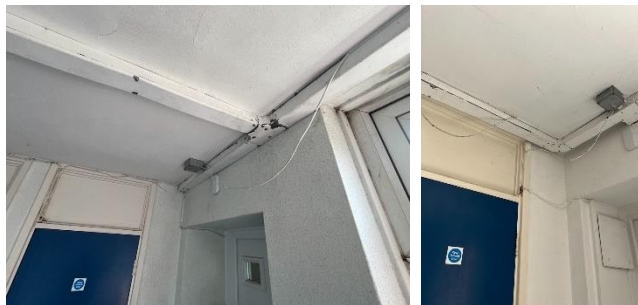
- 15) Loose communication cabling was noted near flat entrance doors for 172 and 126. These cables are required to be secured with metal cable clips. See action in 7/15 a, and b.

Question/ Ref No	Required Action	Supporting photograph	Priority	Timescale and Person Responsible	Date Completed
07/15 a.	Loose communication cabling was noted near flat entrance door for 172. These cables are required to be secured with metal cable clips.

07/15 b.	Loose communication cabling was noted near flat entrance door for 126. These cables are required to be secured with metal cable clips.

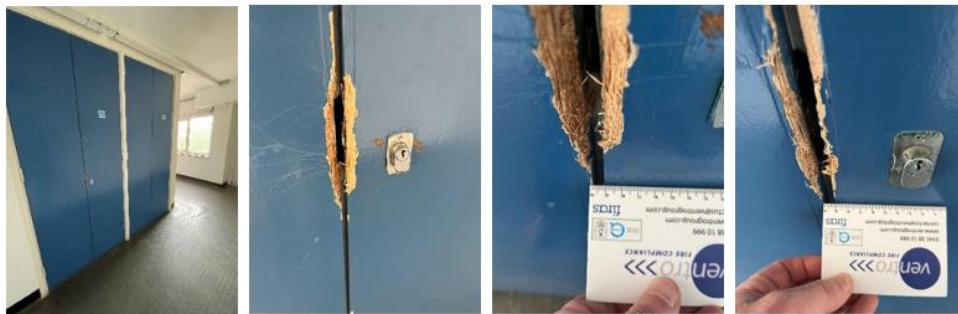
- 5) Service cupboards consist of notional FD30s timber doors and are secured with suited cylinder locks. A key is stored within the Firefighters white box. Residents have been provided with a key for those service cupboards with double doors for access to their electricity meters. The following service cupboards have deficiencies requiring repair; See actions 10/5 a, b, c, and d.
- a) 4th floor electrical cupboard near flat 164 has an excessive gap between the door leaves.
 - b) 2nd floor electrical cupboard near flat 144 has an excessive gap between the door leaves and damage.
 - c) 1st floor electrical cupboard near flat 144 has damage around the lock.
 - d) Ground floor electrical cupboard near flat 122 has damage around the lock.

P3	Fire Rapid Response 3 – 6 months.	
10/5 b.	The 2nd floor electrical cupboard near flat 144 has an excessive gap and damage between the door leaves, requiring repair and adjustment.

10/5 c.	The 1st floor electrical cupboard near flat 134 has damage between the door leaves around the lock, requiring repair.

P3	Fire Rapid Response 3 – 6 months.	
10/5 d.	The ground floor electrical cupboard near flat 122 has damage between the door leaves around the lock, requiring repair.

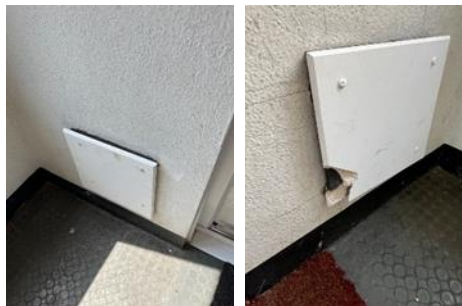
- 10) Access panels to stop taps are fixed to masonry adjacent flat entrance doors and bedded on intumescent material. The access panel outside flat 150 is damaged. The panel should be repaired. See action 10/10.

P3	Fire Rapid Response 3 – 6 months.	
10/10.	The access panel outside flat 150 is damaged. The panel should be repaired or replaced.

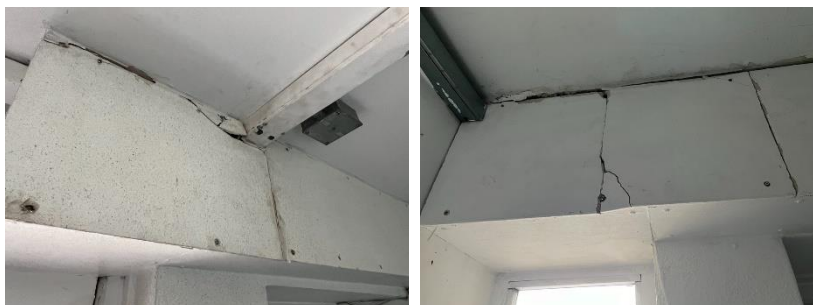
- 11) There is service ducting on all floors at high level. Ducting was noted to be damaged, requiring repair, near flats 152 and 122. See actions 10/11 a, and b.

P3	Fire Rapid Response 3 – 6 months.	
10/11 a.	Ducting was noted to be damaged, requiring repair or replacement, near flat 152.

10/11 b.	Ducting was noted to be damaged, requiring repair or replacement, near flat 122.	 	P3	Fire Rapid Response 3 – 6 months.	
----------	--	--	----	--------------------------------------	--
