Fire Risk Assessment

Wallace House

Badsey Rd, Oldbury,
B69 1ER

Date Completed: 12/05/2025.

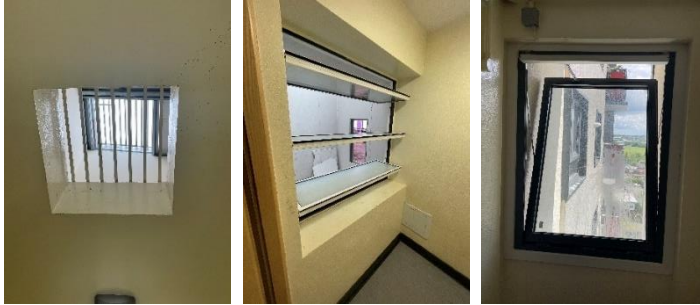
- 12) Automatic opening vents have been installed to the head of protected staircase and in each corridor above the ground floor. However, it was noted that the opening vents in the 12th floor corridors are of a different design to other corridors within the building.

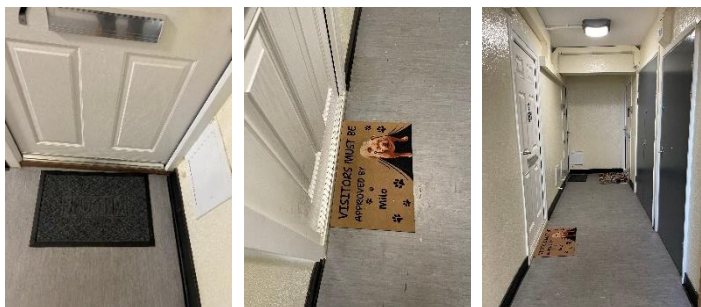
- 18) Individual floor mats were noted outside some flats. Fire rating of the mats is unknown but deemed to be of low risk.

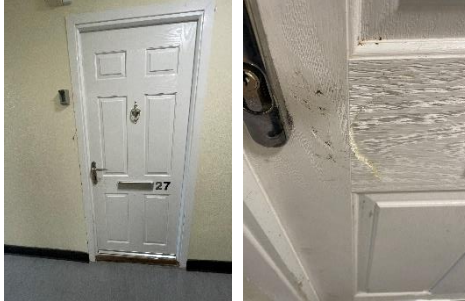
- f) Flat 27 – No access was granted at the time of the FRA to inspect the flat entrance door, but it was clear there is some damage. The door should be replaced or repaired using appropriate materials.**

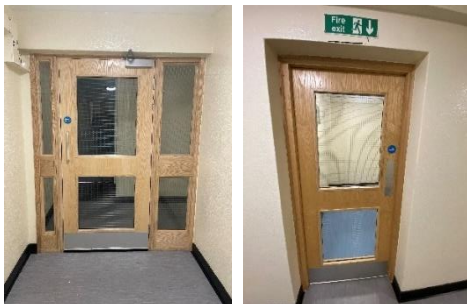
- 7) **On the 10th floor, outside flat 62, some fire stopping is required in the electrical cupboard. This is where there have been cable penetrations through the wall.**
- 8) **On the 8th floor, outside flat 50, some fire stopping is required in the electrical cupboard. This is where there have been cable penetrations through the wall.**
- 9) The fire stopping / compartmentation is subject to a 12-week check by the Fire Safety Rapid Response Team.
- 10) Any remedial works arising from the fire stopping / compartmentation check(s) will be actioned immediately by the Fire Safety Rapid Response Team.
- 9) Individual flat doors are nominal FD30s composite fire door sets manufactured by IG doors.
- 10) The communal corridor and staircase doors are nominal FD30s timber fire doors with vision panels.

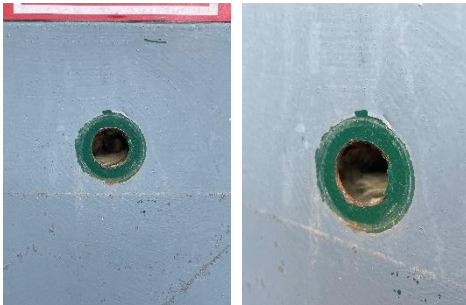
- 15) The caretakers room door that leads to fresh air (By the main entrance) is missing a spy hole leaving insulation exposed, this should be rectified as soon as possible as it is a potential Arson risk.

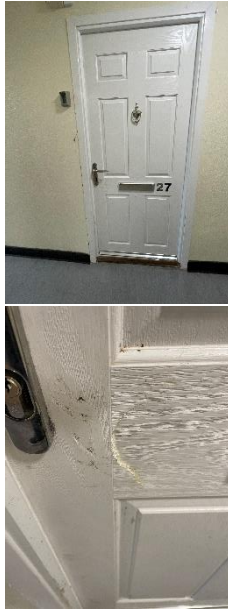
P2	Fire Rapid Response Within 1-3 months	
07/22 f)	Flat 27 – No access was granted at the time of the FRA to inspect the flat entrance door, but it was clear there is some damage. The door should be replaced or repaired using appropriate materials.

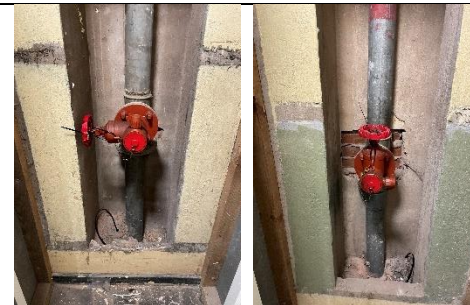
In some cases, it was noted that Dry Risers outlets had been secured so that access to operate could be difficult in an emergency. When any maintenance or servicing is carried out consideration should be given to rectifying this so that emergency service access and operation is simplified.
