Fire Risk Assessment

Wallace House

**Badsey Rd, Oldbury,
B69 1ER**

Date Completed: 06/05/2026

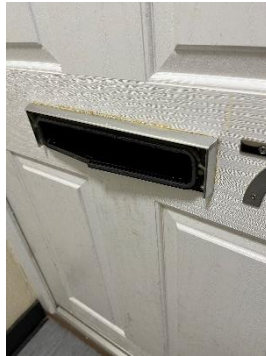
- 16) Flat 70 flat front door has a damaged letterbox opening. This letterbox is required to be repaired. See action 7/16.

Question/ Ref No	Required Action	Supporting photograph	Priority	Timescale and Person Responsible	Date Completed
7/16	Flat 70 flat front door has a damaged letterbox opening. This letterbox is required to be repaired.

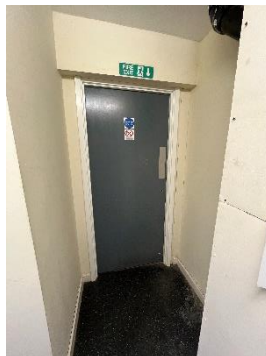
- 17) The designated fire escape door from the main caretaker's room is locked with a key. This final fire escape is not required as adequate escape is available from this room into the common area, and then to ultimate safety.

This room is only used in office hours by trained SMBC staff and is not accessible to residents. The fire escape door into the common area requires a thumb-twist lock to be fitted to the inside to prevent persons being locked in room. See action 7/17. See also, action 12/1.

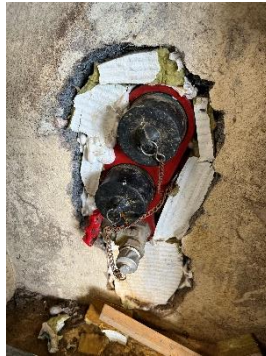
- 5) **Fire stopping around the dry riser inlet is of a poor standard and requires renewing. See action 10/5.**

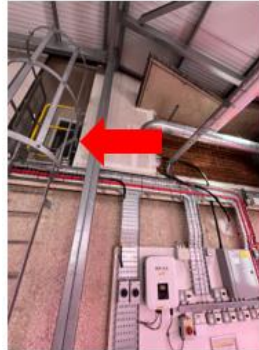
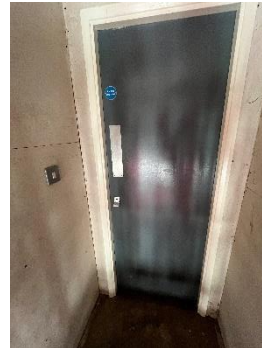
- 8) The service cupboard fire door at the top of the cat ladder accessible from the lift motor room side of the block, will not lock, adjustment is required. See action 10/8.

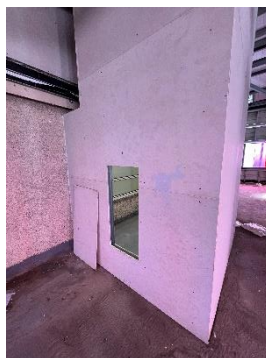
- 13) **An inspection hatch for the AOV smoke extraction stack (on the lift motor room side roof void) has been removed and is required to be refitted. See action 10/13.**

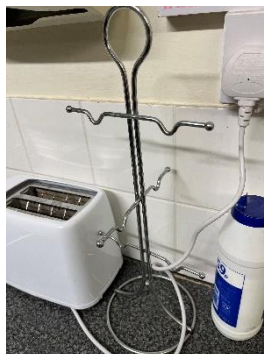
- 6) Portable heaters are not allowed in any common parts of the premises.
- 7) **Most sampled portable electrical equipment is in date. Electrical equipment used as part of the Caretaking / Cleaning regime is subject to annual PAT Testing. This information is held by the Estate Services Manager. However, there was no evidence of a PAT on the toaster in the caretaker's room. See action 14/7.**

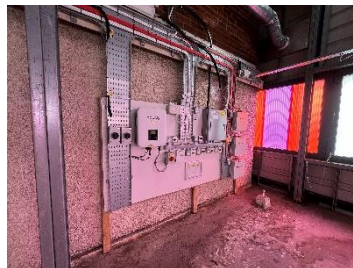
8) There are no service records available for the servicing and maintenance of Solar Equipment provided for this building. This testing falls under several British Standards. For example: -

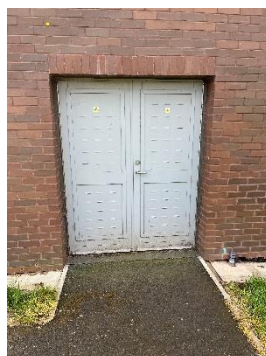
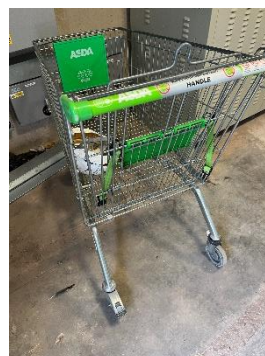
- 2) The tenancy conditions, Section 7 – Condition 5.6 stipulates “If you live in a flat or maisonette, you, people living with you and any visitors to your property must not keep or use paraffin oil, petrol, bottled gas appliances or any other explosive, FLAMMABLE, or dangerous material in the property. This restriction also applies to any storage facility situated in or attached to the block, which has been provided for your use.”
- 3) No Flammable liquids are stored on site by Caretakers / cleaners.
- 4) There are no flammable liquids or gas cylinders stored on site.
- 5) **The shopping trolley currently stored in the externally accessed main incoming electrical plant room is required to be removed. See action 18/5.**
