Fire Risk Assessment

Wallace House

**Badsey Road, Oldbury,
B69 1ER**

Date Completed: 4th October 2022

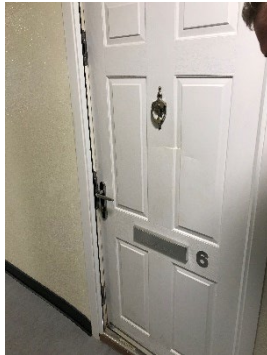
B. Flat 6 – Door binds on leading edge and doesn't reliably self-close fully into frame. Also, a small split in front panel was evident which may require repair / door replacement. 29/3/23 replacement FD30s composite door set installed.

| 07/22b | Flat 6 – Entrance door requires adjustment, door doesn't reliably self-close fully into frame. Also inspect / repair small split in front panel. Door to be replaced if damaged beyond repair. | | P2 | Within 1 – 3 months of action plan date. Fire Rapid Response JMN9709738 | 29/03/2023 |

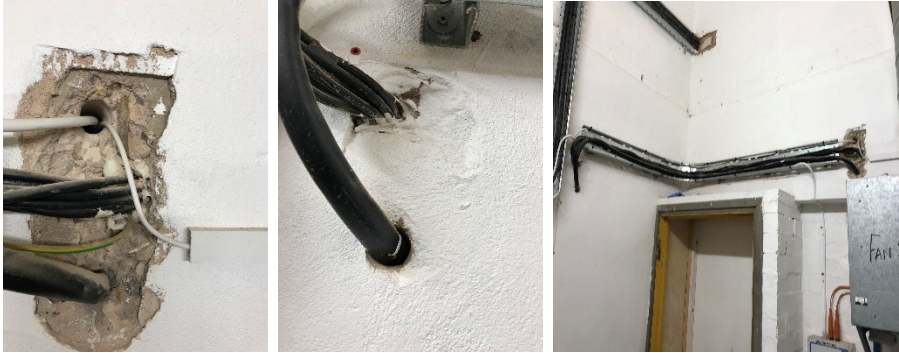
- 24) 12th floor lift motor room has gaps where cables penetrate walls. Gaps to be fire stopped. Resolved 17/10/22**

| 07/24 | 12 th floor lift motor room – Fire stop gaps were cables penetrate walls. | | P2 | Within 1 – 3 months of action plan date. Fire Rapid Response JM9708535 | 17/10/2022 |

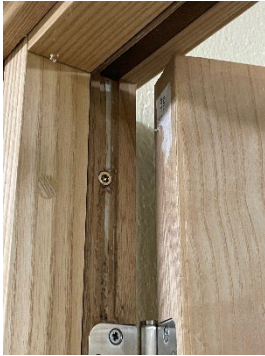
- 25) 9th floor communal door to stairwell is missing a section of intumescent strip from above the top hinge. Resolved 17/10/22**

| 07/25 | 9 th floor door to stairwell reinstate intumescent strip above top hinge. | | P2 | Within 1 – 3 months of action plan date. Fire Rapid Response JM9708560 | 17/10/2022 |

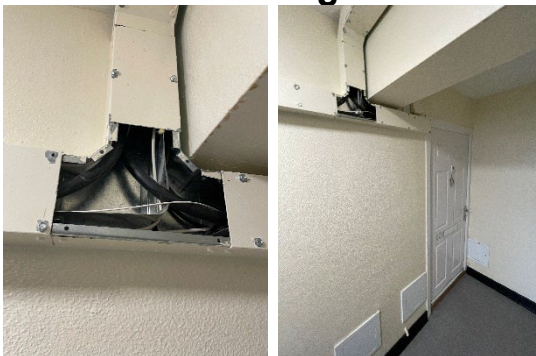
- 26) 8th floor between flats 48 & 49 there is a cover missing from a section of trunking. Resolved 20/02/23**

| 07/26 | Replace cover to trunking by flats 48, 49. | | P2 | Within 1 – 3 months of action plan date. Repairs – Electrical JM9728930 | 20/02/2023 |

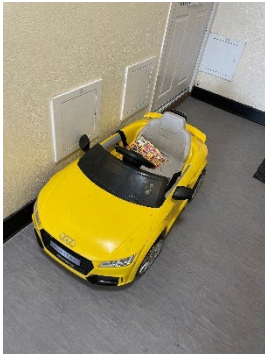
- 27) 8th floor near flats 45, 46 & 47 used cigarettes have been discarded in corner between wall and cable trunking adjacent communal window. Residents should be reminded of the No Smoking Policy that exists within any communal area of the building and the associated risks from the inappropriately discarding of smoking materials. *Resolved 28/04/23*

| 07/27 | Advise occupiers of flats 45, 46, 47 of no smoking policy as discarded cigarettes have been wedged in crevice in communal corridor. | | P2 | Within 1 – 3 months of action plan date. Housing Manager | 28/04/2023 |

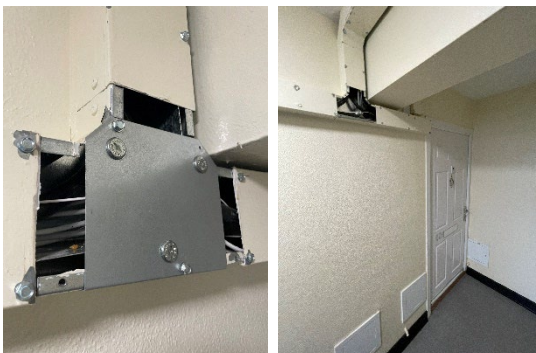
- 29) 6th floor adjacent flat 37 there are gaps within cable trunking where an original cover has been replaced with one that is not of the correct size. Cover should be replaced with one of the correct size with intumescent pad / pillow where appropriate. *Resolved 20/02/23*

| 07/29 | Replace cover to trunking with one that fully covers the missing section by flat 37 | | P2 | Within 1 – 3 months of action plan date. Repairs – Electrical JM10177927 | 20/02/2023 |

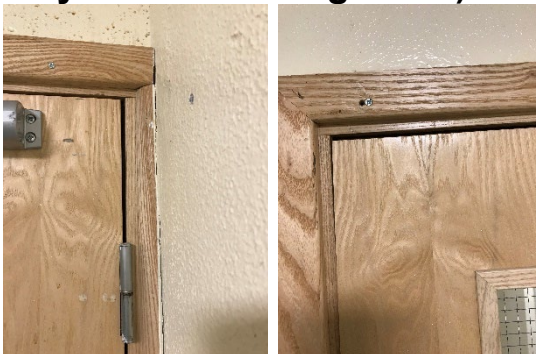
- 32) 2nd floor communal door to stairwell, excessive gap above top hinge and door binds on leading edge (fixings to frame may be loose / hinge side). *Resolved 18/10/22*

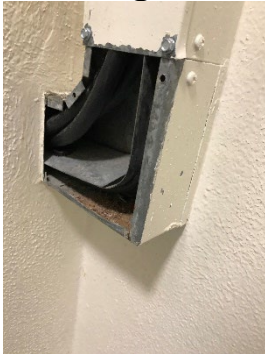
- 33) 1st – 2nd floor stairwell there is a section missing from the trunking where cables penetrate wall. *Resolved 20/02/23*

| 07/33 | Replace cover to trunking with one that fully covers the missing section on 1 st / 2 nd floor stairwell. | | P2 | Within 1 – 3 months of action plan date. Repairs - Electrical | 20/02/2023 |

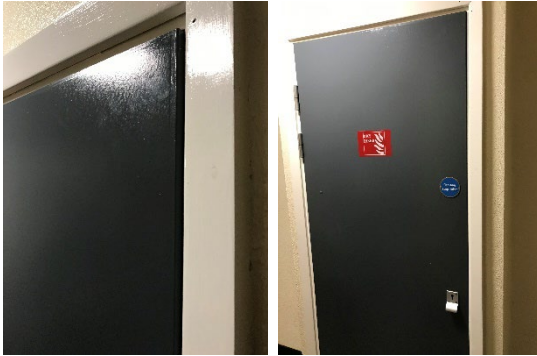
- 34) 1st floor dry riser cupboard doesn't fully close into frame in top corner on lock side. Key is stiff to turn within lock. *Resolved 18/10/22*

| 07/34 | 1 st floor dry riser cupboard requires adjustment, doesn't close fully into frame and key is stiff within lock. | | P2 | Within 1 – 3 months of action plan date. Fire Rapid Response JM9712464 | 18/10/2022 |

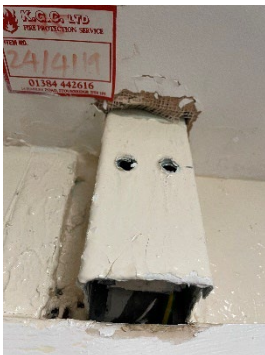
- 35) Ground floor by flat 1 – Bottom of trunking above service cupboard door and where it meets the ceiling requires enhanced fire stopping. *Resolved 18/10/22*

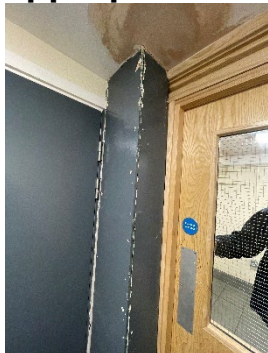
- 36) Ground floor by flat 1 / service cupboard –There are no signs of fire stopping externally to the boxing and ceiling has signs of a previous repair. Boxing to be removed and inspected for appropriate fire stopping. *Resolved 18/10/22*

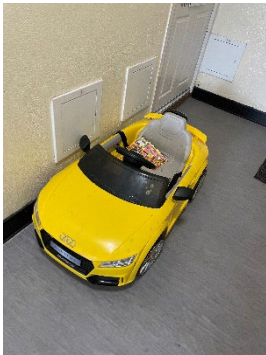
| 07/28 | Childs ride on car to be removed from corridor outside flats 40 & 41 | | P2 | Within 1 – 3 months of action plan date. Housing Manager | 28/04/2023 |
