Fire Risk Assessment

Wyrley House

**Sedgley Rd East,
Tipton, DY4 7TT**

Date Completed: 02/06/2025

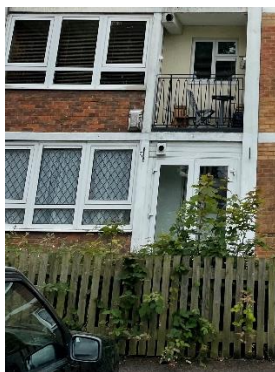
A. Flat 186 (ground floor) There are UPVC doors installed to the balcony with a section of UPVC shiplap cladding above. This has previously been reported and accepted by SMBC.

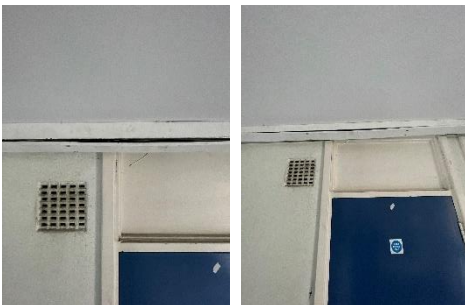
- 19) It was noted outside flat 184 ground floor that metal conduit needs to be repaired to ensure electric cables cannot be tampered with.

| 07/19 | Metal conduit outside flat 184 needs to be repaired to ensure electric cables cannot be tampered with. | | P3 | Electrical 3 – 6 months. | |

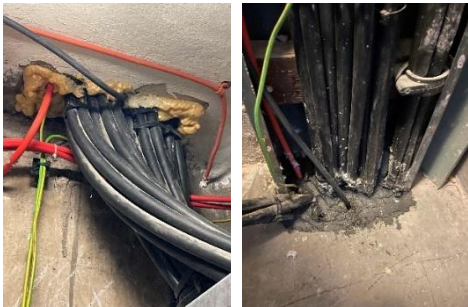
- 6) There is a minimal amount of foam present where power cables penetrate through the slab from the service cupboard to the service cupboard above (ground to 1st floor). This has not been removed due to the close proximity of live terminals within the mains distribution board. Where the cables enter the 1st floor service cupboard above the penetration has been suitably fire stopped.

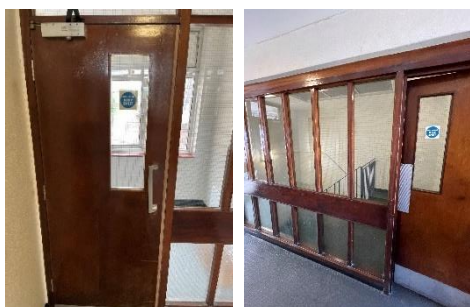
- 8) The communal corridors, landing & staircases are protected by use of notional self-closing 44mm 30-minute timber fire doors with vision panels & 25mm stops, along with 30 minute notional hardwood fire screens with Georgian wired glazing (stairwell).

It is acknowledged that these doors do not meet today's benchmark of a certified FD30s fire doors. However, because they were installed at the time of the building's construction and to the standard of that time they are deemed as acceptable so long as the doors are free from damage and function as they were originally intended to.

| Observations | | |
|---|---|--|
| Some notional communal landing doors show signs of wear and tear due to age. Consideration should be given to upgrade with certified FD30s door sets, combination frames / screens as part of any future refurbishment works. | | |

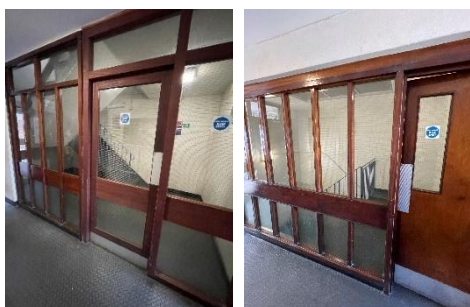
- 9) It was noted that the notional hardwood fire screens with Georgian wired glazing that protect staircases only provided 30 mins fire resistance. When any future refurbishments take place, this should be upgraded to a minimum of 60 mins.

| Observations | | |
|---|---|--|
| When any future refurbishments take place the notional hardwood fire screens with Georgian wired glazing that protect staircases should be upgraded to ensure a minimum of 60 mins fire resistance is provided. | | |

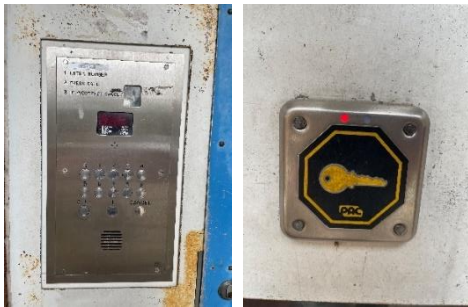
- 3) At the time of the fire risk assessment, it was noted that both access doors were faulty. The locking mechanisms are defective and in need of replacement. An email has been sent to the CCTV team who have confirmed that contractors have been engaged and will complete a repair when parts are available. This defect will not impact on people escaping in any emergency, it will however provide a low risk with regard to security of the building and allow unauthorised access to the premise.
 - 4) There is no current evidence of arson.
 - 5) The perimeter of the premises is well illuminated.
 - 6) There have been no reported fire incidents since the previous FRA June 2024.
-
