Fire Risk Assessment

Wyrley House

**Sedgley Rd East,
Tipton, DY4 7TT**

Date Completed: 04/01/23

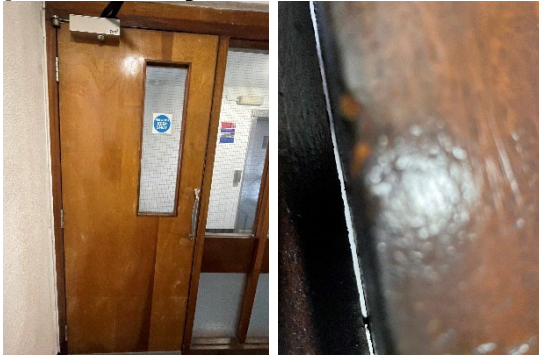
- 23) 5th floor FD30s communal door to stairs has excessive gaps particularly to the bottom. Also gaps between stop and frame.**

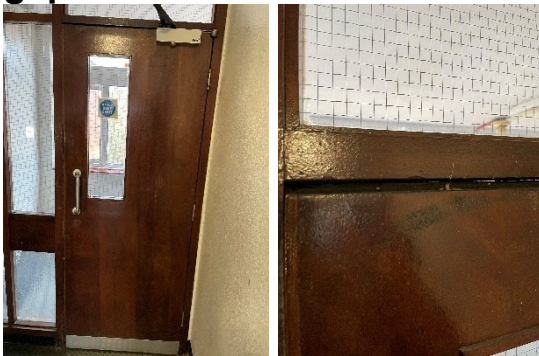
- 24) 5th floor FD30s communal door by flat 230 has excessive gaps.**

07/24	5 th floor communal door by flat 230 – excessive gaps adjustment / repair required.

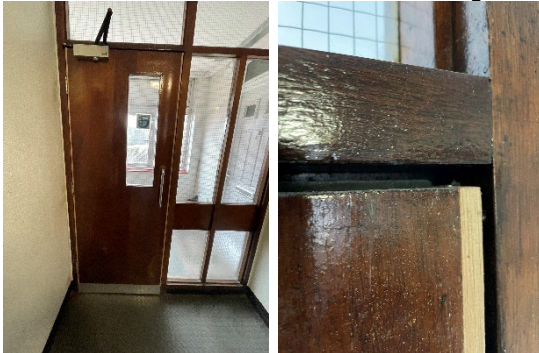
- 25) 5th floor communal door by flat 238 has excessive gaps.**

P2	Within 1 to 3 months of action plan date. Fire Rapid Response JM10631596	20/04/2023
07/25	5 th floor fd30s communal door by flat 238 – excessive gaps adjustment / repair required.

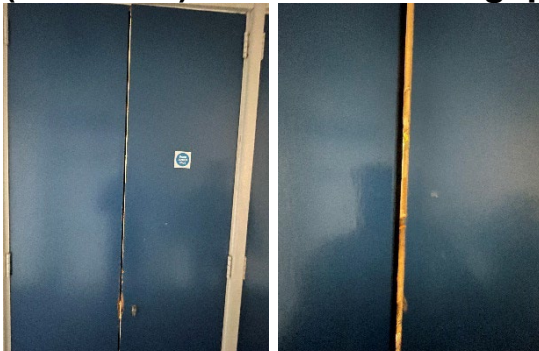
- 26) 5th floor by flat 234 left hand side service cupboard doors (electrical) have excessive gap between doors.**

P2	Within 1 to 3 months of action plan date. Fire Rapid Response JM:10631605	20/04/2023
07/26	5 th floor fd30s left side electrical service cupboard doors by flat 234 excessive gap between doors adjustment / required.

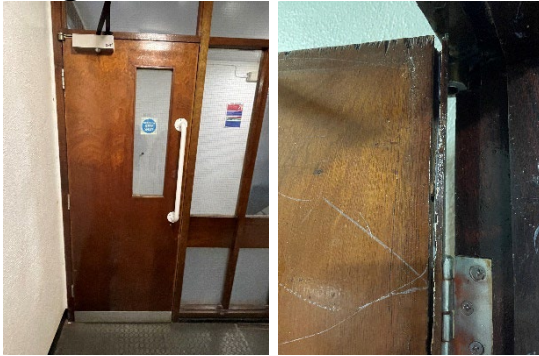
- 27) 4th floor communal door to stairs excessive gaps to leading edge and bottom edge. Also, door edge is split above top hinge.**

07/27	4 th floor communal door to stairs excessive gaps and door split along edge on hinge side, adjustment / repair required.

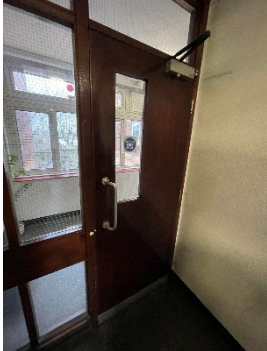
- 28) 4th floor communal door by flat 220 has excessive gaps.**

P2	Within 1 to 3 months of action plan date. Fire Rapid Response JM10631632	20/04/2023
07/28	4 th floor communal door by flat 220 has excessive gaps adjustment / repair required.

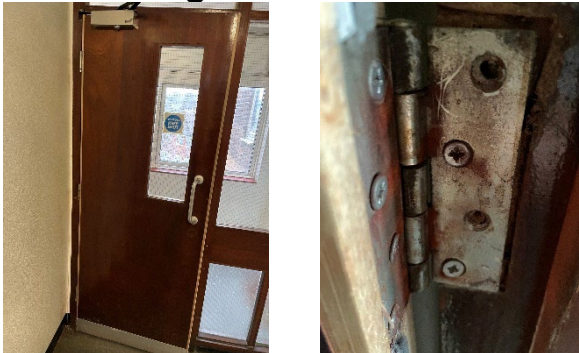
- 29) 4th floor communal door by flat 228 has 3 missing screws from 2 hinges.**

P2	Within 1 to 3 months of action plan date. Fire Rapid Response JM10631644	20/04/2023
07/29	4 th floor communal door by flat 228 replace missing screws to 2 hinges.

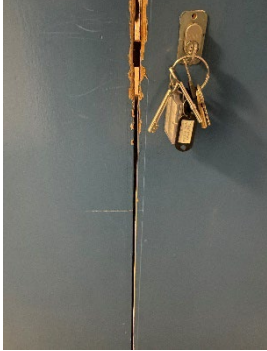
- 30) 4th floor service cupboards (electrical) opposite flat 224 – left hand cupboard has a defective lock (can't unlock) and excessive gap between doors, cold smoke seal doesn't meet opposite edge.**

07/30	4 th floor opposite flat 224 left side electrical service cupboard has excessive gaps between doors / require adjustment. Defective lock / unable to unlock requires attention / replacement.

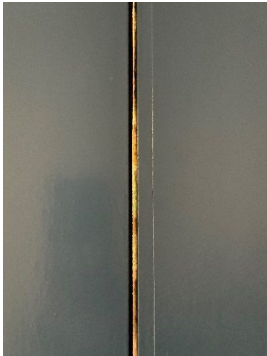
- 31) 4th floor service cupboards (electrical) opposite flat 224 – right hand cupboard has excessive gaps between doors, cold smoke seal doesn't meet opposite edge.**

P2	Within 1 to 3 months of action plan date. Fire Rapid Response JM:10631671	20/04/2023
07/31	4 th floor opposite flat 224 right side electrical service cupboard has excessive between doors / requires adjustment.

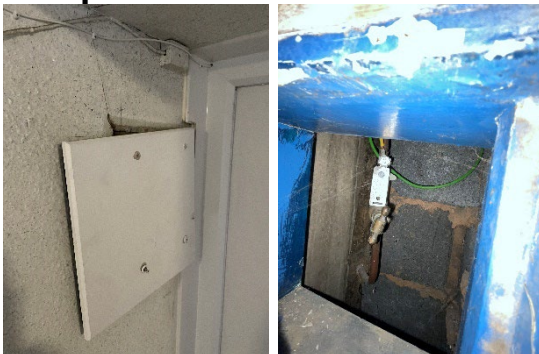
- 32) Access panel to stop tap adjacent flat 226 is hanging loose and requires re-fixing to masonry to maintain compartmentation.**

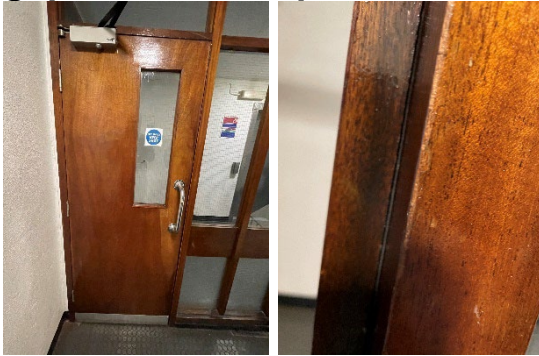
- 33) 3rd floor communal door to stairs has excessive gaps. Also gap between stop and frame on handle side.**

JM:10631690	
07/33	3 rd floor by communal door to stairs has excessive gaps and gap between stop and frame handle side / adjustment / repair required.

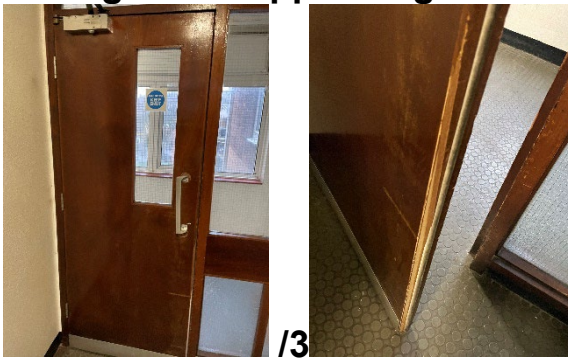
- 34) 3rd floor communal door by flat 218 excessive gaps and damage to re-lipped edge on leading edge.**

P2	Within 1 to 3 months of action plan date. Fire Rapid Response JM:10631774	20/04/2023
07/34	3 rd floor by flat 218 communal door has excessive gaps and damage to re-lipped edge, adjustment / repair required.

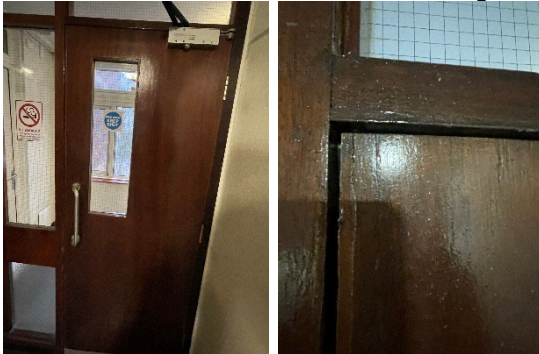
- 35) 3rd floor communal door by flat 210 has excessive gaps.**

07/35	3 rd floor communal door by flat 210 has excessive gaps adjustment / repair required.

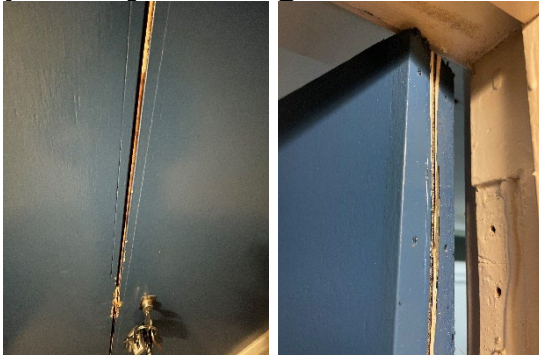
- 36) 3rd floor by flat 214 service cupboard doors (electrical) have excessive gaps between both sets of doors. Smoke seal is partially missing from the left-hand door of the left-hand set.**

P2	Within 1 to 3 months of action plan date. Fire Rapid Response JM:10631824	20/04/2023
07/36	3 rd floor by flat 214 electrical service cupboard has excessive gaps between both sets of doors, adjustment required. Also replace cold smoke seal that is partially missing from left hand door (left side cupboard).

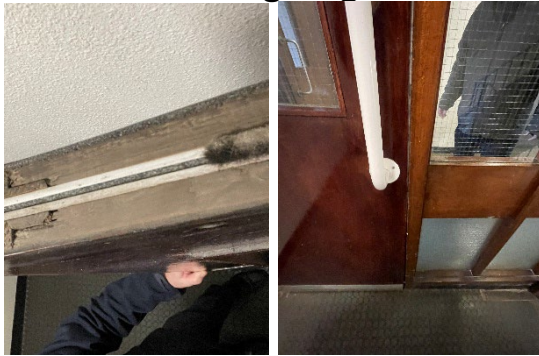
- 37) 2nd floor communal door to stairs smoke seal is partially missing from head. Also, excessive gaps towards bottom of door on leading edge.**

07/37	2 nd floor communal door to stairs has excessive gaps towards bottom on leading edge adjustment / repairs required. Replace cold smoke seal to head.

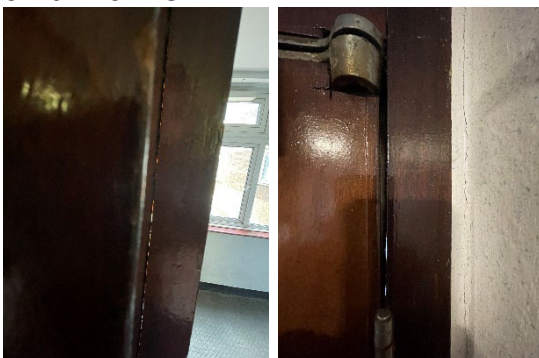
- 38) 2nd floor communal door by flat 200 gaps between door stop and frame.**

P2	Within 1 to 3 months of action plan date. Fire Rapid Response JM:10631855	20/04/2023
07/38	2 nd floor by flat 200 excessive gaps (each side) between stop and frame require adjustment.

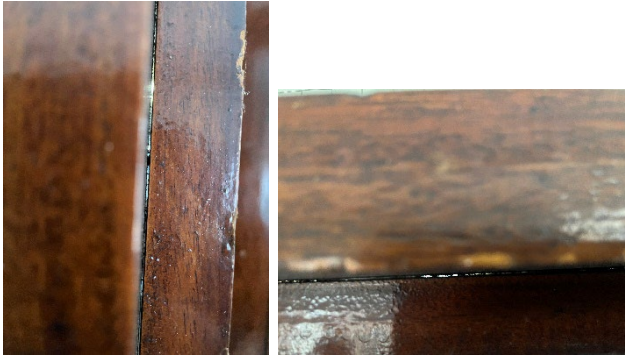
- 39) 2nd floor communal door by flat 208 gaps between door stop and frame on handle side and head.**

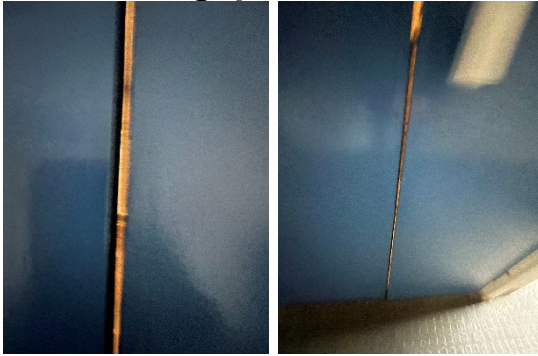
- 40) 2nd floor service cupboard doors (electrical) by flat 204 have excessive gaps between both sets of doors.**

P2	Within 1 to 3 months of action plan date. Fire Rapid Response JM:10631868	20/04/2023
07/40	2 nd floor electrical service cupboards excessive gaps between both sets of doors require adjustment.

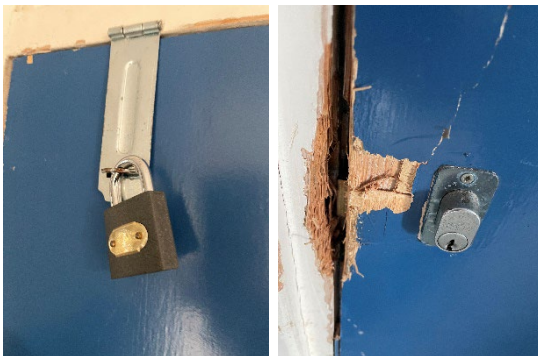
- 41) 2nd floor, unable to gain access to the left side service cupboard between flats 204 & 206 because the door has been secured by a padlock. It was noted that there was some minor exterior damage to the door and frame.**

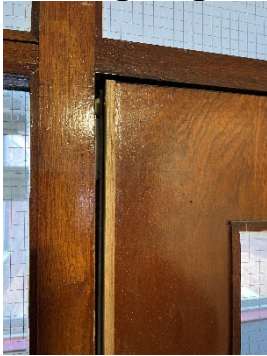
- 42) 1st floor by flat 190 communal door has excessive gap to leading edge and between stop and frame on handle side.**

07/42	1 st floor by flat 190 communal door excessive gap to leading edge and gap between stop and frame on same side, adjustment / repair required.

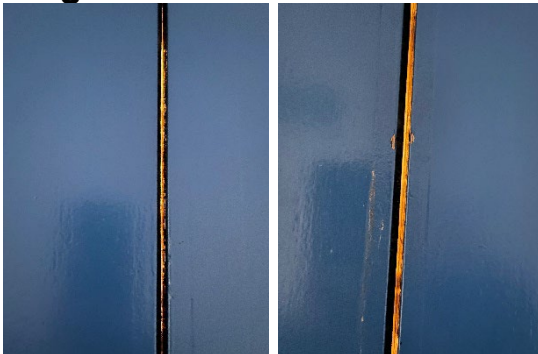
- 44) 1st floor service cupboard doors (electrical) have excessive gaps between both sets of doors. The left-hand doors to both sets are tight on the hinge side with compressed smoke seal seals. Right door on right-hand set has excessive gap on hinge side.**

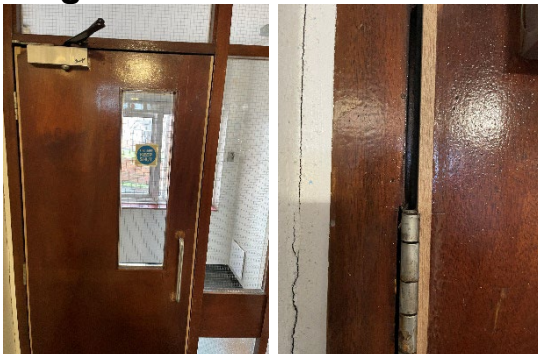
- 45) 1st floor communal door by flat 198 has excessive gaps to hinge side and head.**

07/45	1 st floor by flat 198 communal door has excessive gaps hinge side and head adjustment / repairs required.

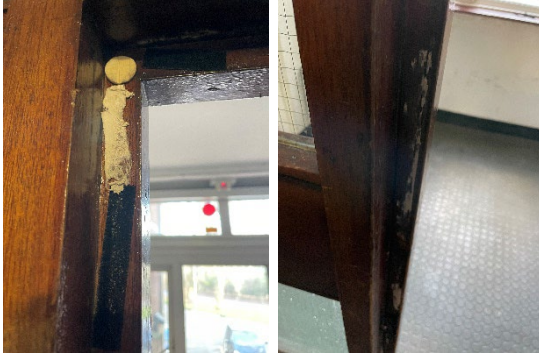
- 46) 1st floor communal doors to stairs and near to flat 190 had various sticky pads and Velcro stuck to the door stops. This prevented the doors from closing fully into the frame which potentially could allow the passage of smoke in the event of a fire. The pads were removed at the time of the FRA.**

P2	Within 1 to 3 months of action plan date. Fire Rapid Response JM:10632038	20/04/2023
07/46	1 st floor communal doors leading to flat 190 had sticky pads and Velcro applied to the door stops to prevent banging. Housing officer to contact all flats on this floor to inform that interference with fire doors will significantly increase the risk to all in the event of a fire.

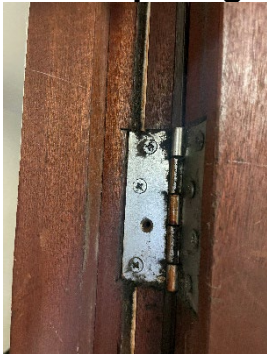
- 47) Ground floor communal door to stairs has a screw missing from top hinge.**

07/47	Ground floor communal door to stairs / replace missing screw to top hinge

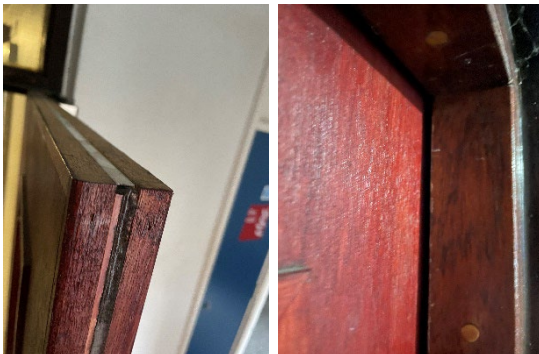
- 48) Ground floor communal door by flat 188 has no smoke seal to the head and door doesn't always reliably self-close fully into frame.**

P2	Within 1 to 3 months of action plan date. Fire Rapid Response JM:10632071	20/04/2023
07/48	Ground floor by flat 188 communal door doesn't reliably fully self-close adjustment required, also requires cold smoke seal to head.

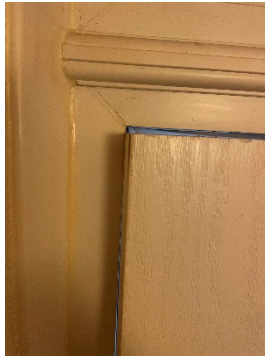
A. 4th floor flat 220 door binds top corner lock side.
