Fire Risk Assessment

Wesley Court

**Southbank Rd,
Cradley Heath, B64 6LQ**

Date Completed: 11/07/2025

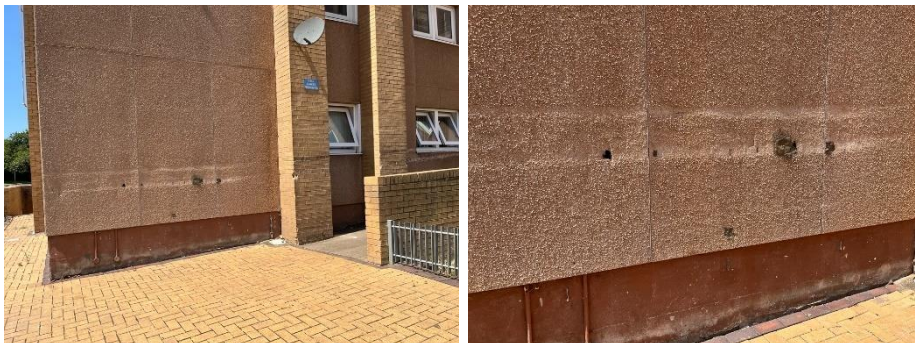
5. Cladding was found to be damaged near the bin store entrance. This damage should be repaired. See observations.

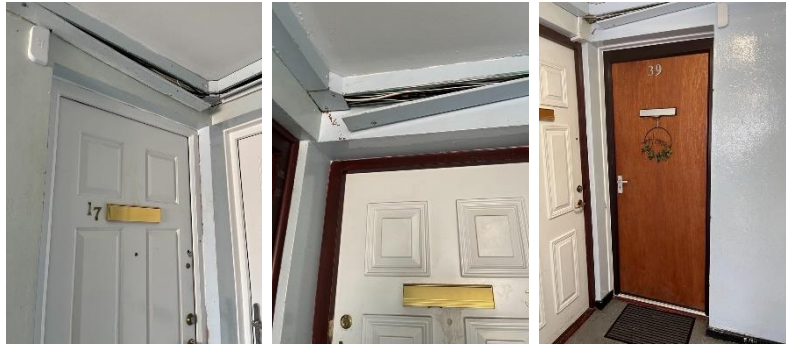
- 19) The means of escape should be kept free of loose cabling. Loose electrical trunking lids were noted on the 2nd floor over the entrance doors to flats 16, 17 and 18, and on the 5th floor over flat 36 and on the 6th floor over flat 39. The cabling and trunking lids should be resecured. See Action 07/19**

Question/ Ref No	Required Action	Supporting photograph	Priority	Timescale and Person Responsible	Date Completed
07/19	Loose electrical trunking lids were noted on the 2 nd floor over the entrance doors to flats 16, 17 and 18, and on the 5 th floor over flat 36 and on the 6 th floor over flat 39. The cabling and trunking lids should be resecured.

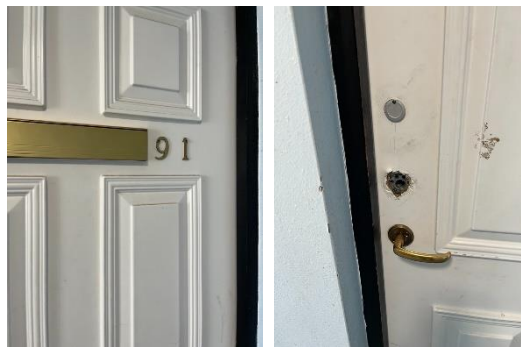
23) Flat 91 was not accessed but damage to the door leaf around the lock was noted. This damage should be repaired. See Action 07/23.

P2	Electrical. 1 – 3 months.	
07/23	Flat 91 has damage to the door leaf around the lock. This damage is required to be repaired.

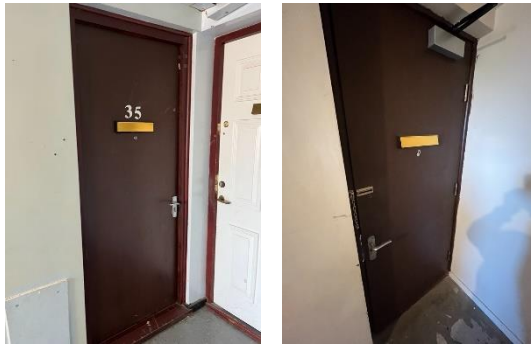
h) Flat 35 - Door fails to close into its frame from the open position. Adjustment is required. See Action 07/24h.

07/26h	Flat 35 front door fails to close into its frame from the open position. Adjustment is required.

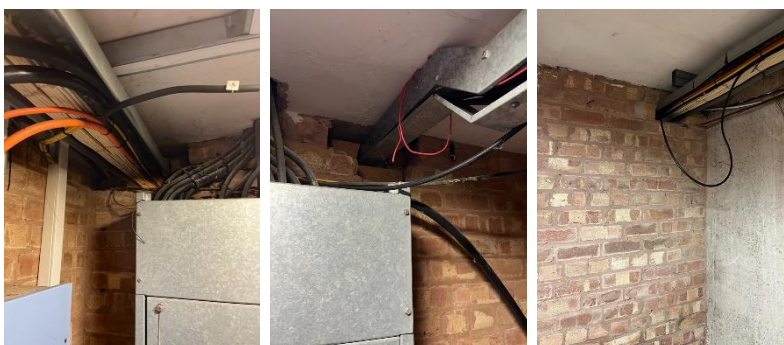
- 1) The building is designed to provide as a minimum 1-hour vertical fire resistance and 1-hour horizontal fire resistance around flats stairwells and lift shafts. All doors are 30-minute fire resistant with cold smoke seals, including those in 1-hour rated walls.
- 2) The premise has sufficient compartmentation to limit the travel and effect of smoke and flame in event of a fire. Whilst the existing fire stopping is fit for purpose, there is a cyclical programme to ensure fire stopping as not been compromised by third parties and where applicable enhance the fire stopping.
- 3) **The basement contains a brick-built compartment for the main incoming electrical supply. This compartment has no fire stopping around cable and pipe penetrations. The cable and pipe penetrations are required to be fire-stopped. See Action 10/03**

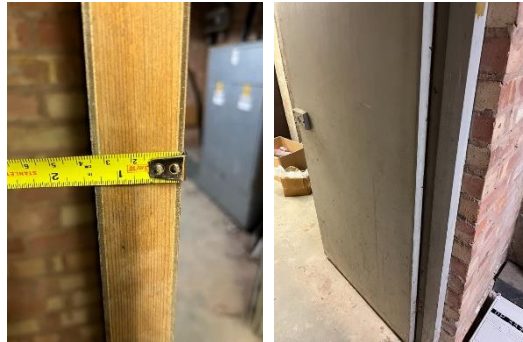
- 4) **The basement contains a brick-built compartment for the main incoming electrical supply. The door to this compartment is not a fire door, the door should be replaced with a FD30s fire door. See Action 10/04.**

P3	Fire Rapid Response 3 – 6 months.	
10/04	The door to the main incoming electrical supply in the basement is not a fire door. The door is required to be replaced with a FD30s fire door set.

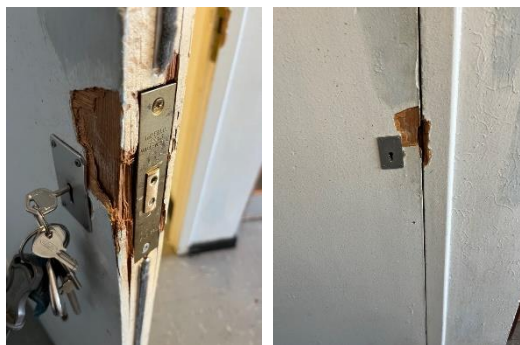
- 9) **The 13th floor electrical service cupboard has damage around the lock area, requiring repair. See Action 10/09.**

P3	Fire Rapid Response 3 – 6 months.	
10/09	The 13 th floor electrical service cupboard has damage around the lock area, requiring repair.

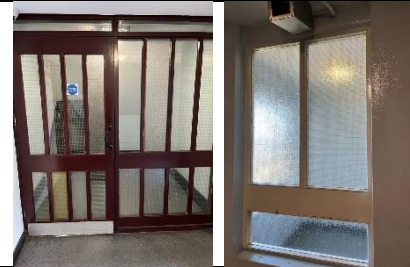
When any future refurbishments take place the notional hardwood fire screens with Georgian wired glazing that protect the staircase, and lobbies should be upgraded to ensure a minimum of 60 mins fire resistance is provided.

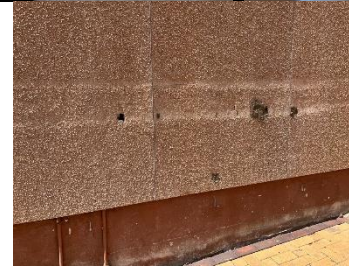
The exterior cladding is showing signs of age. This cladding should be removed or upgraded in any future improvement works program. The cladding is for decorative purposes only and covers the ground and first floors and a small percentage of the 2nd and 3rd floors only.
