# Fire Risk Assessment

## St Giles Court

**Reservoir Road,  
Rowley Regis  
B65 9PE**

**Date Completed: 21/07/2025**

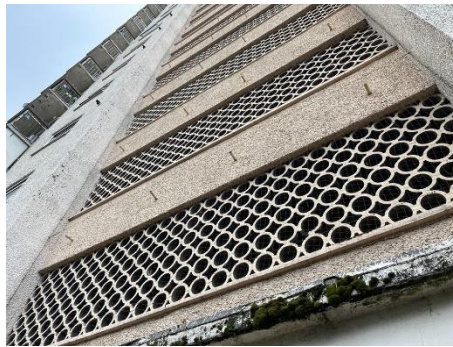
6. The ventilated block work to the chute rooms on the rear elevation have been externally covered with pest control netting. The netting will be permanently removed during significant refurbishment works that are anticipated in the future.

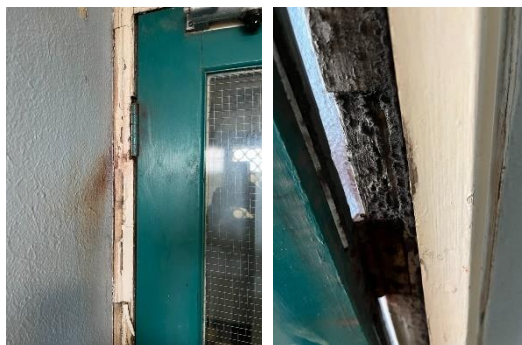
- 8) The 11<sup>th</sup> floor bin chute lobby fire door frame is damaged at the hinge side, requiring repair. See Action 07/08.

07/08	The 11 <sup>th</sup> floor bin chute lobby fire door frame is damaged at the hinge side, requiring repair.

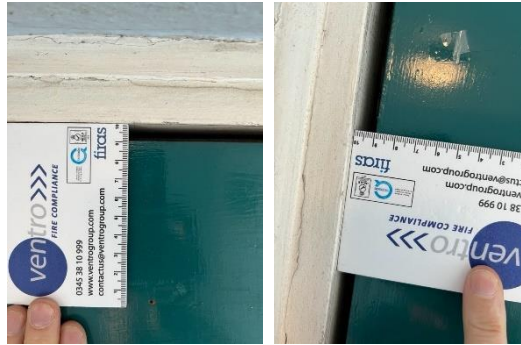
- 9) The 7<sup>th</sup> floor stairwell fire door has an excessive head and latch side gap, requiring adjustment. See Action 07/09.

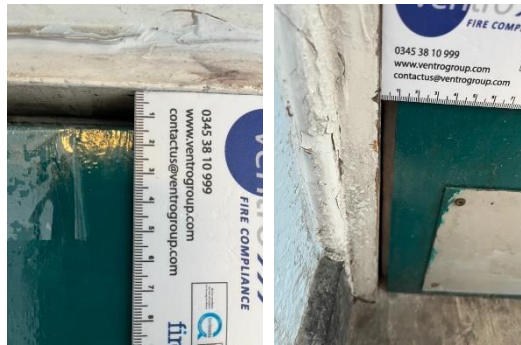
- 10) The 6<sup>th</sup> floor stairwell fire door has an excessive head and latch side gap, requiring adjustment. See Action 07/10.

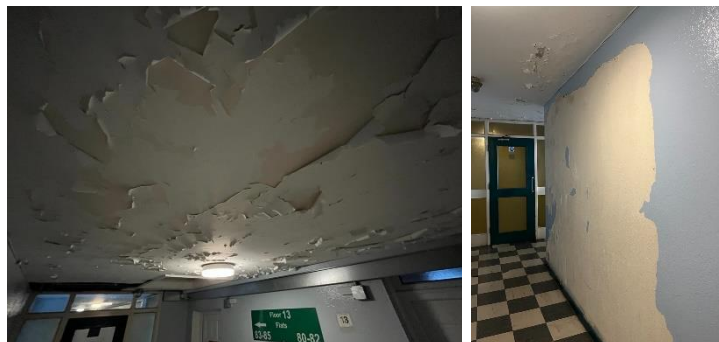
- 21) **The surface coatings to the communal areas are Class 0 rated. The paint in the common areas on the 13<sup>th</sup> and 11<sup>th</sup> floor is becoming detached from the building fabric. Affected areas are required to be repainted with a suitable Class 0 rated product. See Action 07/21.**

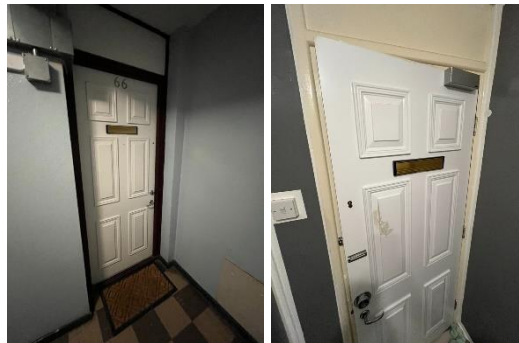
b) Flat 66 - Door has no working self-closing device. A self-closing device is required to be fitted. See Action 07/25b.

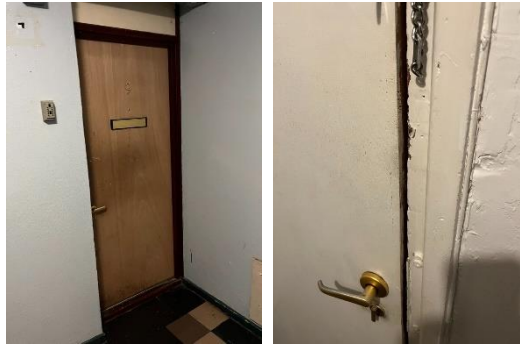
- h) Flat 9 – Door leaf fails to close into its frame from the open position. Adjustment is required. See Action 07/25h.**

07/25h	Flat 9 – Door leaf fails to close into its frame from the open position. Adjustment is required.

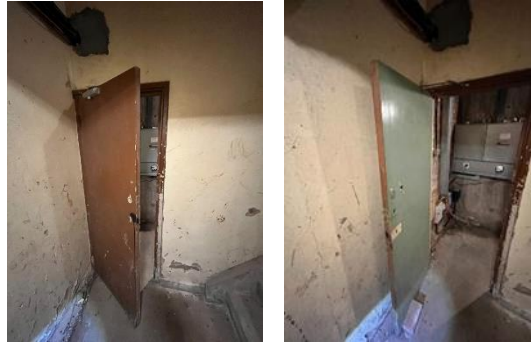
- 4) The lower ground floor contains a 2<sup>nd</sup> brick-built compartment containing electrical switchgear and the emergency lighting battery backup unit. The door to this compartment is not a sufficient fire door, the door should be replaced with a FD30s fire door. See Action 10/04.

10/04	The lower ground floor brick-built compartment containing electrical switchgear and the emergency lighting battery backup unit. The door to this compartment is not a sufficient fire door, the door should be replaced with a FD30s fire door.

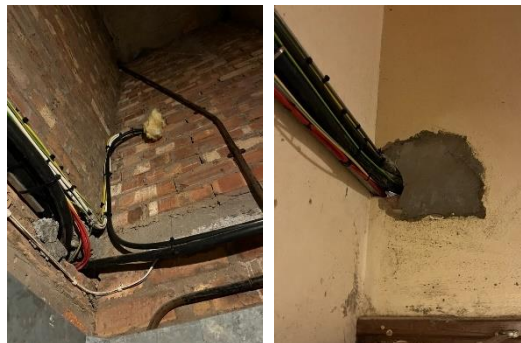
- 5) The lower ground floor contains a 2<sup>nd</sup> brick-built compartment containing electrical switchgear and the emergency lighting battery backup unit. There are gaps around the cable penetrations through this compartment. These gaps are required to be fire stopped. See Action 10/05

P3	Repairs 3-6 months.	
10/05	The lower ground floor brick-built compartment containing electrical switchgear and the emergency lighting battery backup has gaps around cable penetrations. These gaps are required to be fire stopped.

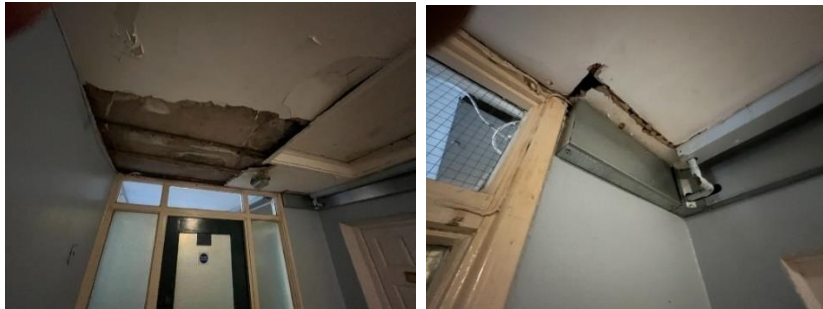
- 8) **The lift lobby ceiling for flats 80-82 on the 13<sup>th</sup> floor is damaged, potentially affecting compartmentation. This damage should be repaired. See Action 10/08.**

P3	Fire Rapid Response 3 – 6 months.	
10/08	The lift lobby ceiling for flats 80-82 on the 13 <sup>th</sup> floor is damaged, potentially affecting compartmentation. This damage should be repaired.

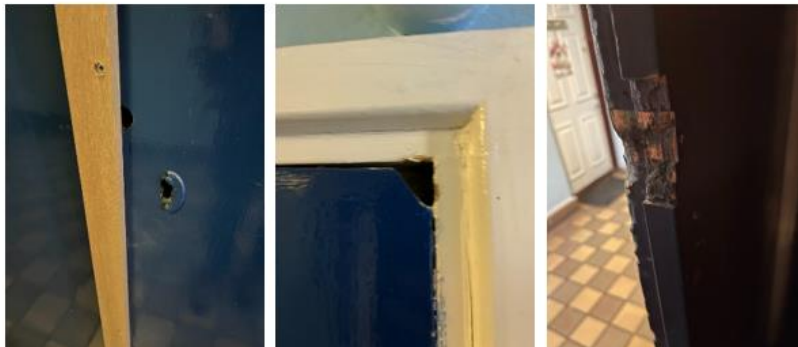
- 11) **The ground floor electrical service cupboard near flats 5, 6 and 7 fails to close securely and has holes and damage. This damage should be repaired and adjustments made to keep the doors securely closed. See Action 10/11.**

P3	Fire Rapid Response 3 – 6 months.	
10/11	The ground floor electrical service cupboard near flats 5, 6 and 7 fails to close securely and has holes and damage. This damage should be repaired and adjustments made to allow the doors to be securely closed.

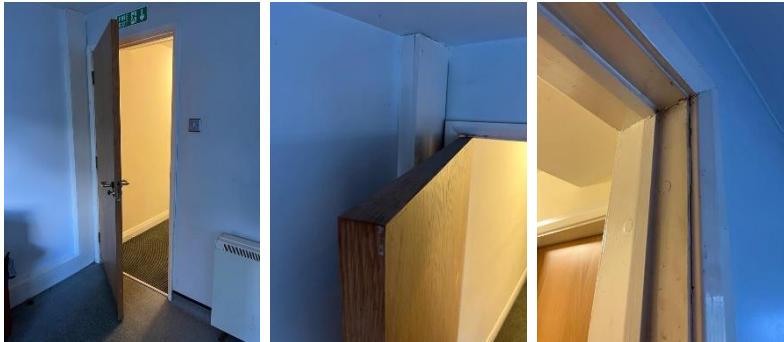
- 16) **The communal kitchen fire door does not have a self-closing device, and the door has no cold smoke or intumescent strip. The door is required to be upgraded with a self-closing device and a combined cold smoke/ intumescent strips. See Action 10/16.**
