Fire Risk Assessment

Addenbrooke Court

**Southbank Rd,
Cradley Heath, B64 6LJ**

Date Completed: 01/07/2025

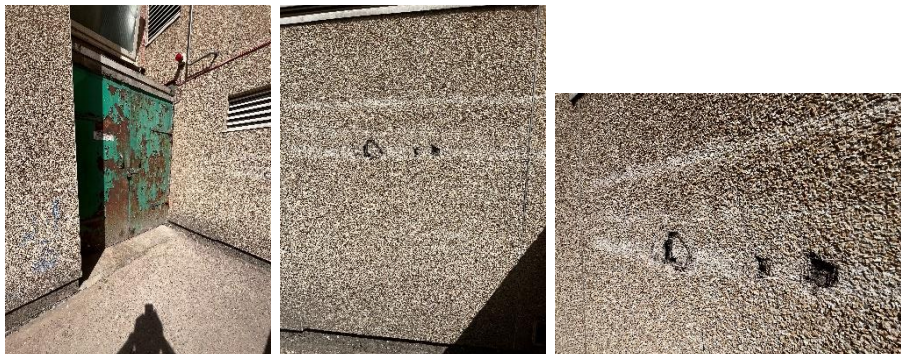
5. Cladding was found to be damaged near the bin store entrance. This damage should be repaired. See observations.

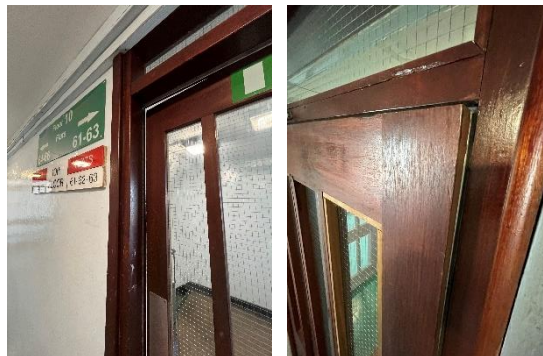
- 9) On the 10th floor, the corridor fire door from the staircase into the lift lobby requires adjustment to close into its frame correctly. See Action 07/09.

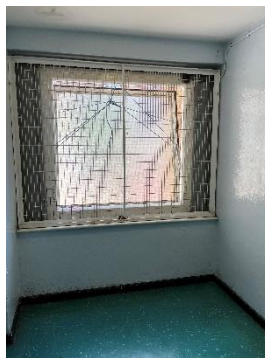
- 13) The AOV to the first-floor lobby by flats 10, 11, 12 is defective and stuck in the open position due to a failed actuator. The assessor has been informed that a replacement actuator is on order from the contractor. An email was sent to the Team Leader Fire Safety and Facilities, the reply (08.07.25.) stated that a replacement actuator has been fitted by the contractor and the AOV is working correctly.

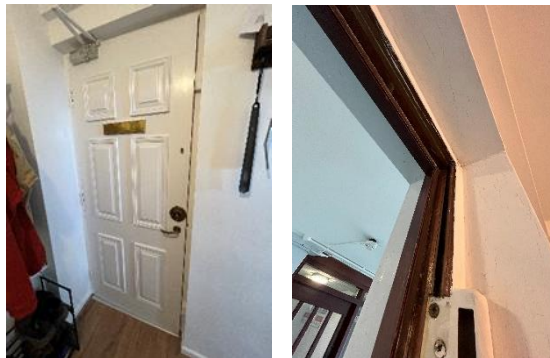
- a) **Flat 79 – Door fails to close from open position, requiring adjustment and the cold smoke brush is missing from the head of the door frame, requiring replacement. See Action 07/26a.**

P2	Fire Rapid Response 1 – 3 months.	
07/26a	Flat 79 – Door fails to close from open position, requiring adjustment and the cold smoke brush is missing from the head of the door frame, requiring replacement.

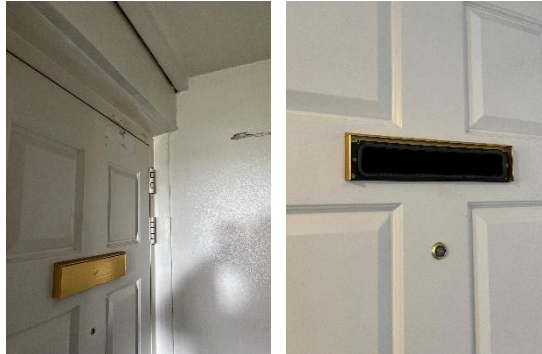
- d) Flat 59 – Door has no self-closing device fitted. The letterbox is damaged. A self-closing device is required to be fitted and the letterbox repaired. See Action 07/26d.**

07/26d	Flat 59 – Door has no self-closing device fitted. The letterbox is damaged. A self-closing device is required to be fitted and the letterbox repaired.

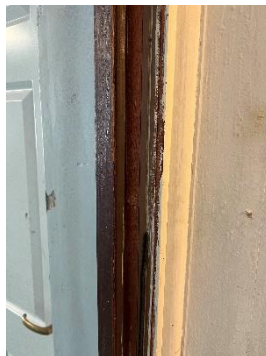
- e) Flat 48 – Door set has a damaged smoke seal on the latch side of the frame, requiring repair. See Action 07/26e.**

P2	Fire Rapid Response 1 – 3 months.	
07/26e	Flat 48 – Door has a damaged smoke seal on the latch side of the frame, requiring repair.

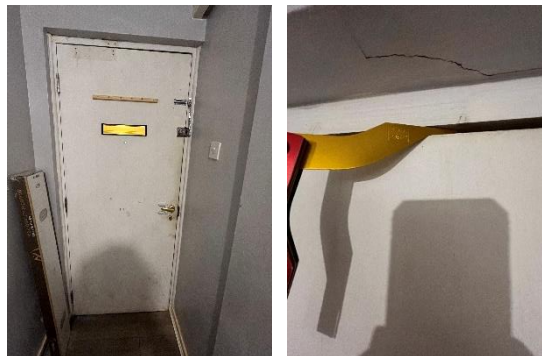
- i) Flat 45 - Door has no self-closing device fitted. There is an excessive head gap. A self-closing device is required to be fitted, and the excessive head gap requires adjustment. See Action 07/26i.**

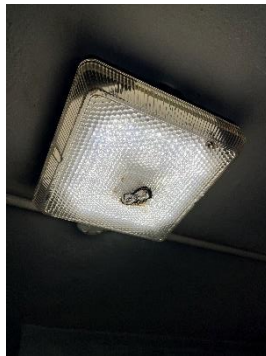
- 3) **The emergency light fitting in the bin chute room on the 14th Floor has been damaged and requires repair. See Action 09/03.**

P2	Fire Rapid Response 1 – 3 months.	
09/03	The emergency light fitting in the bin chute room on the 14 th Floor has been damaged and requires repair.

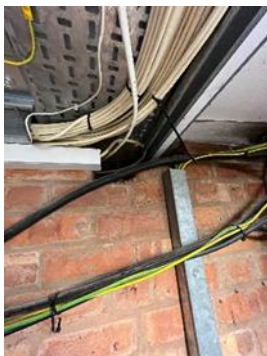
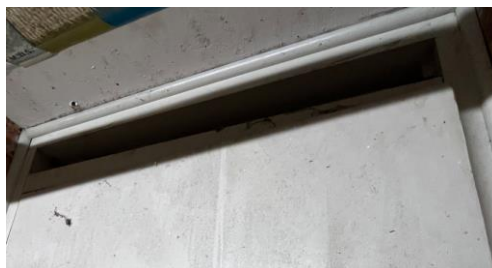
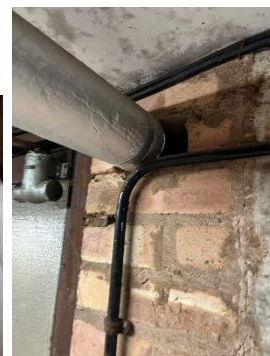
- 3) **The basement contains a brick-built compartment for the main incoming electrical supply. This compartment has no fire stopping around cable and pipe penetrations and there is a gap where the door transom is missing. The cable penetrations and the door transom gap are required to be fire-stopped. See Action 10/03**

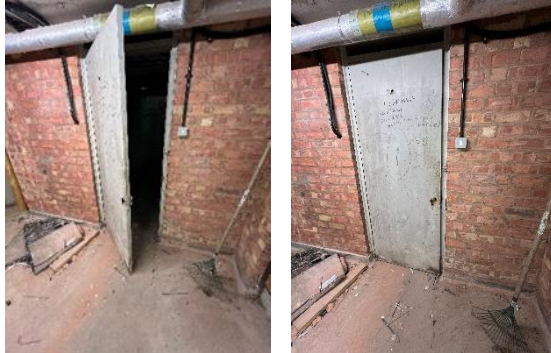
- 4) **The basement contains a brick-built compartment for the main incoming electrical supply. The door to this compartment is damaged and unsuitable, the door should be replaced with a FD30s fire door. See Action 10/04**

P3	Fire Rapid Response 3 – 6 months.	
10/04	<p>The door to the main incoming electrical supply in the basement is damaged. The door is required to be replaced with a FD30s fire door.</p>

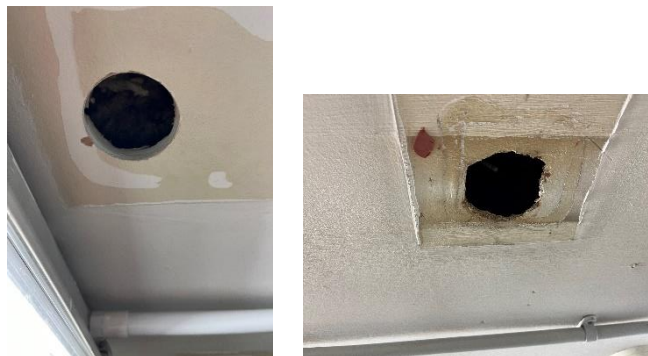
- 6) **There are minor holes in the ceiling of the AOV room that require filling with a fire-resistant material. See Action 10/06.**

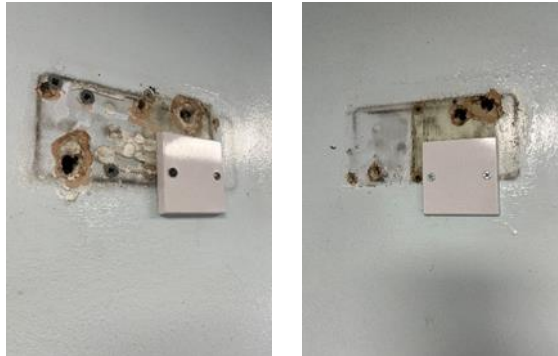
- 7) **There are minor holes in the entrance foyer walls, requiring filling with fire resistant material. See Action 10/07.**

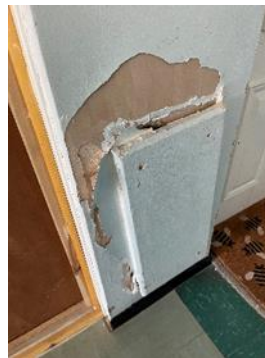
- 8) **Access panels to stop taps are fixed to masonry adjacent flat entrance doors and bedded on intumescent material. The access panel outside flat 82 is damaged. The panel should be repaired. See action 10/08.**

P3	Fire Rapid Response 3 – 6 months.	
10/08	The service access panel outside flat 82 is damaged. The panel should be repaired.

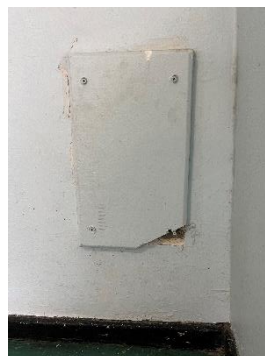
- 9) **Access panel to stop tap outside flat 66 is damaged. The panel should be repaired. See action 10/09.**

10/09	The service access panel outside flat 66 is damaged. The panel should be repaired.

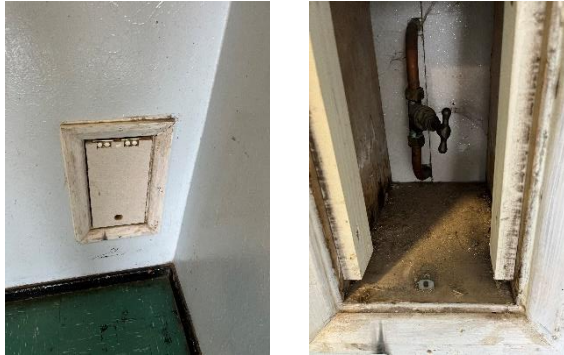
- 10) **The access panel to stop tap outside flat 21 has not been upgraded as per all other service access panels in the block. The panel should be upgraded to offer sufficient fire and smoke resistance. See action 10/10.**

P3	Fire Rapid Response 3 – 6 months.	
10/10	The access panel to stop tap outside flat 21 has not been upgraded as per all other service access panels in the block. The panel should be upgraded to offer sufficient fire and smoke resistance.

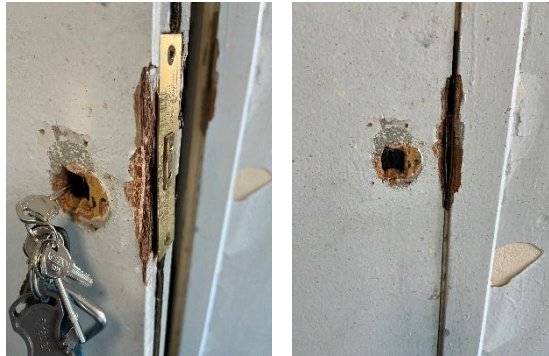
- 13) **The 15th floor electrical service cupboard has damage around the lock area, requiring repair. See Action 10/13.**

P3	Fire Rapid Response 3 – 6 months.	
10/13	The 15 th floor electrical service cupboard has damage around the lock the damage is required to be repaired.
