Fire Risk Assessment

Moorlands Court

**Reservoir Road,
Rowley Regis
B65 9PB**

Date Completed: 29/07/2025

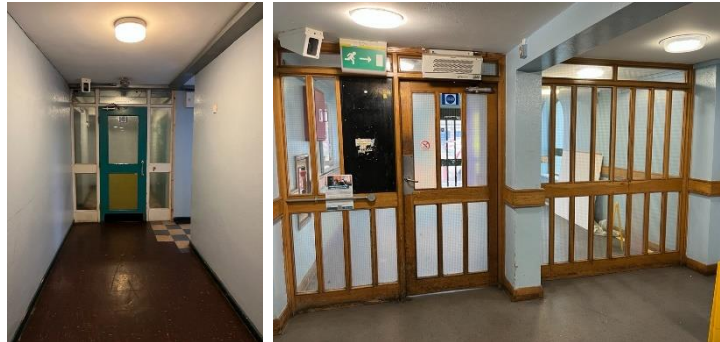
- 6) The communal landing / staircases are protected by use of notional FD30s fire doors with vision panels. It was noted that some communal doors have been replaced with nominal FD30s fire doors.

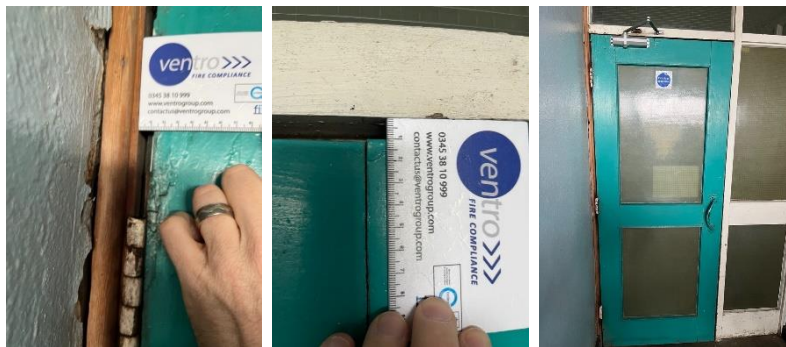
- 7) The 9th floor bin chute lobby fire door has an excessive gap at the head and hinge side, requiring adjustment. See Action 07/07.

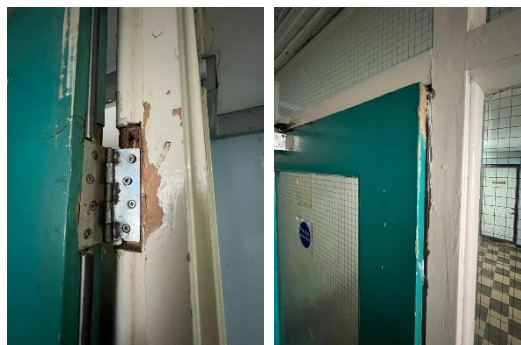
- 8) The 8th floor lobby fire door for flats 50, 51 and 52 has damage at the top hinge and fails to close into its frame correctly, requiring repair and adjustment. See Action 07/08.

07/08	The 8 th floor lobby fire door for flats 50, 51 and 52 has damage at the top hinge and fails to close into its frame correctly, requiring repair and adjustment.

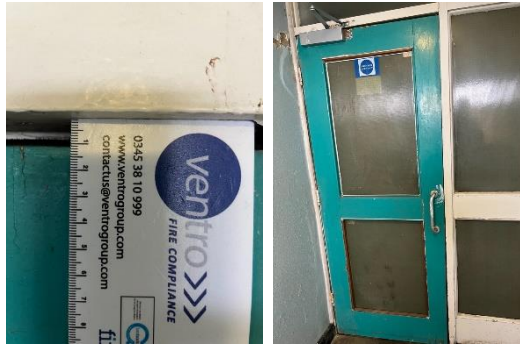
- 9) The 7th floor bin chute fire door has an excessive head gap, requiring adjustment. See Action 07/09.

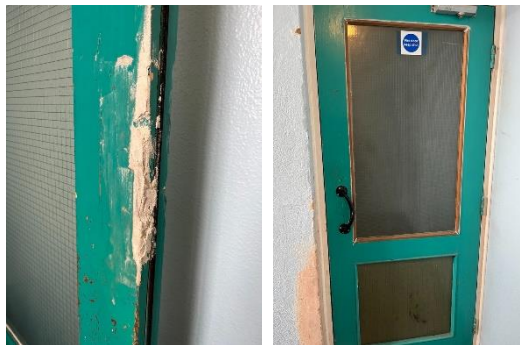
- 10) The 7th floor stairwell fire door has an excessive damaged leaf at the latch side, requiring repair. See Action 07/10.

P2	Fire Rapid Response 1 – 3 months.	
07/10	The 7 th floor stairwell fire door has an excessive damaged leaf at the latch side, requiring repair.

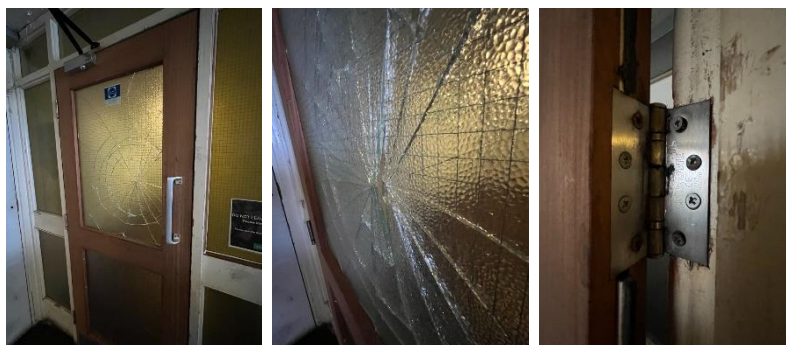
- 11) The 4th floor lobby fire door to flats 26, 27 and 28 has a broken top glazing panel and a loose top hinge, requiring repair. See Action 07/11.

07/11	The 4 th floor lobby fire door to flats 26, 27 and 28 has a broken top glazing panel and a loose top hinge, requiring repair.

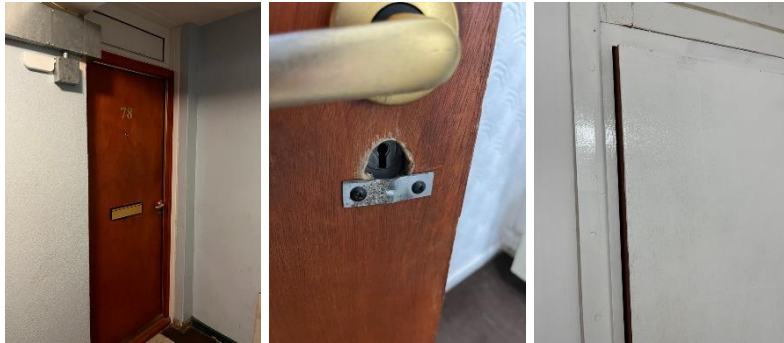
- b) Flat 78 - Door leaf has damage around lock and fails to close into frame from open position, requiring repair and adjustment. See Action 07/25b.**

P3	Repairs 3 – 6 months.	
07/25b	Flat 78 - Door leaf has damage around lock and fails to close into frame from open position, requiring repair and adjustment.

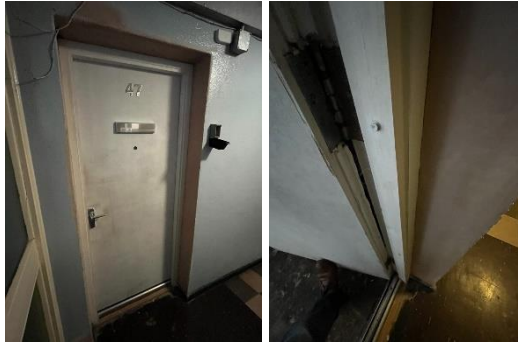
- e) Flat 47 - Door leaf fails to close into its frame from the open position. Adjustment is required. See Action 07/25e.**

07/25e	Flat 47 - Door leaf fails to close into its frame from the open position. Adjustment is required.

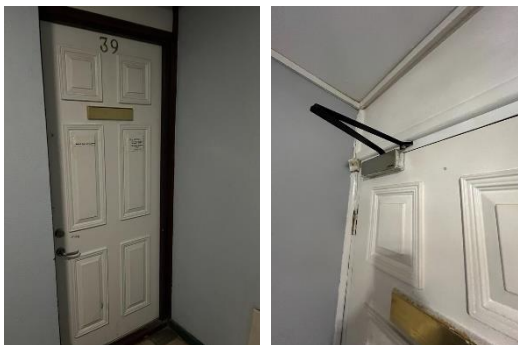
- g) Flat 39 – Self-closing device offers no resistance, door leaf slams, adjustment of repair required. See Action 07/25g.**

P2	Fire Rapid Response 1 – 3 months.	
07/25g	Flat 39 – Self-closing device offers no resistance, door leaf slams, adjustment of repair required.

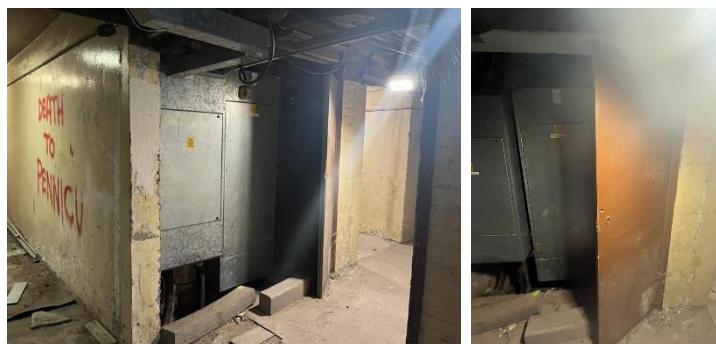
- 1) The building is designed to provide as a minimum 1-hour vertical fire resistance and 1-hour horizontal fire resistance around flats stairwells and lift shafts. All doors are 30-minute fire resistant with cold smoke seals, including those in 1-hour rated walls.
- 2) The premise has sufficient compartmentation to limit the travel and effect of smoke and flame in event of a fire. Whilst the existing fire stopping is fit for purpose, there is a cyclical programme to ensure fire stopping as not been compromised by third parties and where applicable enhance the fire stopping.
- 3) **The lower ground floor contains a brick-built compartment for the main incoming electrical supply. This compartment has no fire doors and is open to the lower ground floor. A double FD30s fire door set is required to be fitted. See Action 10/03**

P2	Fire Rapid Response 1 – 3 months.	
10/03	The lower ground floor contains a brick-built compartment for the main incoming electrical supply. This compartment has no fire doors and is open to the lower ground floor. A double FD30s fire door set is required to be fitted.

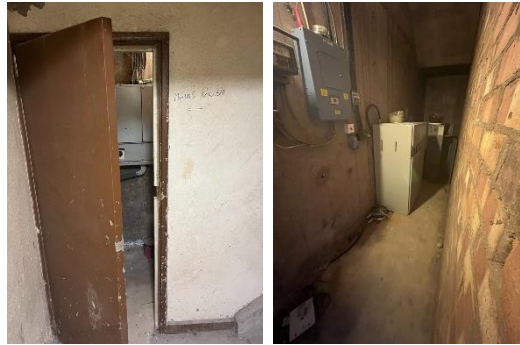
- 4) The lower ground floor contains a 2nd brick-built compartment containing electrical switchgear and the emergency lighting battery backup unit. The door to this compartment is not a sufficient fire door, the door should be replaced with a FD30s fire door. See Action 10/04.

10/04	The lower ground floor brick-built compartment containing electrical switchgear and the emergency lighting battery backup unit. The door to this compartment is not a sufficient fire door, the door should be replaced with a FD30s fire door.

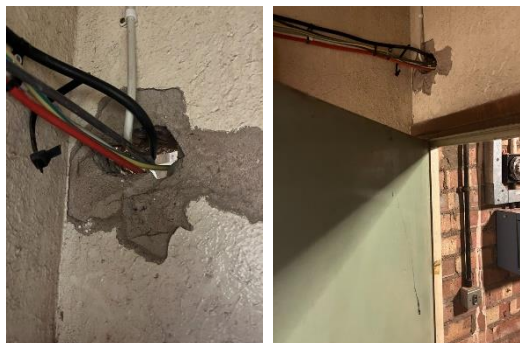
- 5) The lower ground floor contains a 2nd brick-built compartment containing electrical switchgear and the emergency lighting battery backup unit. There are gaps around the cable penetrations through this compartment. These gaps are required to be fire stopped. See Action 10/05

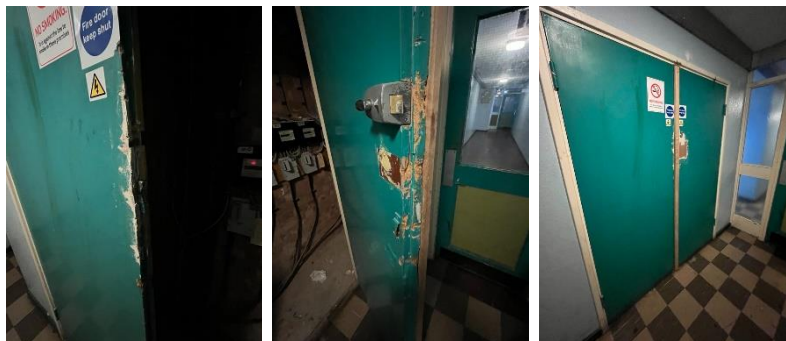
- 10) **The 6th floor electrical service cupboard near flats 41, 42 and 43 has damage to its door leaves. This damage should be repaired and adjustments made to keep the doors securely closed. See Action 10/10.**

10/10	The 6th floor electrical service cupboard near flats 41, 42 and 43 has damage to its door leaves. This damage should be repaired and adjustments made to keep the doors securely closed.	 	P2	Fire Rapid Response 1 – 3 months.	
-------	--	--	----	--------------------------------------	--
