# Fire Risk Assessment

**Falcon Place,  
1-12,  
Tividale,  
Oldbury,  
B69 1PD.**

**Date Completed: 05/05/2026**

**Officer: C. Hudson Fire Risk Assessor**

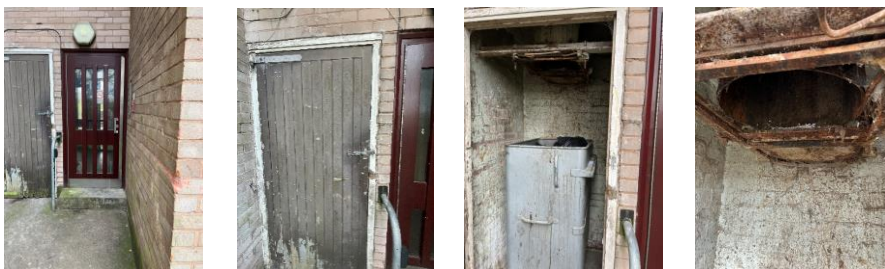
The bin store is located on the ground floor near the rear exit. The bin store is not secured with any type of lock. There is a latch present to keep the bin store door closed.

As the refuse hoppers are located within a common area, it is recommended that the manual bin chute be upgraded to a fusible link to ensure it will automatically close in the event of a fire, thereby reducing the risk of fire and smoke spread in the common areas.

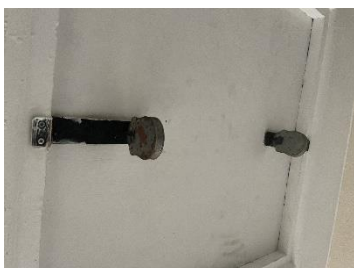
Internal access to the loft space can be gained on the third floor communal area . Residents do not have access to the roof space.

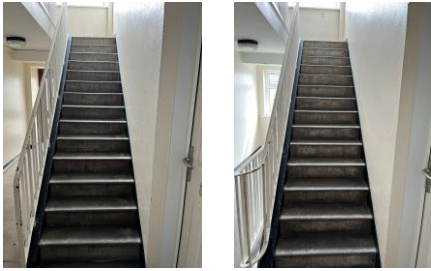
The block has a single concrete staircase as the sole means of escape (above ground floor).

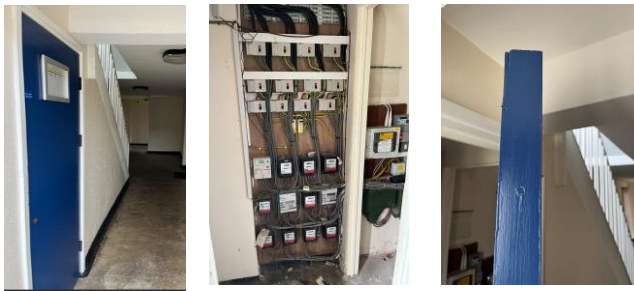
The service cupboard housing electrical intakes is situated at the front of the building behind the staircase; the door is a notional FD60 door, secured with a type 138 suited mortice lock. Residents have been provided with a key for access to their electricity meters.

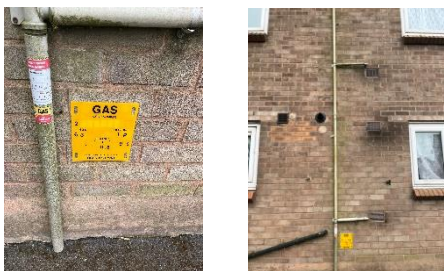
The gas supply to the block is supplied externally.

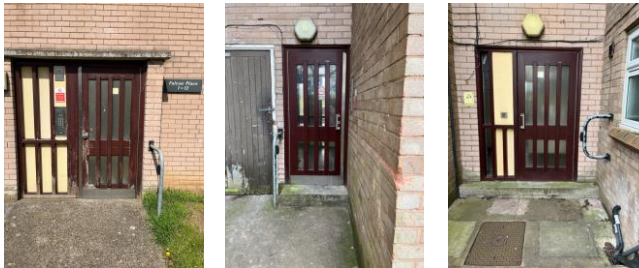
- 6) Access is gained to all flats from the ground floor using the main access door leading to the staircase area, further egress is available via the two rear access doors. All doors are solid timber with glass vision panels and have a Fob access system and a self-closer attached.

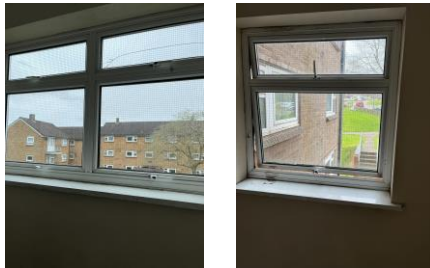
- 9) In the building the 1<sup>st</sup> 2<sup>nd</sup> and 3<sup>rd</sup> floor landings, have UPVC frames with Georgian wired glass, these windows can be opened without the use of a key, these also allow sufficient ventilation. There is no automatic smoke ventilation system installed in this premises.

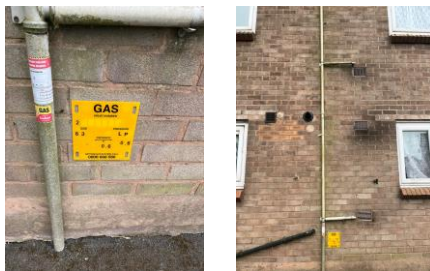
- 10) Gas risers enter the building on the external elevations.

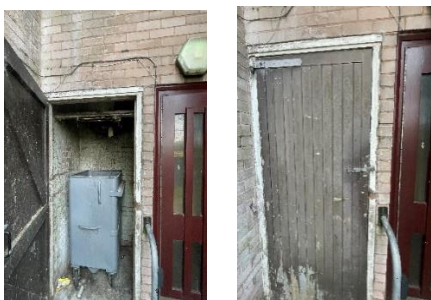
- 11) The bin store located on the ground floor is located near the rear exit. The bin store is not secured with any type of lock. There is a latch present to keep the bin store door closed.

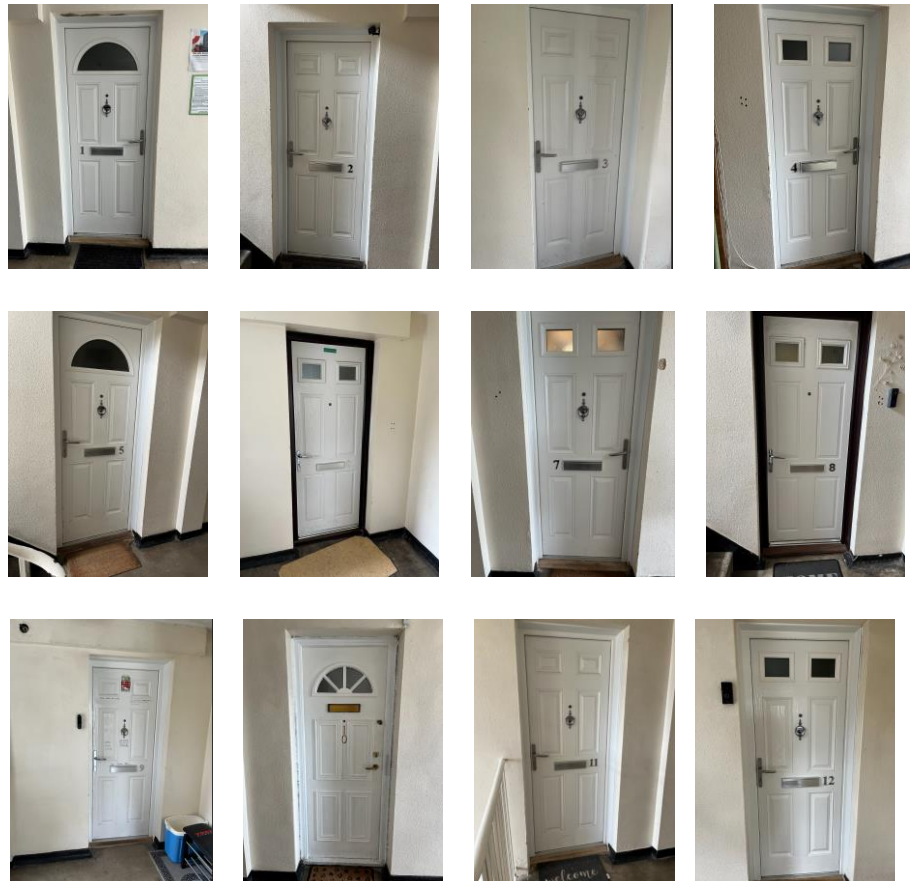
- 1) The majority of Individual flat doors are FD30s rated composite fire doors, with flat No 10 being a notional timber door.

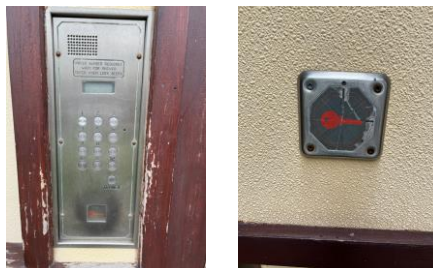
- 15) The front final exit door has a door entry system installed. These systems are designed to fail safe i.e., door unlocked in the event of a power failure. This prevents residents being locked in or out of the building.

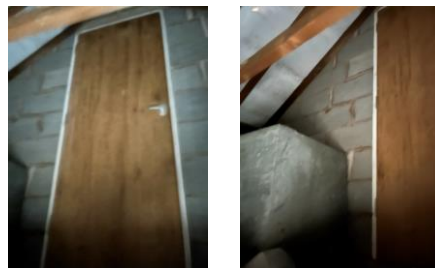
- 10) The loft area was inspected visually from the head of a ladder. The solid block wall with a fire door fitted in it appeared to be in good condition, but this assessment was limited and does not constitute a comprehensive compartmentation survey.

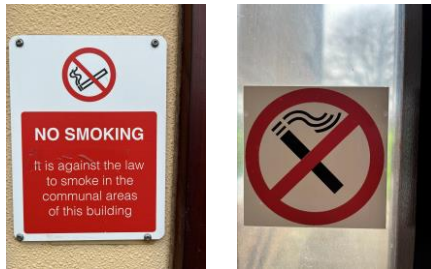
- 1) Appropriate signage is displayed throughout the building.
- 2) No smoking (Smoke Free England) signage is displayed at the front entrance to the premises.

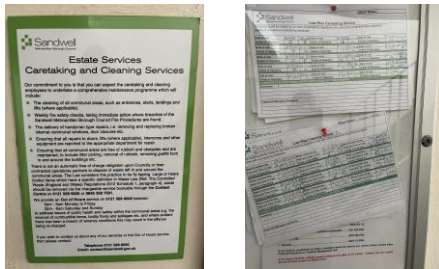
5. Regular checks by Caretakers minimise risk of waste accumulation.

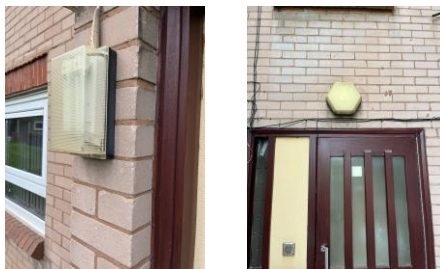
3. No CCTV is present at the block.
4. There is no current evidence of arson.
5. The perimeter of the premises is well illuminated.
