Fire Risk Assessment

19-24 Falcon Place

Tividale, B69 1PD

Date Completed: 13th May 2026

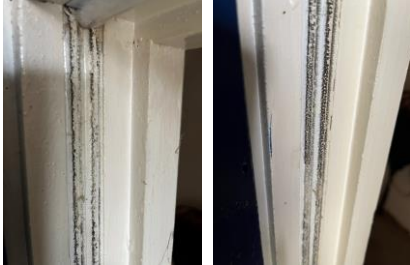
- 4) **Electrical cupboard does have brush smoke seals installed to the door frame, however the brush seal on the hinge side has been fouled by paint reducing its performance.**

Question/ Ref No	Required Action	Supporting photograph	Priority	Timescale and Person Responsible	Date Completed
10/4	Ground floor electrical cupboard, brush smoke seal on the hinge side have been fouled by paint. Damaged seal to be replaced by new seal.

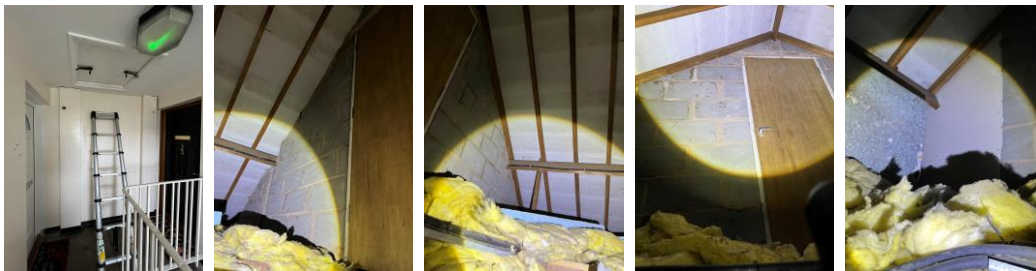
- 5) **Access to the roof is by means of roof hatch which is on the 2nd floor landing, this was inspected for compartmentation and firestopping, no issue was found.**

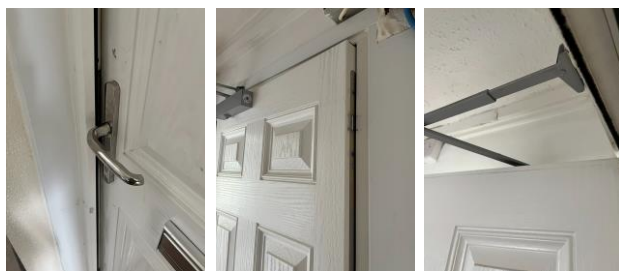
Access was gained to flats 20 and 23 to assess the operation of the self-closing device, the condition of the fire and smoke seals to the flat entrance door and smoke detection, Flat 20 self-closing device requires adjustment to allow the door to close automatically into the frame.

- 9) Flat 20 self-closing device does not allow the door to self-close into the frame.

P2	1-3 Months Fire Rapid Response	
10/9	Flat 20 self-closing device requires adjusting to allow it close smoothly into frame.

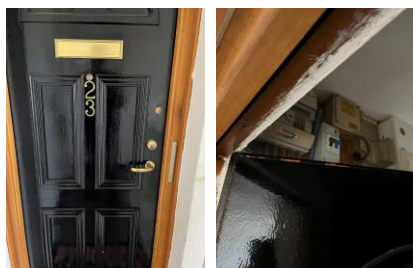
- 10) Flat 23, resident has removed self-closing device. This will need reinstalling.

P2	1-3 Months Fire Rapid Response	
1010	Flat 23 has had a self-closing device removed. Refit new self-closing device

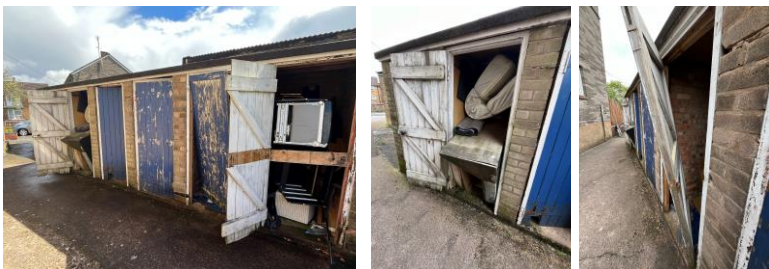
- 1) Residents instructed not to bring L.P.G cylinders into block.
- 2) The tenancy conditions, Section 7 – Condition 5.6 stipulates “If you live in a flat or maisonette, you, people living with you and any visitors to your property must not keep or use paraffin oil, petrol, bottled gas appliances or any other explosive, FLAMMABLE or dangerous material in the property. This restriction also applies to any storage facility situated in or attached to the block, which has been provided for your use.”
- 3) No Flammable liquids stored on site by Caretakers / cleaners.
- 4) There are no flammable liquids or gas cylinders stored on site.
- 5) **Unsecured resident external storage units at the rear of the building contain combustibile materials, presenting a significant arson risk.**

18/5	Resident external storage cupboards are unsecure leaving combustible at risk. make cupboards secure.	 	P2	1-3 Months Repairs Team	
------	--	---	----	----------------------------	--
