Fire Risk Assessment

Bishops Close 8 -12

Bishops Close, Smethwick B66 2RD

Date Completed: May 2026

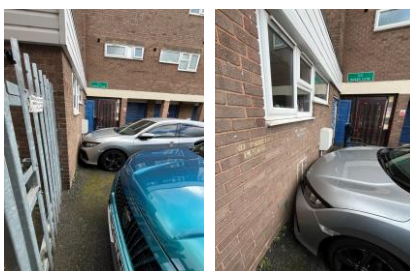
- 5) **Vehicles parked on the front are parked too close to the envelope of the block, was evident that a vehicle was parked directly under a residents flat window.**

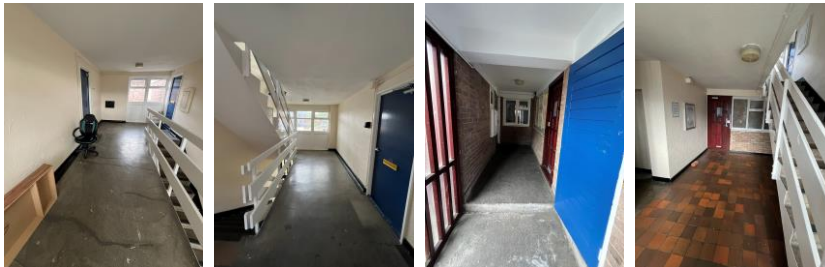
- 3) All corridors, landing and staircase are of adequate width and are kept clear to promote & maintain safe exit in an event of fire. *2nd floor resident has been advised to remove items outside of the flat. Resident will remove items.*

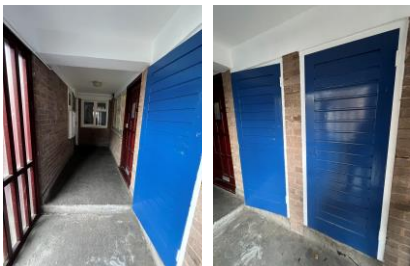
- 4) Resident storage cupboards are within the means of escape, these are made secure by residents. Has been noted in previous FRA, that these are to be upgraded to FD30S fire rated doors in any future refurbishment of the block.

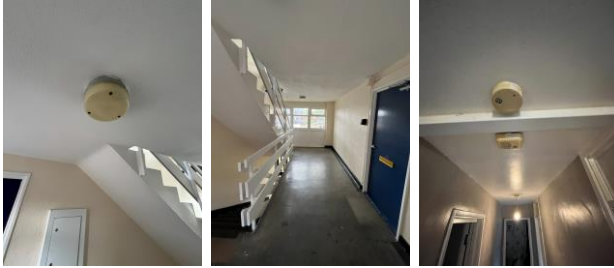
8) Emergency lighting is not installed throughout the building, The use of conventional lighting and borrowed lighting from street lighting provides sufficient lumens for the means of escape.

9) Has been mentioned by resident that the conventional lighting does not seem to come on when it becomes dark, this has been a on going issue since winter, most likely due to the incorrect time set on the timer. This will need to be corrected to provide sufficient lighting at the times needed.

7/9	Conventional lighting does not come on at the required times due to incorrect time setting on the timer. Set correct switch on time.

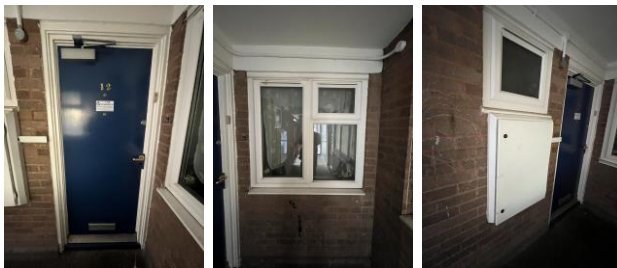
- 12) Ground floor flat 12 has UPVC window units that face into the communal hallway of the block, *Recommendation on any future refurbishment of the block these are to be removed and replaced with sufficient fire resistance to maintain complete compartmentation between the flat and of the communal area.*

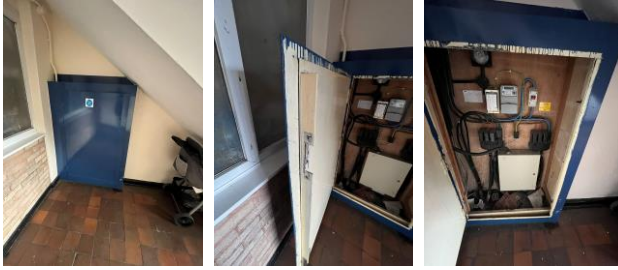
An inspection of the ground floor electrical cupboard, which houses the main incoming power supply for the block, revealed significant security and fire safety failures. The existing locking mechanism is inoperable, leaving high-voltage infrastructure unsecured. The absence of smoke and intumescent seals on this door as well as on the communal door that separates the communal area into two compromises the building's fire compartmentation, creating an elevated risk to life safety.

- 3) **The electrical cupboard beneath the communal staircase and within the escape route presents critical non-compliances. A damaged locking mechanism leaves electrical infrastructure unsecured. Additionally, the door assembly lacks intumescent and cold smoke seals. Located under the sole exit stairs, these defects severely compromise fire compartmentation and elevate life safety risks.** *Recommended that on any future works programme to the block that this door be replaced with a certified FD30s fire door.*
-

P2	1-3 Month Electrical Team	
10/3	Ground floor main electrical intake cupboard does not secure shut, has no smoke or intumescent seals installed. Make door secure and if possible, add smoke and intumescent seals

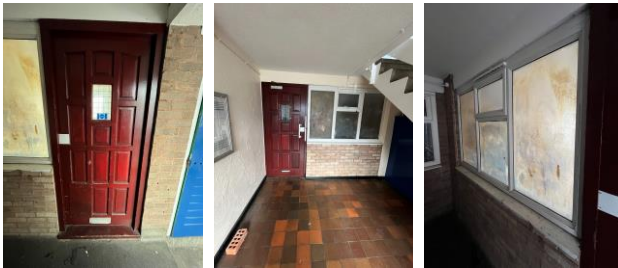
- 4) On the ground floor, there is a UPVC window unit and a timber glazed door that divide the communal area into 2, in the event of a fire the UPVC window unit will not provide the sufficient compartment required to resist any fire and smoke in an event of fire. *Recommendation on any future refurbishment of the block that the UPVC window unit to be removed and replaced with sufficient fire resistance and the glazed door to be upgraded to a certified FD30s fire door to maintain complete compartmentation between the 2 communal areas.*

Timber glazed door and UPVC window unit separates the block communal area on the ground floor. *Recommended that the door to be upgraded to a certified FD30S and the UPVC window unit to be removed and the cavity to be blocked up to maintain sufficient compartmentation in the block*

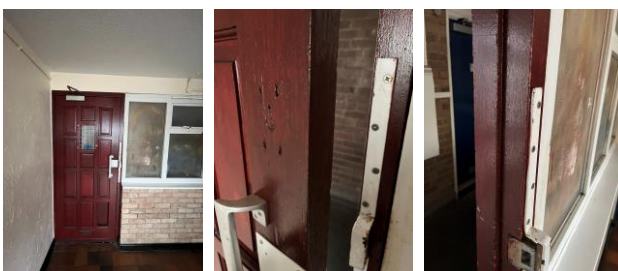
- 5) Communal door on the ground floor that separates the two entrances to the block does not have the sufficient smoke and intumescent seals.

P2	1-3 Months Fire Rapid Response	
10/5	Ground floor communal door that separates the two entrances in the block does not have required smoke and intumescent seals. Requires seals to be installed.

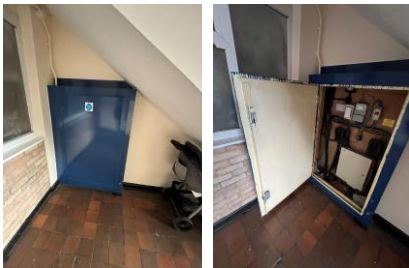
- 7) Electrical service cupboard on the ground floor which is located within the communal area under the stairs near the rear final exit, this cannot be made secure due to faulty locking mechanism, this has been noted in section 10 (Compartmentation). Cupboard is free from any combustibles.

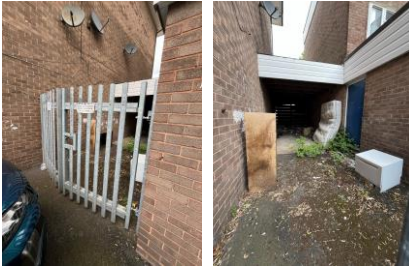
4) Rubbish has been placed in the communal courtyard to the front of the building.

15/4	Rubbish has been placed in the communal courtyard to the front of the block. This will require removing,

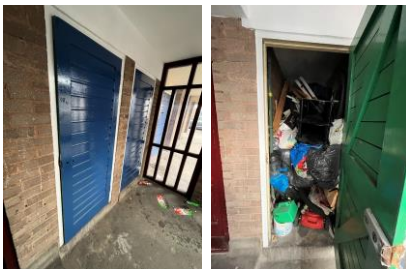
- 3) No Flammable liquids stored on site by Caretakers / cleaners.
- 4) There are no flammable liquids or gas cylinders stored on site.
- 5) **Residents have access to internal storage units within the communal area the building; these are generally kept secure by residents themselves; however, a storage cupboard was left open and has many items of combustion stored within it.** (*Atempt was made to engage with resident of storage the cupboard, no answer from resident.*)

P2	1-3 Months Caretaking Team	
18/5	Ground floor resident storage cupboard is left open with combustibles inside. Identify owner and arrange for cupboard to be made secure.
