Fire Risk Assessment

25-30

**Blue Rock Place,
Tividale,
B69 1PB**

Date Completed: 18/05/2026

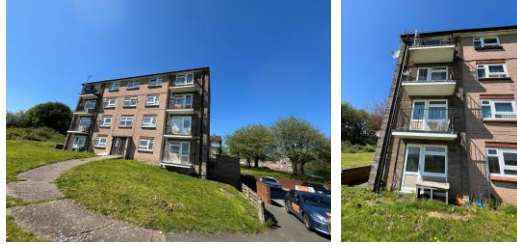
- 3) The flats on the first and second floors each have a small balcony. Each balcony consists of a reinforced concrete floor slab supported by the main building structure. The outer edge is fitted with metal balustrade railings, which provide fall protection while maintaining an open, non-combustible boundary.

- a. On a first floor balcony there is a fire bin along with other items. These are to be removed from the balcony and the fire bin removed completely from the block.

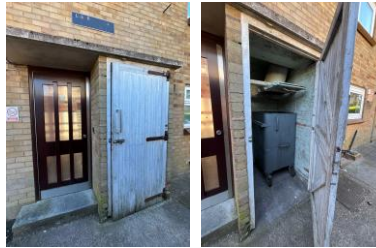
- 6) The bin room is accessible from outside through a timber door. This door is to be kept shut when not in use.

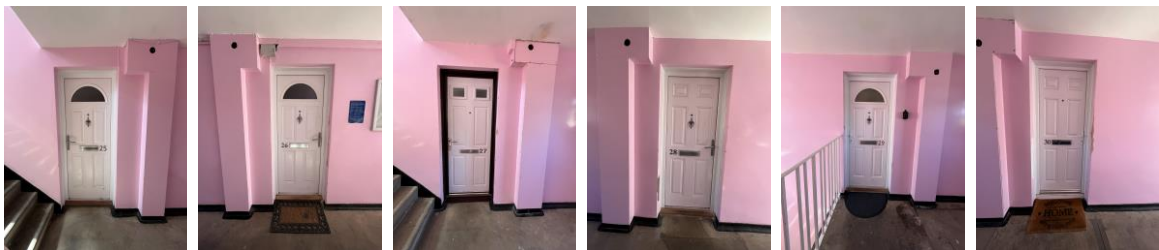
- 1) Each property is fitted with a minimum of an LD3 detection system within the flat. See Section 8
- 2) Individual flat doors appear to be a minimum of FD30 rated; there is a mixture of timber and composite doors sets.

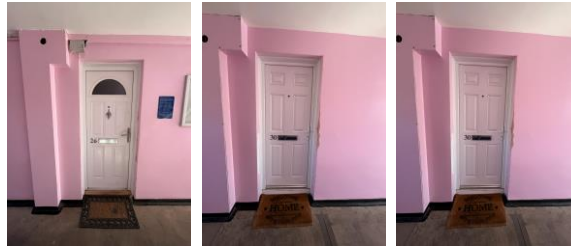
- 4) At a number of flat entrances door mats are present; the fire rating is not known on these door mats and are deemed to be low risk.

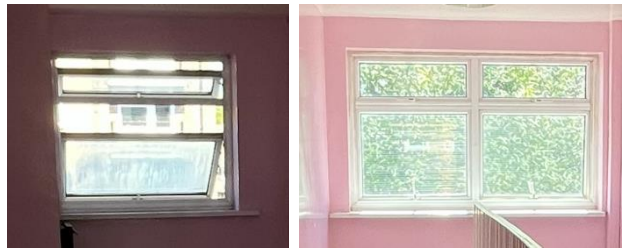
- a) Second Floor: Installed upon the floor is a double and a single unit fitted with top and bottom openers. All the units were fully working at the time of the fire risk assessment.

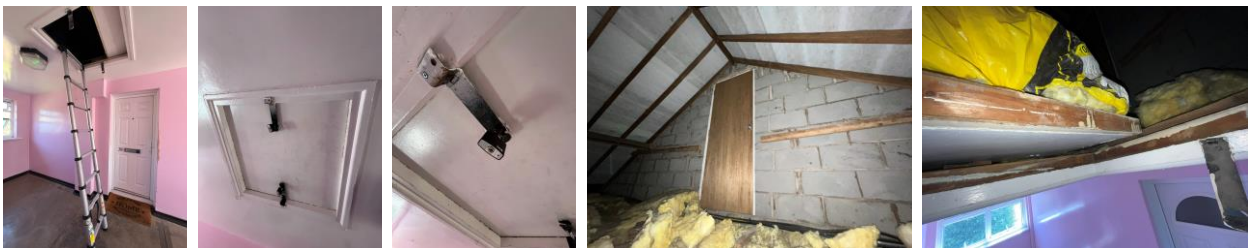
- b) Second Floor: Access to the roof void is located on the third floor and is provided via a solid timber loft hatch secured with two padlocks. This area was inspected during the Fire Risk Assessment and was found to be fully fire-stopped, incorporating dividing block walls and timber fire doors installed within those partitions. The compartmentation appeared consistent with the requirements for maintaining the integrity of the protected escape route.

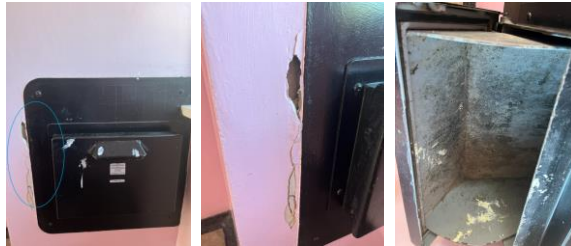
- c) **Second Floor:** The bin chute hopper located adjacent to Flat 29 was inspected and found to be operating correctly at the time of the assessment. All seals were intact, and no defects were observed. Ongoing maintenance and regular checks are essential to ensure the hopper continues to function effectively and does not compromise fire safety within the protected escape route. One area that requires a repair is to the wall the left-hand side of the chute hopper, where a hole goes behind the hopper plate. This requires to be fire stopped.

<p>P2</p>	<p>Within 1-3 months Fire Rapid Response</p>	
<p>7/8c</p>	<p>Second Floor: Repair of plasterwork required around the bin chute hopper.</p>

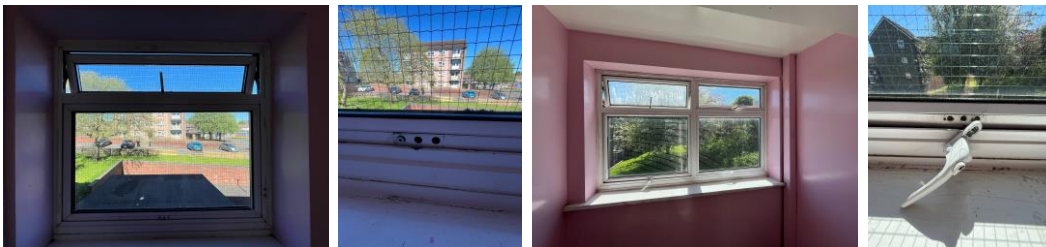
- d) **First Floor:** On the first floor, the double unit was inspected, and all sections were operable except for the bottom left-hand unit, where the handle was hanging off. The single unit when inspected the top opener does not close, and the bottom unit had been screwed shut. Repair to the top opener is required.

<p>P2</p>	<p>Within 1-3 months Repairs Plasterer</p>	
<p>7/8d</p>	<p>First Floor: Top opener of the double glazed window unit requires handle reinstating as unable to close the window</p>

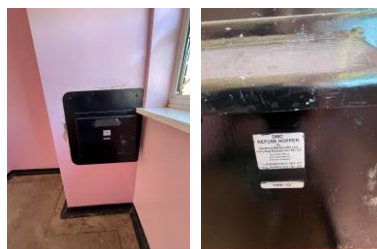
- e) **First Floor:** The bin chute hopper located adjacent to Flat 27 was inspected and found to be operating correctly at the time of the assessment. All seals were intact, and no defects were observed. Ongoing maintenance and regular checks are essential to ensure the hopper continues to function effectively and does not compromise fire safety within the protected escape route.

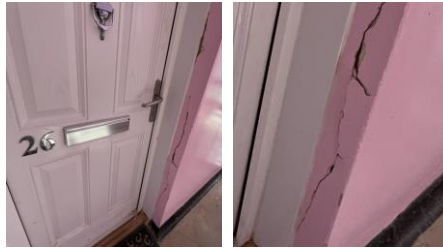
- f) Ground Floor: Service cupboard is situated adjacent to the main entrance door; full details are listed within section 10.
- g) Ground Floor: Adjacent to Flat 26, the recessed section of wall on the handle side of the flat entrance door requires repair. The plaster is deteriorating and coming away from the surface, reducing the level of fire-resisting protection provided in this area.**

7/8g	Ground Floor: Repair required to external plasterwork around Flat 26's entrance door

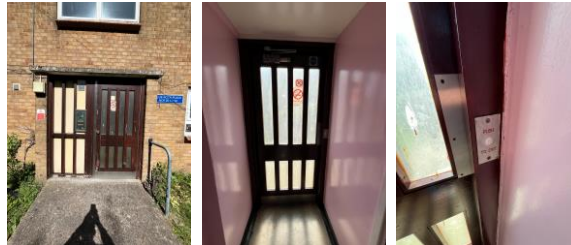
- 9) The final exit doors (x2) are fitted with automatic closing devices. To exit the doors, you do so by using a push button. These are checked on a regular basis by caretaking teams as part of their checks. Defective closing devices are replaced either by the Caretaking Team(s) or the in-house repairs team(s). These systems are designed to fail safe i.e. door unlocked in the event of a power failure. This prevents residents being locked in or out of the building.

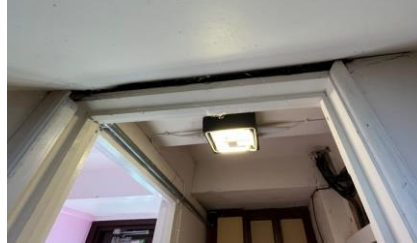
- a) **Within the service cupboard that is situated on the ground floor, above the door frame of the second room there is a gap that requires compliant fire-stopping measures, due to being unsure where this space goes to.**

P2	Within 1-3 months Repairs Plasterer	
10/6a	Ground Floor: Within the ground floor service cupboard, fire stopping required at the head of the door frame within the second room

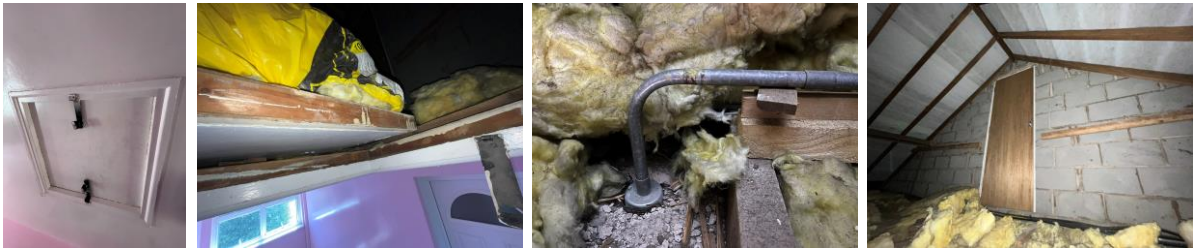
- 7) Individual flat doors appear to be FD30 doors sets. See section 7/2
- 8) On the top floor, access to the loft space is provided via a solid timber loft hatch. The fire rating of this hatch is unknown, and it is recommended that it be upgraded during future refurbishment works. Given that the communal area is maintained as a sterile zone, the current arrangement presents a low level of risk. The loft hatch must remain padlocked at all times. During the Fire Risk Assessment, the loft areas were inspected and found to have appropriate fire-stopping in place throughout the space.

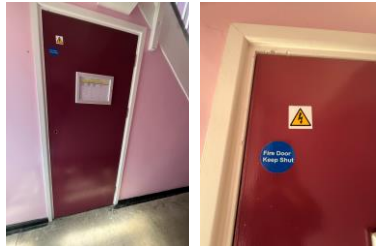
- 1) The service cupboard displays “Fire Door Keep locked” also an electrical warning sign.

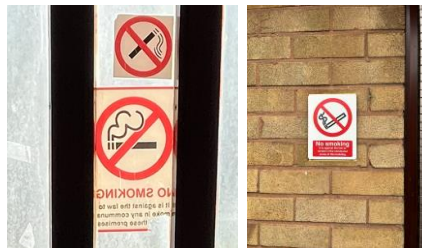
- 2) Smoking is prohibited within any communal parts of the building in line with Smoke Free England legislation. Signage is displayed around the building.

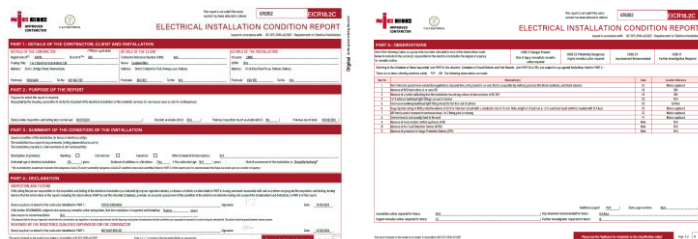
- 1) Smoking is prohibited on entrance and within any communal parts of the building in line with Smoke Free England legislation.
- 2) Hot working is not normally carried out. If essential maintenance requires the use of hot work processes, then corporate policies and procedures are to be followed.
- 3) Portable electrical equipment used as part of the Caretaking / Cleaning regime is subject to annual PAT Testing. This information is held by the Estate Services Manager.
- 4) The fixed electrical installation shall be tested every 5 years. The date of the last EICR was 01/10/2024 and was unsatisfactory. *Email sent to electrical team 29/04/2026 to chase up the C2s and FI.*

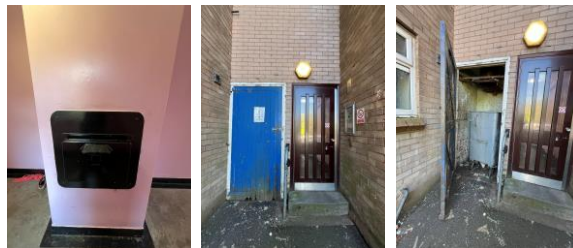
- 1) There is a regular Cleaning Service to the premises.
- 2) The blocks refuse is deposited via a bin chute accessed on all of the upper floors via the hopper door. Ground floor flats can place their bags directly into the bin via the bin room that is accessed from at the rear of the block.

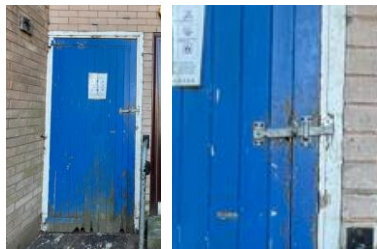
- 3) The bin room is accessible from outside through a timber door.

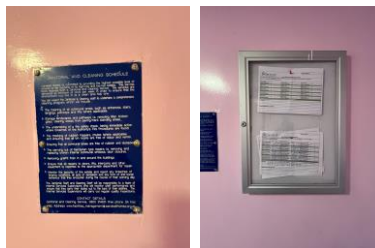
- 4) Regular checks are carried out by Caretakers to minimise risk of waste accumulation.
