# Fire Risk Assessment

**18-22**

**New Hope Road,  
Smethwick,  
B66 3TY**

**Date Completed: 02/07/2026**

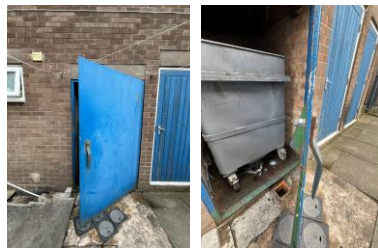
- 4) The blocks bin store is located at rear of the premises and built within the block. This is secured by a steel door; at the time of the survey the locking mechanism was seen to be defective. Within this store is a commercial-grade metal wheelie bin, functioning as the receptacle for refuse discharged via the block's bin chute.

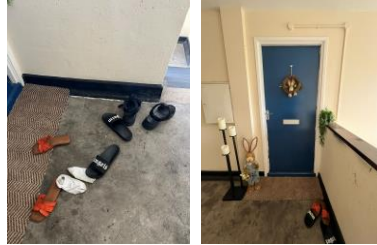
- 6) Flat 22, a number of items are being stored within the communal area. The Housing Manager has been notified and asked to remind the resident that these items must be relocated, as the communal landing is required to remain sterile and free from obstruction. email sent on 22/06/2026 to housing manager

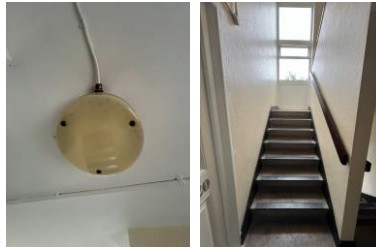
- 13) No emergency lighting is installed on the communal landings or stairways. Borrowed light is obtained through the communal windows and by the standard lights fitted. See section 9/2

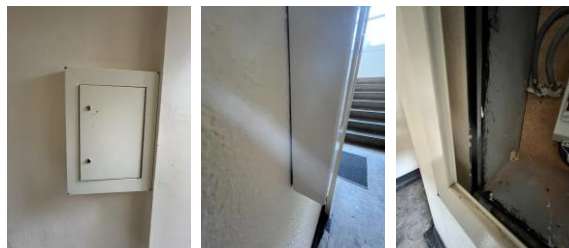
- 14) Adjacent to the flat entrance doors on the first and second floor, there are service over-cupboards. Both of these cupboards were defective at the time of the survey.

- a) **Flat 20: The electrical over-cupboard adjacent to Flat 20 cannot be fully closed due to a new over-cupboard frame and door having been installed over the original backing box. In addition, fire-stopping is required around the cupboard where it meets the wall, as there are visible gaps that compromise the fire-resisting barrier.**

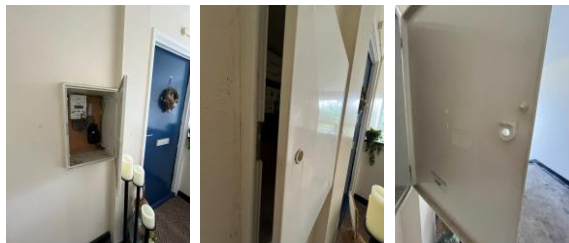
- b) **Flat 22: The electric meter over-cupboard adjacent to Flat 22 is missing its locking mechanism, meaning the unit cannot be properly locked or secured. This requires repair to reinstate the necessary level of safety and security.**

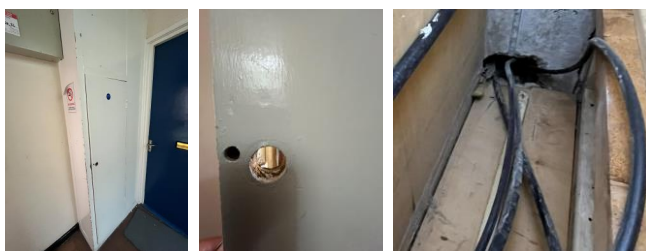
- 16) Within the communal area on the ground floor, adjacent to Flat 18, there is an electrical service cupboard constructed from a timber frame and panel. Fire-stopping is required within this cupboard (see Section 10) to address identified gaps and ensure adequate compartmentation. It is also recommended that the unit is upgraded to fire-resistant materials during future refurbishment works.

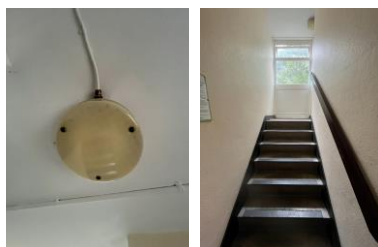
- 1) The premise is not fitted with emergency lighting
- 2) The **communal landings and stairways within this three-storey block are not provided with emergency lighting.** *Approved Document B, paragraph 3.41* requires that, except for two-storey blocks of flats, all escape routes must have adequate artificial lighting, with escape lighting operating in the event of a mains power failure. To meet this requirement and comply with the *Regulatory Reform (Fire Safety) Order 2005*, it is recommended that emergency lighting is installed throughout the escape routes as part of future upgrade works. At present, illumination is limited to standard luminaires and natural light from the landing window and final exit door. Added to recommendations after emailing conversation with Building and Fire Safety Team Manager.

[Approved Document B](#) See page 35 paragraph 3.41

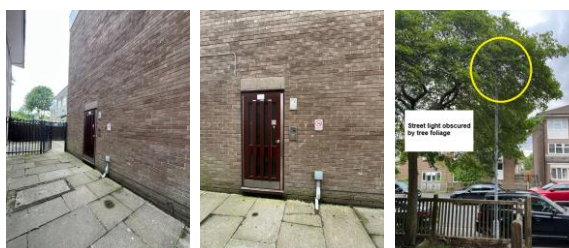
- 3) Recommend installing safety/security lighting above the external entrance doorway. Although there is street lighting in the vicinity, it does not adequately illuminate the immediate entrance area.

**Block entrance door:** Recommend installing safety/security lighting above the external entrance doorway. Although there is street lighting in the vicinity, it does not adequately illuminate the immediate entrance area.

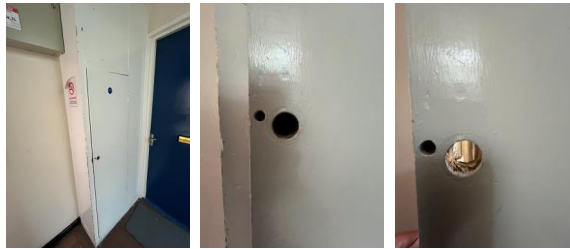
7) The electrical service cupboard adjacent flat 18 requires fire stopping in a couple of places

- a) **The door to the electrical service cupboard has a hole that goes completely through the timber. This requires either the installation of a hard wood timber fillet to reinstate the door's integrity or the provision of a new compliant door.**

| 10/7a | <b>Adjacent Flat 18:</b> Install a hard wood fillet in to the hole within the service cupboard door, or replace the door. | | P2 | Within 1-3 months<br>Fire Raid Response | Completed |

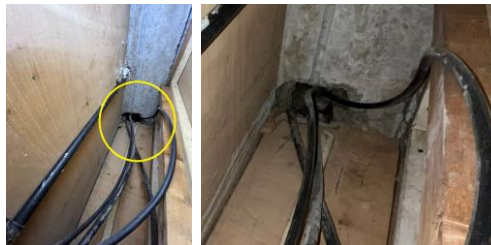
- b) **Within the electrical service cupboard on the ground floor adjacent to Flat 18, fire-stopping is required where the electrical cables pass through the concrete ceiling. Due to the size of the opening, this area will need to be sealed using fire batt and fire stopping mastic around the cables to restore the required level of fire resistance.**

| 10/7b | <b>Adjacent flat 18:</b> Within the service cupboard in the top right hand side, fire stopping is required. Fill with fire mastic and fit fire Batt around the hole. | | P2 | Within 1-3 months<br>Fire Raid Response | Completed |

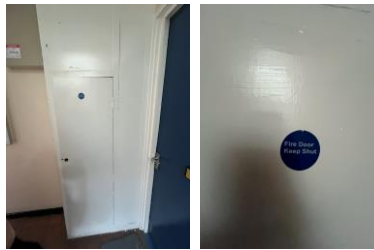
- 1) The service cupboard on the ground floor is currently fitted with *Fire Door Keep Shut* signage; however, this should be replaced with Fire Door Keep Locked signage to reflect the correct requirement for this type of cupboard. In addition, electrical hazard warning signage should be installed on the door.

**a) Replace 'Fire Door Keep Shut' signage with 'Fire Door Keep Locked' signage.**

| 12/1a | <b>Adjacent flat 18:</b> Replace 'Fire Door Keep Shut' signage with 'Fire Door Keep Locked' signage. | | P3 | Within 3-6 months<br>Fire Raid Response | Completed |

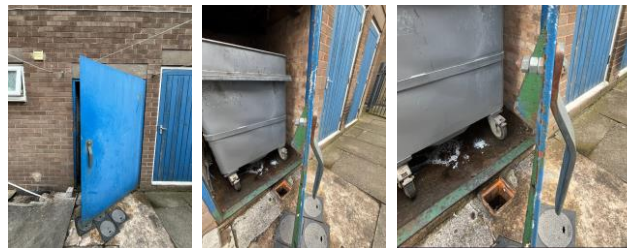
- 2) The refuse bins for 18–22 New Hope Road are stored at the rear of the premises within a designated internal bin-storage cupboard, which is built into the structure of the building. This area also serves as the bin-chute room, with hopper doors located on the first and second floors for residents to dispose of waste. The bins are emptied as part of the routine waste-collection service. This storage area is secured by a steel door; however, at the time of the survey, the locking mechanism was found to be defective, and this requires repair.

| 15/2 | <b>External bin room:</b> Fit a replacement locking mechanism as the old one is missing. | | P3 | Within 1-3 months<br>Repairs<br>Metal fitters | |

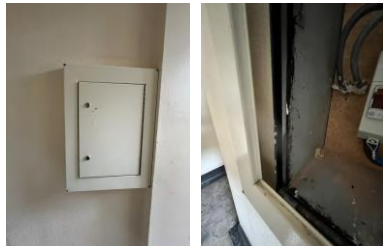
| Question/<br>Ref No | Required Action | Supporting photograph | Priority | Timescale<br>and Person<br>Responsible | Date<br>Completed |
|---|---|---|---|---|---|
| 7/14a | <b>Adjacent flat 20:</b> Refit the electrically over cupboard. This is due to fitting the door and frame over the original back box which the sides prevent the new door closing. | | P3 | Within 3-6 months<br>Fire Rapid Response | |

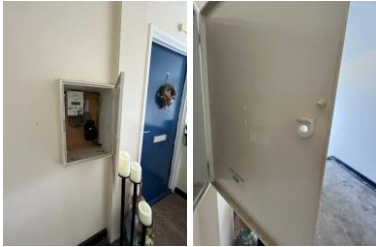
| 7/14b | <b>Adjacent flat 22:</b> Fit new electrical overcupboard. Due to lock missing. | | P3 | Within 3-6 months<br>Fire Rapid Response | |

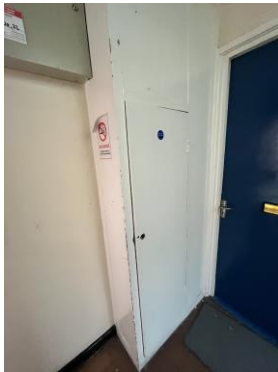
| 12/1b | <b>Adjacent flat 18:</b> Install electrical hazard warning signage to the electrical service cupboard. | | P3 | Within 3-6 months<br>Fire Raid Response | |
