# Fire Risk Assessment

## Scribbans Place 50-64

**Durban Road,  
Smethwick, B66 3SG**

**Date Completed: 08/06/2026**

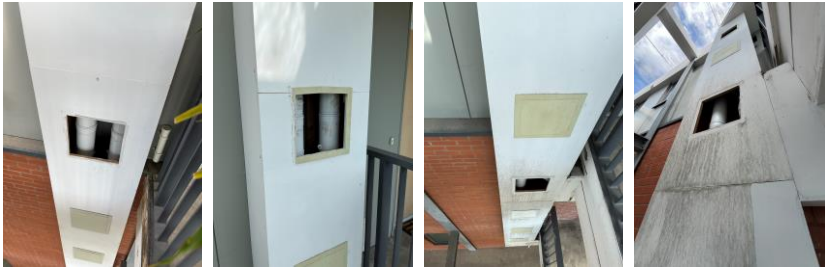
- 8) It was noted that there are a few plastic inspection panels missing of the soil stacks. The ducts are not required to be fire stopped; however, it is recommended that the inspection panels are to be replaced as part of a routine maintenance.

- 11) Inspection panels to the soil service stacks are to be replaced as part of routine maintenance. Email has been sent to repairs on the 23/06/2026.

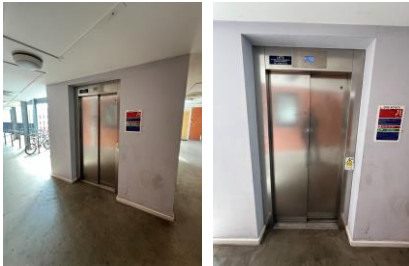
- 11) There is a resident lift in the means of escape that serves ground, 1<sup>st</sup> and 2<sup>nd</sup> floors. At the time of inspection, it was noted that this was out of service, however, a lift engineers signage to notify that the fault had been investigated was evident.

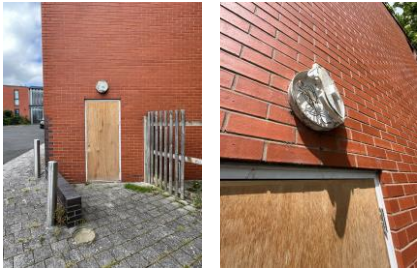
- 4) Damaged external emergency light was evident to the outside of the pump room. *Email has been sent to the Electrical Response team on the 09/06/2026.*

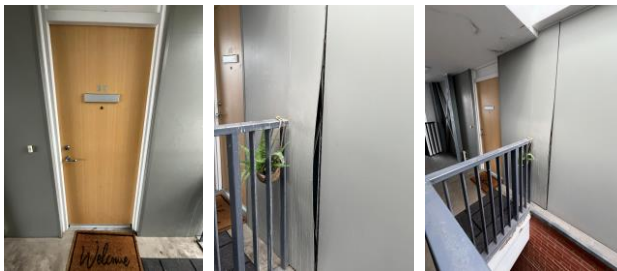
- 12) Cladding to the external wall facing on to the communal corridor for flat 64 has bowed and come apart from its supporting structure compromising the compartmentation between communal area and flat. *Email sent to Responsive Repairs on 23/06/2026*

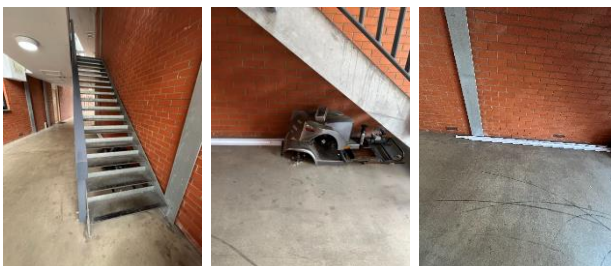
- 4) Regular checks by Caretakers minimise risk of waste accumulation. Sandwell Council 'Out of Hours' service is in place to remove bulk items
- 5) Discarded items left under the stairs on the ground floor communal area.

| 15/5 | Discarded items left under the stairs on the ground floor communal area. Required to be removed. | | P2 | Within 1-3 months.<br>Caretaking Team | |

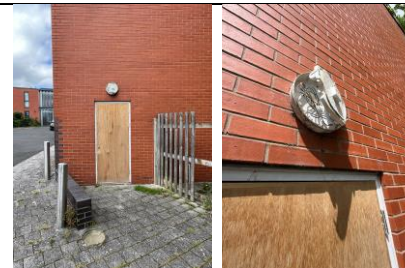
Damaged external emergency light was evident to the outside of the pump room. *Email has been sent to the Electrical Response team on the 09/06/2026.*

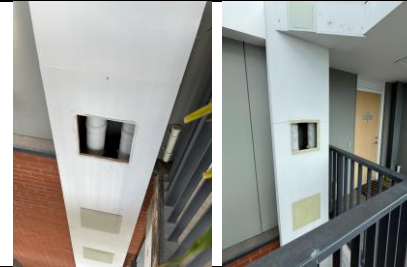
Inspection panels to the soil service stacks are to be replaced as part of routine maintenance. *Email has been sent to repairs on the 23/06/2026.*

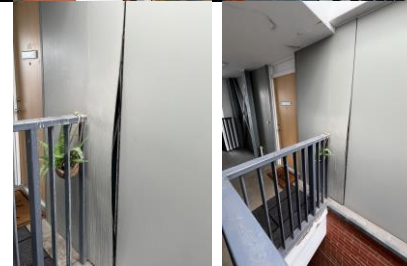
Cladding to the internal wall on flat 64 has bowed and come apart from its supporting structure. *Email sent to responsive Repairs on the 23/06/2026*
