Fire Risk Assessment

Bearwood Road 200-238

Church Gardens 1-20, 29-48, 53-72

**Smethwick,
B66 & B67**

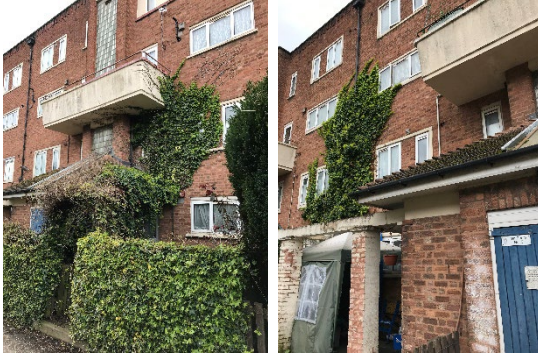
- 7) **Overgrowth to block 1-20 obstructs means of escape from a ground floor maisonette and could aid to the spread of fire vertically up the building.**

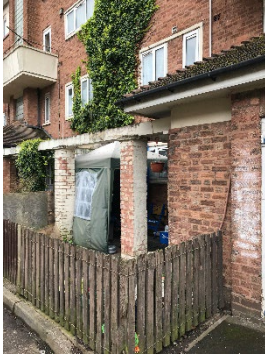
- 8) **Gazebo in close proximity to the building as well as outside of a means of escape to the ground floor maisonette 9 along with the overgrowth above could add to the spread of fire along this elevation towards upper floors.**

<p>06/08</p>	<p>Remove gazebo form close proximity to building maisonette 9</p>

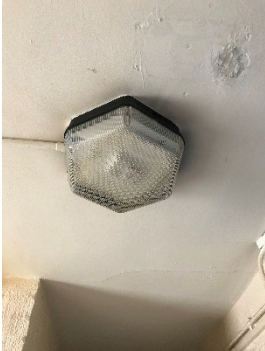
- 8) Could not be determined whether emergency lighting is present within the blocks however it was evident that conventional lighting was present along the means of escape.

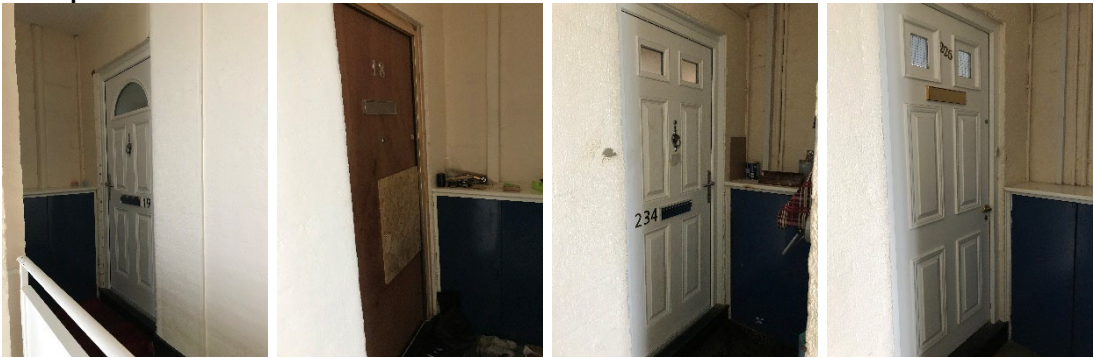
15) Individual maisonette doors are predominantly nominal FD30s self-closing composite doors sets within communal areas with the exception to maisonette 18 which is timber construction.

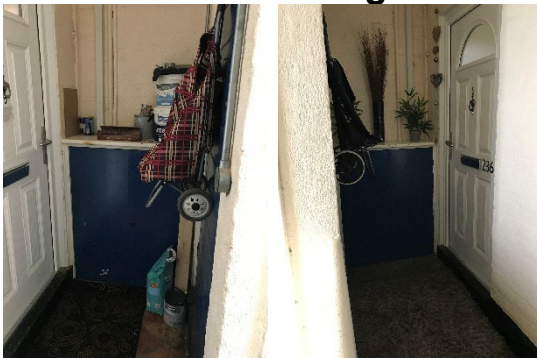
16) Bearwood road outside flat 234 – 236 incense stick left in communal area along with other combustibles

<p>P3</p>	<p>3-6 months Housing Manager</p>	
<p>07/16</p>	<p>Maisonettes 234 – 236 Remove incense stick and combustibles form communal area</p>

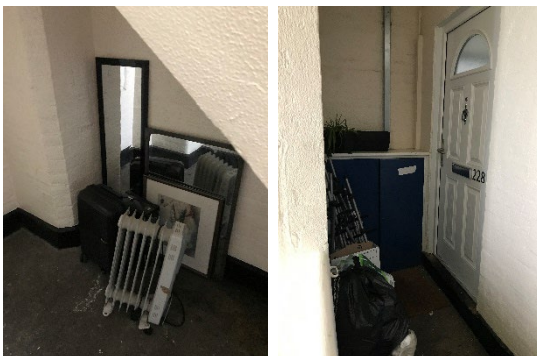
17) Bearwood Road 226 – 228 Items left under stairs and outside flat entrance doors in the communal area

<p>P2</p>	<p>1-3 months Housing Manager</p>	
<p>07/17</p>	<p>Maisonettes 226 - 228 remove items left in communal areas</p>

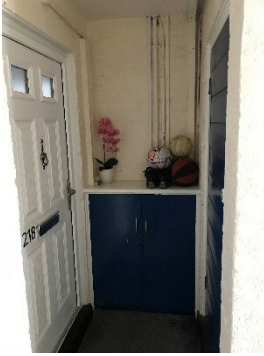
18) Bearwood Road 218 – 220 candles left in communal area.

07/18	Maisonettes 218 - 220 remove candles from communal area	N/A	P2	1-3 months Housing Manager	
07/19	Maisonettes 202 – 204 remove timber and other combustibles form outside entrance

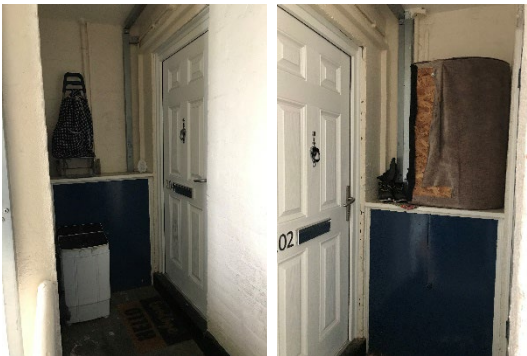
19) Bearwood Road 202 – 204 timber and other items stored within the communal area outside maisonetes.

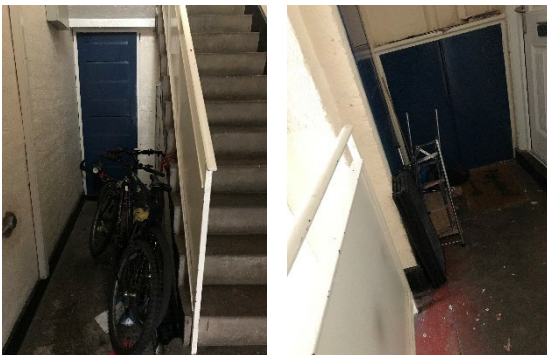
21) Church Gardens 10-11 Bikes and other items stored within communal areas

P2	1-3 months Housing Manager	
07/21	Church Gardens Maisonettes 10-11 remove bikes and other items stored within communal area

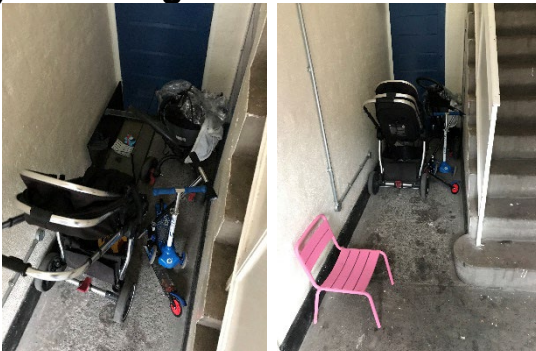
22) Church gardens 34-35 items stored within communal areas

07/22	Church gardens maisonettes 34-35 remove items stored within ground floor communal areas

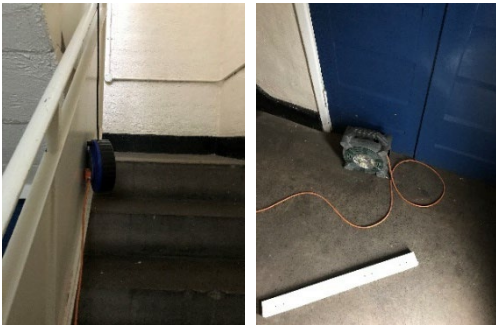
25) Resident to flat 30 had daisy chained several extension leads within the communal area, resident had removed them while the risk assessor was on site.

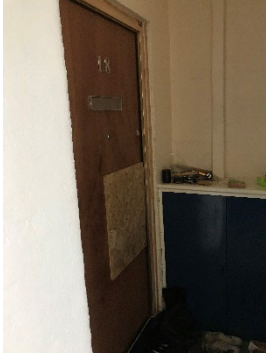
- 10) Maisonette 18 timber door has been damaged and a temporary repair has been made, email has been sent and has been raised with the appropriate people .

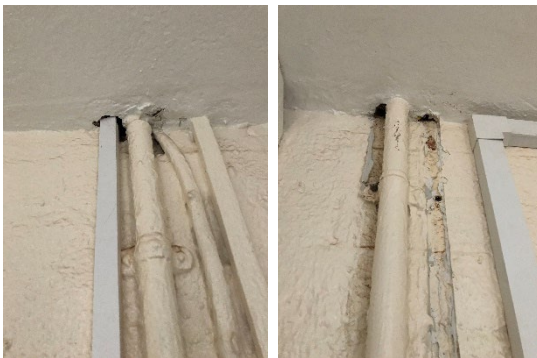
- 11) Holes Penetrating into the floor above within Bearwood road 218-220 nearest maisonettes.

10/11	Fire stop holes penetrating into floor above outside maisonette entrances Bearwood road 218-220

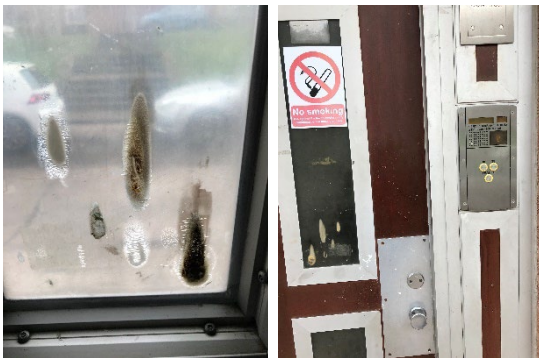
- 1) Regular checks are undertaken by Caretakers / Cleaning Team(s) 365 days per year which helps reduce the risk of arson.
- 2) Restricted access to the premises by means of a door entry system.
- 3) There are no CCTV provisions for the block.
- 4) There is no evidence of arson within the blocks other than some burn marks on the communal main entrance door to maisonettes 38-39
