# Fire Risk Assessment

# New Hope Road, 60-68, 75-83

New Hope Road, Smethwick B66 3TX

**Date Completed:** 29/03/2024.

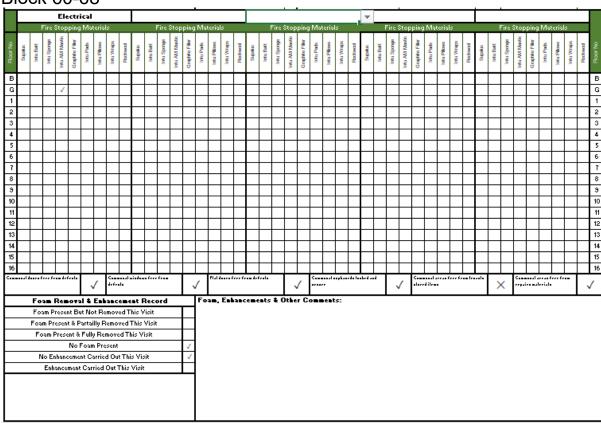
Block 60-68

- 4) Residents have access to storage cupboards within the communal landing areas of the block.
- 5) A variety of methods / materials have been used to achieve firestopping including Rockwool, fire rated sponge and intumescent pillows.

- 6) Any remedial works arising from the fire stopping / compartmentation check(s) will be actioned immediately by the Fire Safety Rapid Response Team.
- 7) Individual flat doors are notional, nominal and composite fire doors within both blocks.

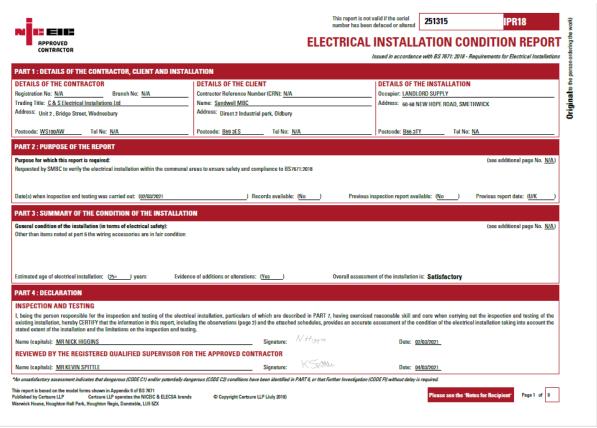
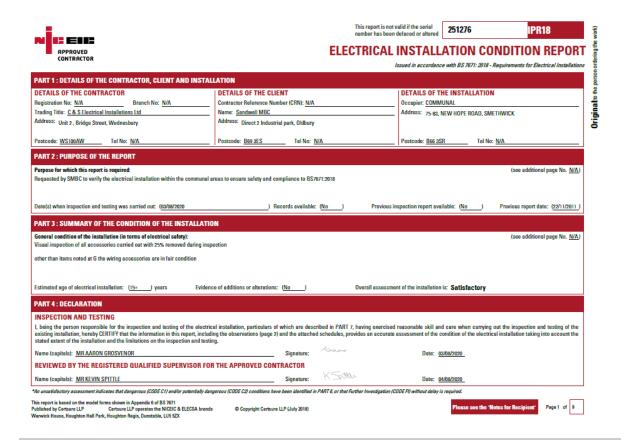
- 1) Smoking is prohibited within any communal parts of the building in line with Smoke Free England legislation.
- 2) Hot working is not normally carried out. If essential maintenance requires the use of hot work processes, then corporate policies and procedures are to be followed.
- 3) Portable electrical equipment used as part of the Caretaking / Cleaning regime is subject to annual PAT Testing. This information is held by the Estate Services Manager Bryan Low.
- 4) The fixed electrical installation shall be tested every 5 years. It was noted that the last inspection was 02/03/2021 for Block 60-68 and 03/08/2020 for Block 75-83.
