Fire Risk Assessment Newmans Close

9 – 14 & 15 – 19 Newmans Close, Smethwick, B66 4SW.

Date Completed: 04/04/2024. Review Period: 3 years. Officer: A Jones Fire Risk Assessor Checked By: J Blewitt Team Lead Fire Safety & Facilities

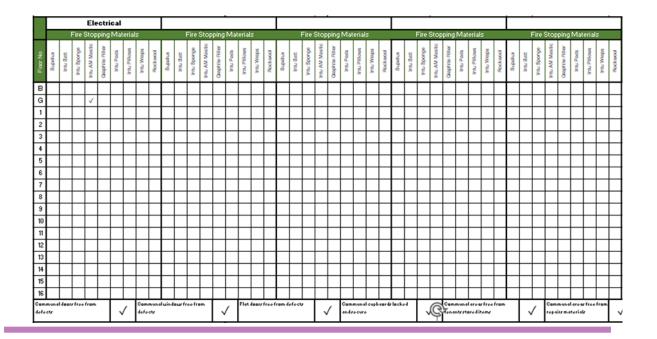
9 – 14 Newmans Close.

5) A variety of methods / materials have been used to achieve firestopping, refer to table below.
