# Fire Risk Assessment

## Priory Close 5 - 9

**Priory Close,  
Smethwick  
B66 3SL**

**Date Completed:** June 2026

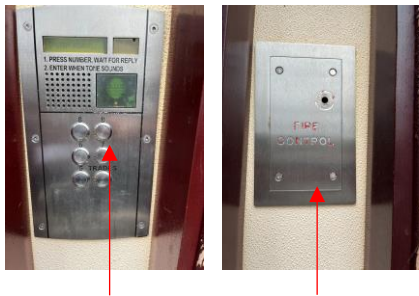
Front and rear entrances to block

Intercom access and firefighter's switch

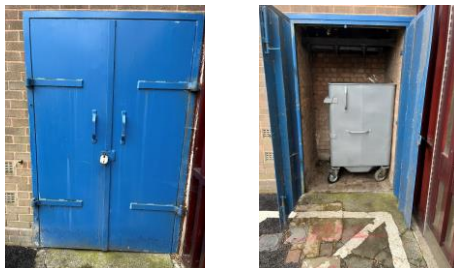
The bin store is located on the ground floor near the front exit. The bin store is secured with a padlock.

The bin chute has a manual closing plate

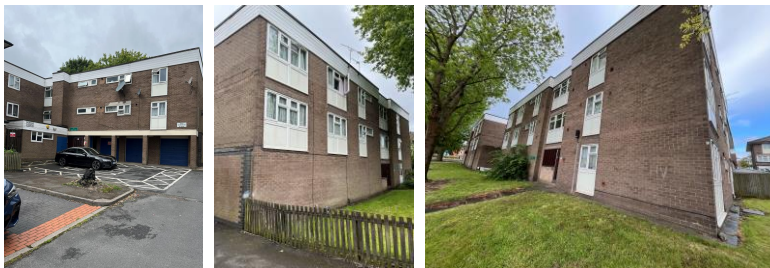
- 1) The exterior of the building is predominately traditional brick construction with a flat roof design with UPVC fascia boards under the roof line and a bitumen and felt roof. Front and rear entrances are through timber doors with glazing in the inserts of the doors alongside the timber panelling to the side.

Front Elevation

Side and Rear Elevation

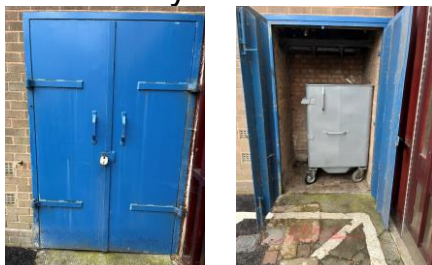
- 2) Adjacent to the front entrance is the refuse bin store, which is enclosed by a timber door.

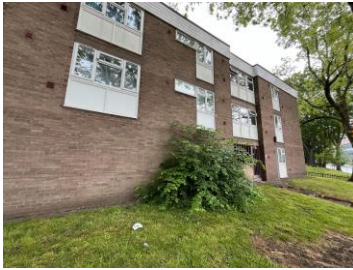
- 4) UPVC double glazed window units have been installed for each flat and communal areas within the block.

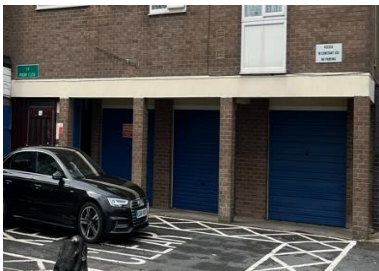
- 5) Front elevation of the building has resident garages; these were not accessed at the time of this FRA.

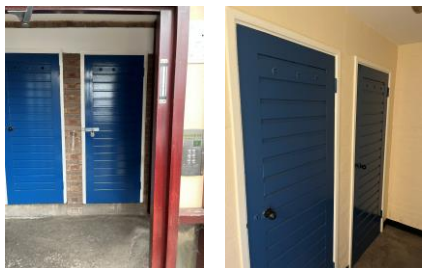
- 8) Resident storage cupboards are within the means of escape, these are made secure by residents. Has been noted in previous FRA, that these are to be upgraded to FD30S fire rated doors in any future refurbishment of the block. **See Observations.**

Resident storage cupboards are within the means of escape, these are made secure by residents. Has been noted in previous FRA, that these are to be upgraded to FD30S fire rated doors in any future refurbishment of the block

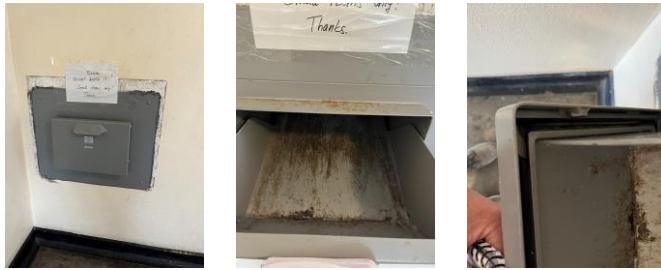
- 13) On both 1<sup>st</sup> floor and 2<sup>nd</sup> floor landings, there are bin chute hoppers within the means of escape.

- 3) Both 1<sup>st</sup> and 2<sup>nd</sup> floor internal refuse chutes are clear of any rubbish.
- 4) The refuse chute has a manual sliding plate. Due to the refuse hoppers being in the communal area of the block it is recommended that they are upgraded to a fused link system when the block has any refurbishment. See Observations.

| <p>The refuse chute has a manual sliding plate. Due to the refuse hoppers being in the communal area of the block it is recommended that they are upgraded to a fused link system when the block has any refurbishment.</p> | | |

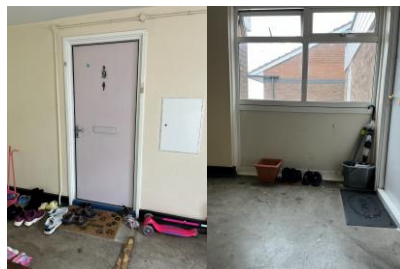
- 23) **Second Floor communal landing being used for storage this requires removing See Acton 7/23.**

| 7/23 | Second Floor communal landing being used for storage this requires removing. | | P2 | 1-3 Month Housing Manager | |

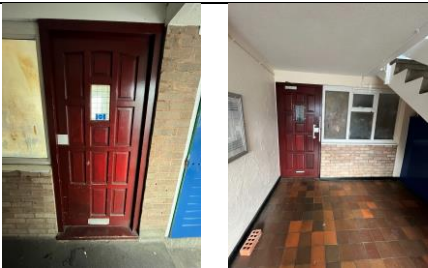
| <p>The communal door on the ground floor is part of a combination frame with a UPVC window frame fitted with Georgian wired double-glazed unit. The timber door has a glazed unit but is not a certified fire door and does not have any smoke seals or intumescent strips fitted so it is recommended that these are replaced with a certified FD30s door and fire rated window frame and glazing when any refurbishment of the block takes place.</p> | |

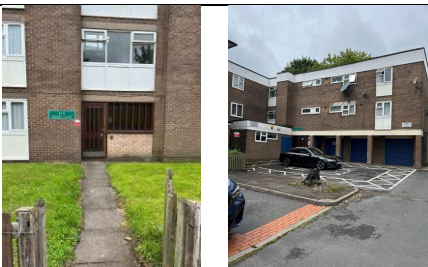
| <p>The front and rear of the perimeter of the premises is not illuminated with external lighting and uses borrowed lighting from the streetlamps. It is recommended to upgrade the external lighting of the building especially to the front and rear final exits.</p> | |
