Fire Risk Assessment

1 - 3

**Curtis Close,
Smethwick,
B66 2RE**

Date Completed: 20/05/2026

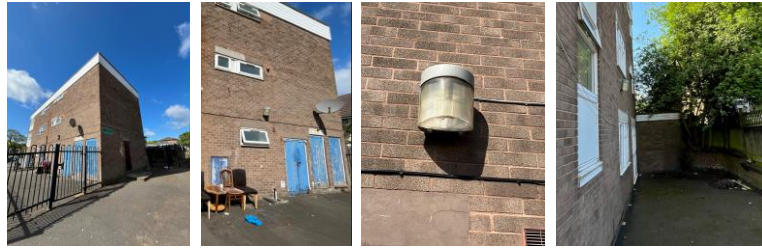
Safety/security light installed at each side of the building, no light was present at the entrance side of the building. This is to be recommended for a future install.

Entrance Door light: It is recommended that a light is installed adjacent to the entrance door to assist with safety and security in this area.

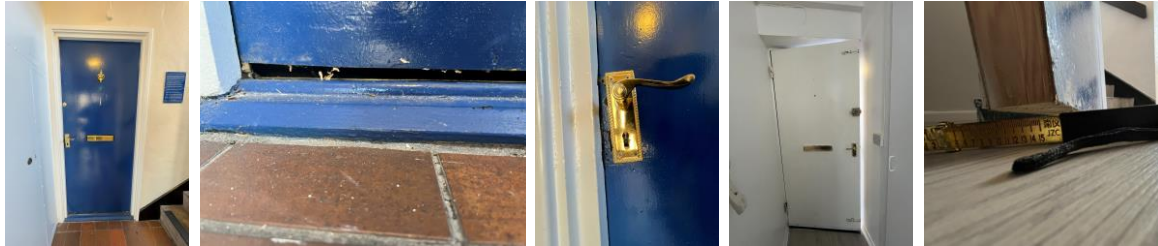
a) Flat 1 (Leaseholder): The entrance door to Flat 1 is non-compliant, lacking a self-closing device and presenting an excessive threshold gap. A compliant drop-down fire seal should be installed, or the door replaced to achieve the required fire-resisting standard.

Question/ Ref No	Required Action	Supporting photograph	Priority	Timescale and Person Responsible	Date Completed
7/5a	Flat 1: New door required due to no self closer and an excessive threshold gap. Repair if not renewing the door	 	P3	Within 3-6 months Leasehold Manager

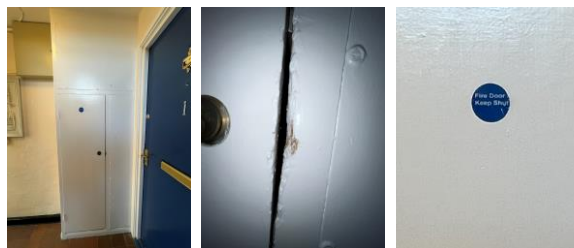
10) **In the communal ground-floor area adjacent to Flat 1, there is a service cupboard. Access to this cupboard was not available at the time of the fire risk assessment; therefore, no observations can be made regarding any internal conditions or potential hazards. The cupboard door has a substantial gap along the closing edge, which requires appropriate fire-stopping to restore its fire-resisting performance. *Fire Door Keep Shut* signage is present on the door.**

7/10	<p>Adjacent Flat 1: Reduce the gap on the service-cupboard door using appropriate fire-stopping and fire-rated door furniture.</p>

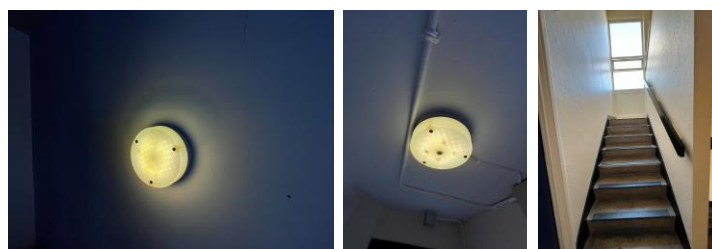
13) No emergency lighting is installed on the communal landings or stairways. See section 9/2

Emergency lighting: It is recommended that compliant emergency lighting be incorporated during future refurbishment works. At present, illumination is provided only by standard lighting and natural light from nearby doors and windows.

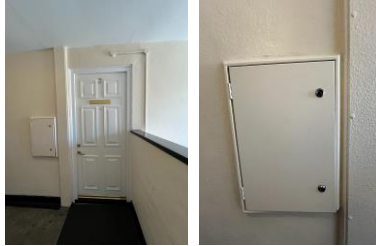
14) On the 1st and 2nd floors, adjacent to the flat entrance doors, there are service over-cupboards. Access to these cupboards was not possible at the time of the assessment, so their internal condition could not be verified. Externally, both cupboards appeared to be in good condition.

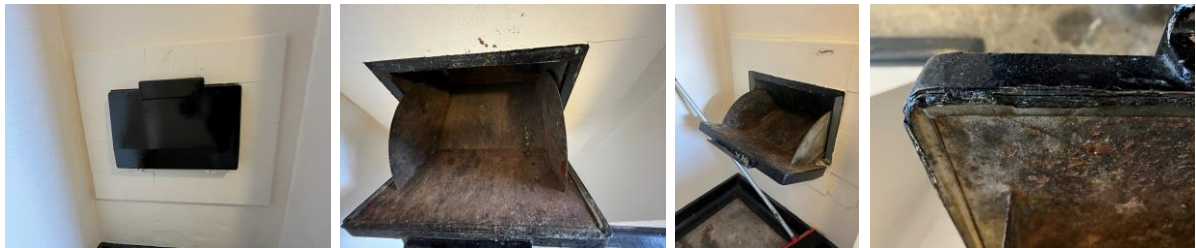
15) On the 1st and 2nd floors, a bin-chute hopper door is located adjacent to the flat entrances for residents to dispose of refuse bags. The hopper doors on both levels stick in the fully open position and therefore require replacement. In addition, one hopper door was found to have a defective seal, which would also require remedial action

P3	Within 3-6 months Fire Rapid Response	
7/15	<p>1st & 2nd Floors: Replace the chute hopper doors on each floor</p>

P2	Within 1-3 months Repairs Metal fitters

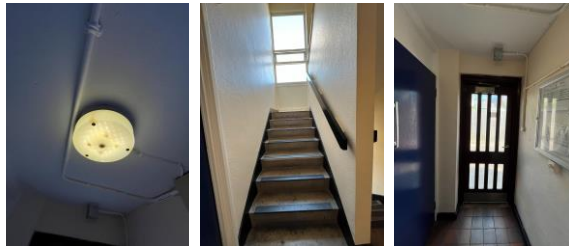
- 1) The premise is not fitted with emergency lighting
- 2) The communal landings and stairways within this three-storey block are not provided with emergency lighting. *Approved Document B, paragraph 3.41* requires that, except for two-storey blocks of flats, all escape routes must have adequate artificial lighting, with escape lighting operating in the event of a mains power failure. To meet this requirement and comply with the *Regulatory Reform (Fire Safety) Order 2005*, it is recommended that emergency lighting is installed throughout the escape routes as part of future upgrade works. At present, illumination is limited to standard luminaires and natural light from the landing window and final exit door.

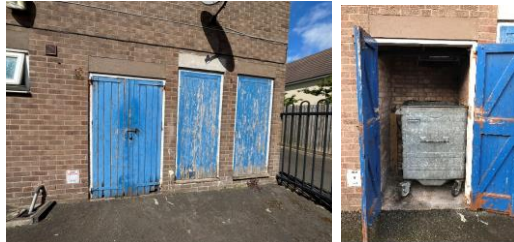
- 2) The refuse bins for Curtis Close 1–3 are stored at the side of the premises within a designated storage cupboard. This area also functions as the bin-chute room, with hopper doors located on the 1st and 2nd floors for residents to dispose of refuse. The bins are emptied as part of the routine waste collection service.
