# Fire Risk Assessment

## Manifoldia Grange

**Coyne Road, West Bromwich,  
B70 7JU**

**Date Completed:** 21<sup>st</sup> January 2026

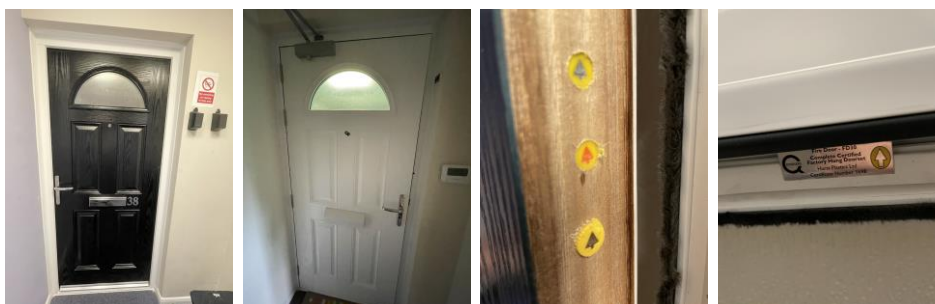
Flat doors to 12, 22 & 36 were checked to ensure they operated correctly.

- 23) Flat 36 flat entrance door needs some adjustment to ensure it closes fully into the frame.**
- 24) It is the opinion of the Fire Risk Assessor that all communal doors should be upgraded. This includes Cross corridor, staircase and service cupboard doors. Following a meeting onsite with the Fire Rapid team there are approx. 16 cross corridor doors for the fire rapid team to assess and repair where required.

**The upgrade should include new hinges, re hanging to align gaps, new cold smoke seals where required, adjustment to self-closing devices and drop down seals where required.**

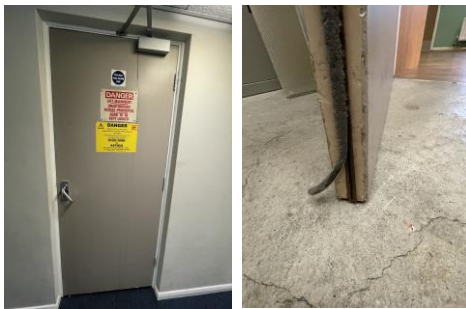
- 25) Main Kitchen door from kitchen to office area needs some maintenance. Refit & the door to ensure it closes correctly into the frame.**
- 26) Final exit door outside flat 30 has a cracked vision panel. This needs to be replaced.**

| 07/28 | Final exit door outside flat 30 has a cracked vision panel. This needs to be replaced. | | P2 | Within 1-3 Months<br>Caretakers | |

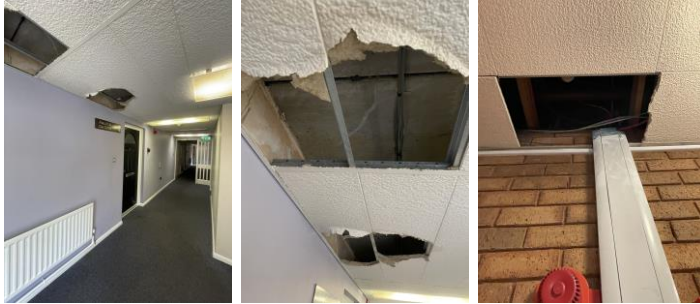
- 27) Communal ceiling tiles within the building are generally in poor condition, replacement tiles are required.**

| 07/29 | Replace missing and damaged ceiling tiles within the building. | | P3 | Within 3-6 Months Repairs | |

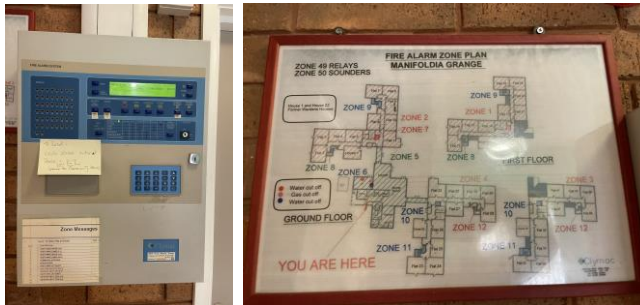
- 1) There is an L1 fire alarm system fitted within the premises. The control panel is located within the main entrance foyer. There is a zone plan on display adjacent to the fire alarm panel.

- 2) At the time of the assessment the fire alarm panel was showing in fault, this point needs to be resolved as soon as possible. John Dolman has instructed Orton's to attend site to rectify the issue.

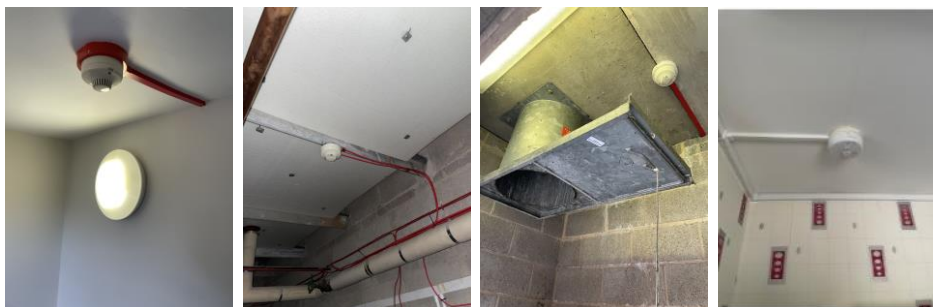
- 6) Hard wired smoke and heat detectors are located on each floor to include communal corridors (including voids above), offices, individual flats, bin room, kitchen, and boiler house (including roof void above).

This is not extended to the roof voids above the communal toilets or above those individual flats with loft hatches 12,14, 15, 16,17, 18, 19, 20, 21, 33, 34, 35, 36, 37, 38, 39, 40, 41. However, consideration should be given to extend detection to these voids should be considered as part any future upgrade to the system.

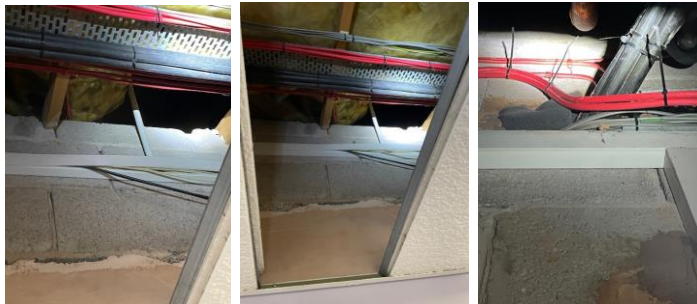
- 5) **Lifting ceiling tiles identified that compartmentation needs to be improved, these areas are located on the first floor means of escape.**

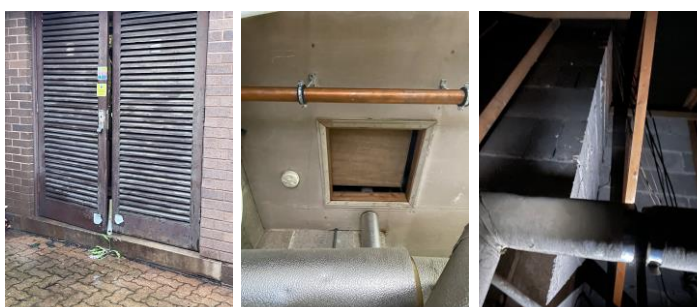
- 6) **In isolated areas where fire resisting sponge has been used to seal voids, these should be replaced with another suitable fire resisting material. i.e., buttered fire batt.**

- 7) **Based on the findings at Manifoldia Grange it is recommended that a full compartmentation survey of the building is undertaken. This should be carried out at the earliest opportunity.**
- 8) Once this work has been completed the premises will have sufficient compartmentation to limit the travel and effect of smoke and flame in event of a fire.
- 9) There is a boiler house to the central building which is accessed externally from the front car park area. It has sufficient compartmentation extending from the boiler house up into the roof void (accessed via a ceiling hatch).

| 10/06 | In isolated areas where fire resisting sponge has been used to seal voids, these should be replaced with another suitable fire resisting material. i.e., buttered fire batt. | | P3 | Within 3-6 Months Fire Rapid Response | |

| 10/07 | Based on the findings at Manifoldia Grange it is recommended that a full compartmentation survey. An approved contractor should carry out this assessment. | | P3 | Within 3-6 Months Asset Management | |

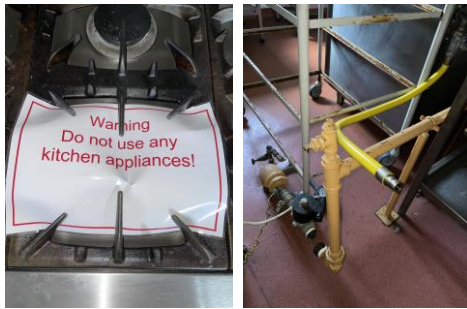
- 8) It was noted that gas appliances within the central kitchen have been disconnected / capped off from the supply. These assets should be redistributed in other areas of the Authority.

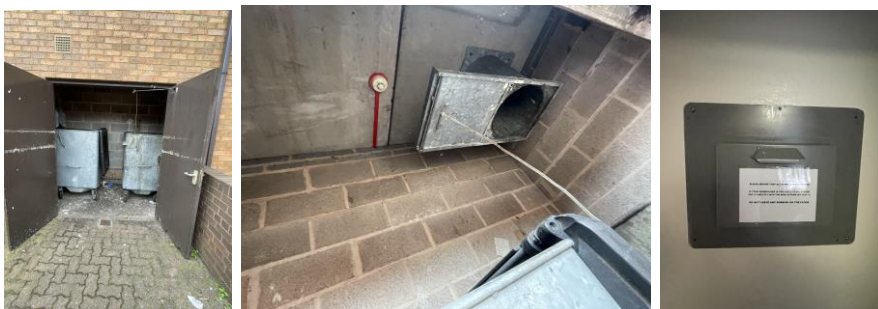
- 2) There are two bin stores containing refuse containers. Each store was noted as open during the survey. The premise manager confirmed that this is to allow residents to discard larger bags of waste which historically may have been left within the chute rooms or beside the bin stores.

This is deemed as acceptable because fire detection linked to the fire alarm panel is present in each store and staff / security regularly patrol the building.
