Fire Risk Assessment

**Maisonettes 231 - 243
St Marks Road,
Tipton,
DY4 0SZ.**

Date Completed: 18/07/2024.

Officer: A Jones Fire Risk Assessor.

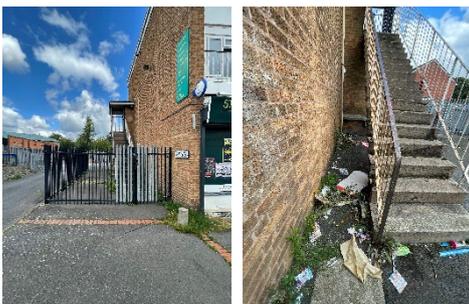
- 2) Access is gained to all maisonettes from the ground floor using one of two external staircases. These were not secured at the time of the assessment.

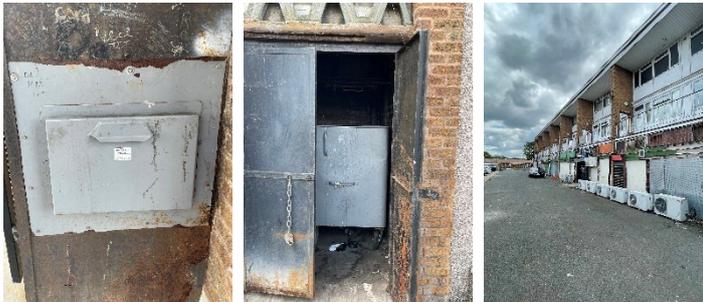
- 4) Access to the bin room(s) is in the rear yard at ground floor level, this area was tidy at the time of the assessment.

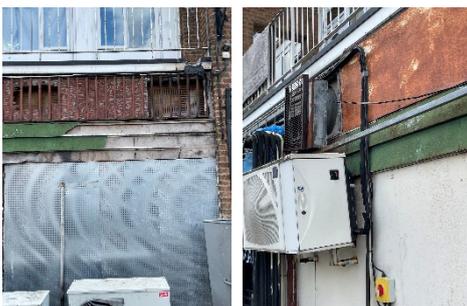
- 5) Ground floor rear commercial premises. Fascia type boarding in the has perished and in need of upgrade. When any future refurbishments are considered, these boards should be replaced.

When any future refurbishments are considered, fascia type boarding in the rear yard should be replaced.

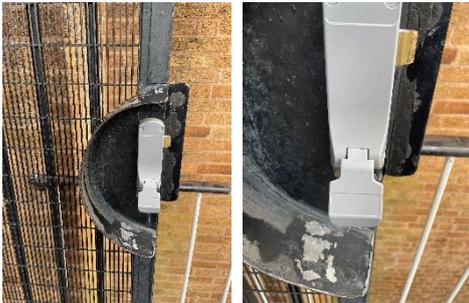
- 1) The building(s) have two external concrete staircases that provides the means of escape. There are security gates at the head of each staircase, these are operated by push pad mechanism in the direction of escape.

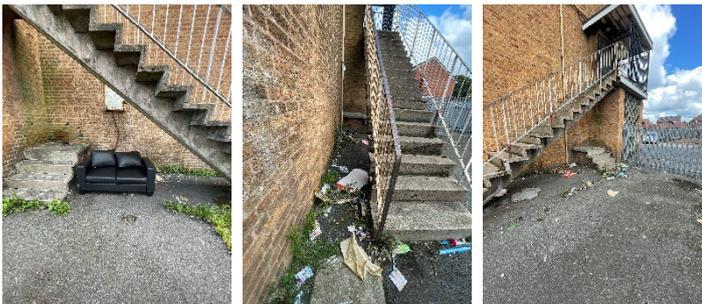
- 2) All staircases are of adequate width (at least 1040mm) and must be maintained clear to that width as a minimum.
- 3) It was noted that litter, furniture, and other combustible items had been left under access/escape staircase(s). These items should be removed as soon as practicable. (Email sent to Housing).

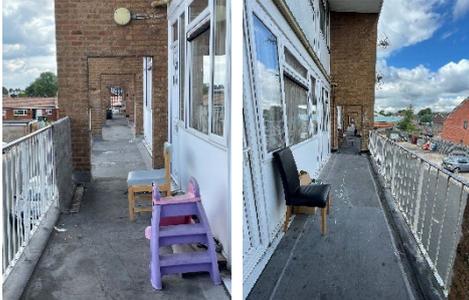
- 4) The communal deck areas should be kept free of flammable items. These areas should be checked on a regular basis by Caretaking / Cleaning teams and all items of rubbish removed. Email sent to housing to remove items. (Email sent to housing).

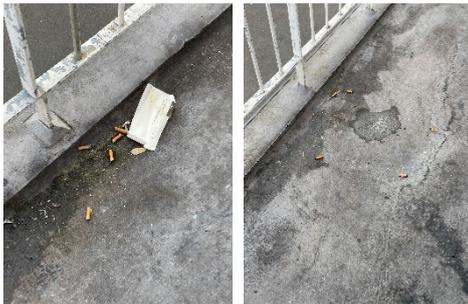
- 5) It is evident that smoking is taking place on the deck access corridor, this should cease immediately means of escape are protected to limit the spread of fire and smoke with UPVC front entrance doors. (Email sent to housing).

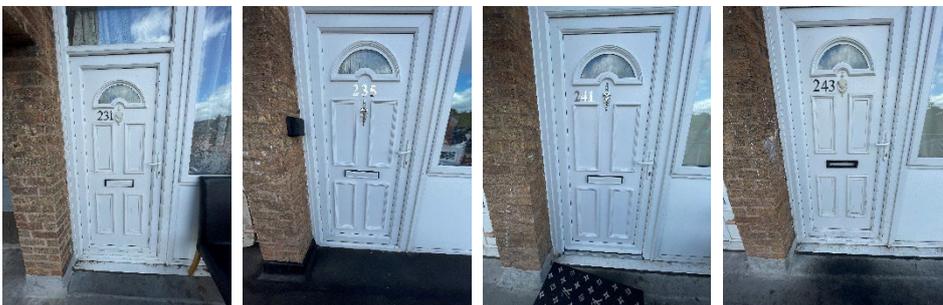
- 6) The means of escape are protected to limit the spread of fire and smoke with UPVC front entrance doors.

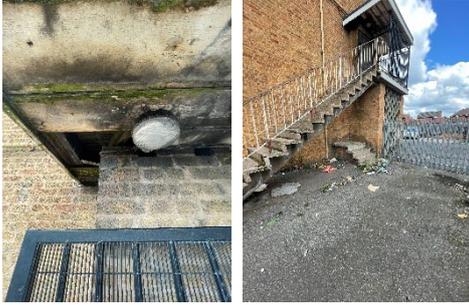
- 8) At the head of each staircase, it was noticeable that old soffit boards had perished and need to be replaced.

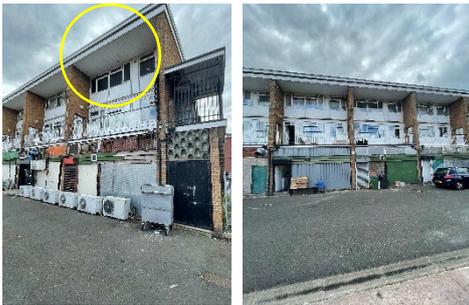
- 9) On the open deck access, it was noted that the soffits board was constructed from UPVC. When any future upgrades are carried out, consideration should be given to replacing these boards with an appropriate fire resisting material.

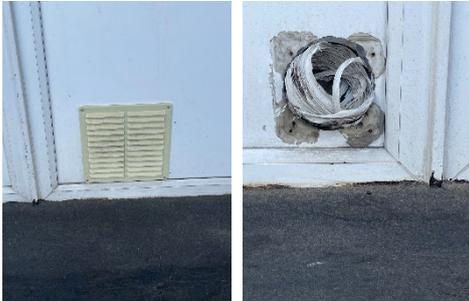
- 6) There was a missing extraction vent cover (Flat 233) on the open deck access corridor. This should be replaced to ensure products of combustion, or any potential acts of arson are mitigated.

Question/ Ref No	Required Action	Supporting photograph	Priority	Timescale and Person Responsible	Date Completed
10/06	Flat 233 - replace extraction vent cover. (On open deck area).

P2	Repairs 1-3 Months.
