Fire Risk Assessment

Birchcroft

**Windmill Lane,
Smethwick, B66 3LN**

Date Completed: 13/08/2025

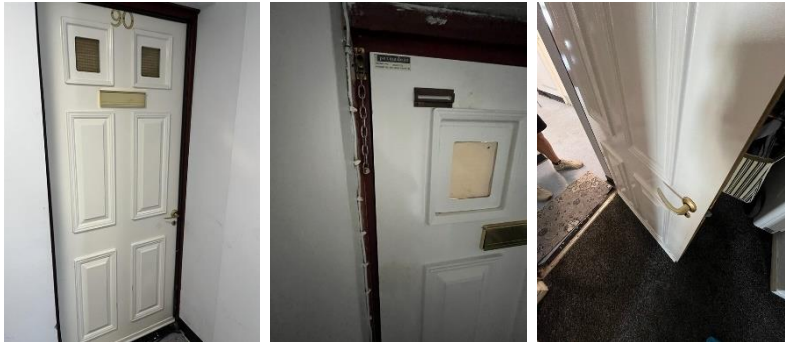
- b) Flat 90 - Door leaf fails to close into its frame from the open position correctly, adjustment required. See Action 07/20b.**

Question/ Ref No	Required Action	Supporting photograph	Priority	Timescale and Person Responsible	Date Completed
07/20b	Flat 90 - Door leaf fails to close into its frame from the open position correctly, adjustment required.

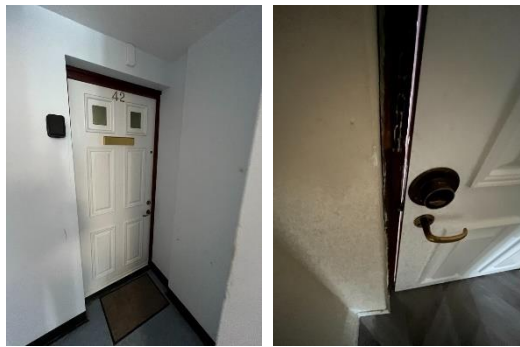
i) **Flat 42 - Door leaf fails to close into its frame from the open position correctly, adjustment required. See Action 07/20i.**

P2	Fire Rapid Response 1 – 3 months.	
07/20i	Flat 42 - Door leaf fails to close into its frame from the open position correctly, adjustment required.

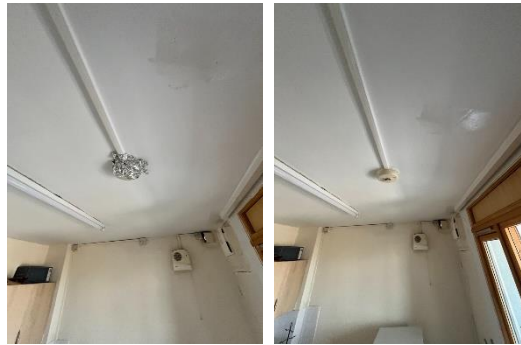
- 3) Flat 85 was accessed and it was noted that the resident had covered the smoke detectors with aluminium cooking foil. The assessor insisted that the covers were be immediately removed, the resident complied. An email was sent to the Operations Manager Housing services and the Housing Services Officer to request a spot check to ensure further compliance.

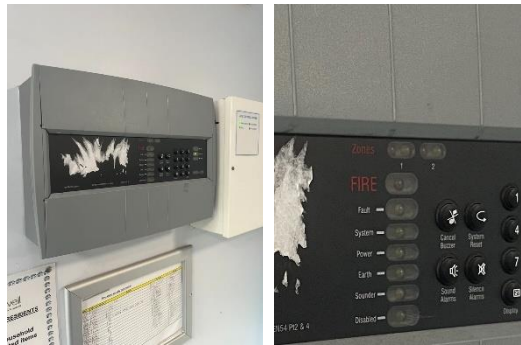
- 6) There is an automatic fire alarm panel in the ground floor entrance foyer. This panel is showing two zones and has no zone map present. Emails were sent to the electrical department to investigate this issue. The panel is believed to serve the AOV detectors only present in the stairwell and lift shaft, and that following the refurbishment of the block the panel was labelled as such. Email confirmation was received from the electrical department stating that the panel will be investigated for system set up and new signs fixed to the panel.

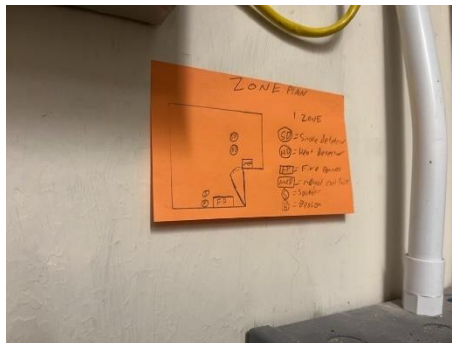
- 9) The zone map for the AFA panel in the CCTV/server room is of a temporary nature. A permanent zone map has been requested from the electrical department by email.

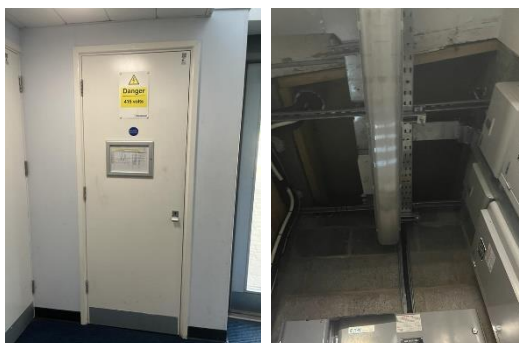
- 3) **The electrical cupboard opening on to the main entrance foyer has exposed timber panelling at the ceiling. The ceiling should be covered over with fire resistant plasterboard. See Action 10/03.**

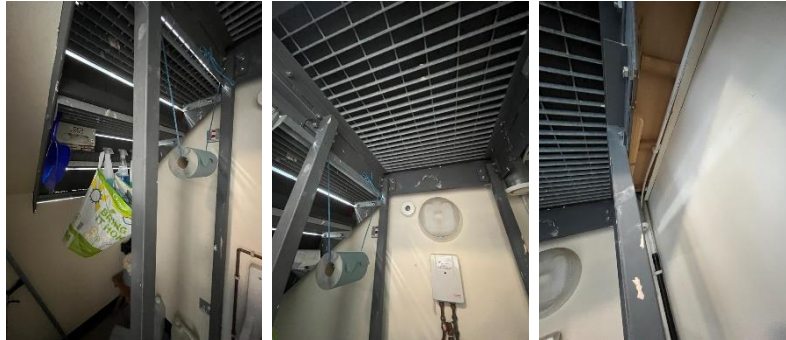
- 4) **The cleaners store under the metal access steps to the roof area is open at the ceiling level. This cupboard should have its ceiling, and the metal staircase legs covered with fire resistant plasterboard and sealed to prevent fire and smoke travel from the cupboard onto the stairwell landing. This cleaner's cupboard has sources of ignition, i.e. electrical fittings present. See Action 10/04.**

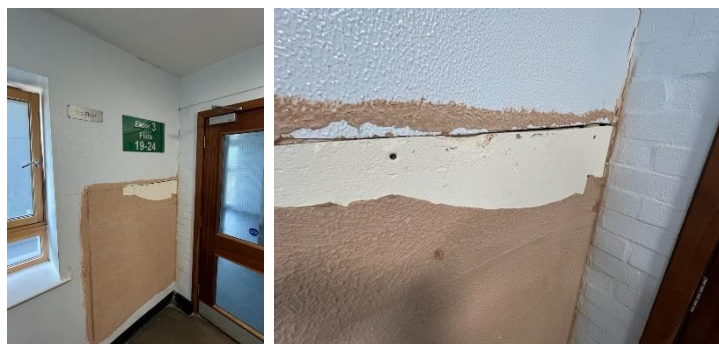
- 5) A variety of methods / materials have been used to achieve fire-stopping including Rockwool and intumescent pillows.
- 6) **There is damage to the stairwell wall on the 3rd floor landing. This damage should be repaired. The repair should be done with materials that offer 60 minutes of fire resistance. See Action 10/06.**

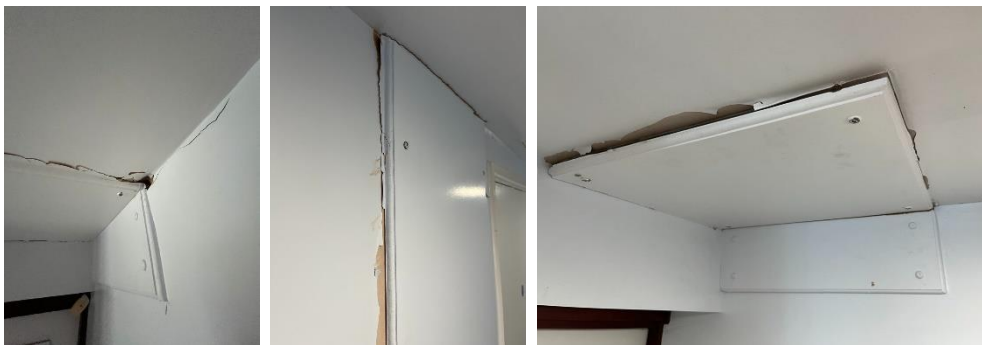
- 7) **Service access panels are fixed to masonry in the ceilings and walls of corridors. The service access panels near the following flats have gaps and appear to be loosely fitted. These panels require securing and resealing. See Action 10/07.**

- **11th floor ceiling near flat 68.**
- **11th floor wall panel near flat 71.**
- **9th floor ceiling panel near flat 59.**
- **3rd floor ceiling panel near flat 23.**

10/07	<p>The service access panels near the following flats have gaps and appear to be loosely fitted. The panels require resealing and resealing with fire resistant materials.</p> <ul style="list-style-type: none">•11th floor ceiling near flat 68.•11th floor wall panel near flat 71.•9th floor ceiling panel near flat 59.•3rd floor ceiling panel near flat 23.

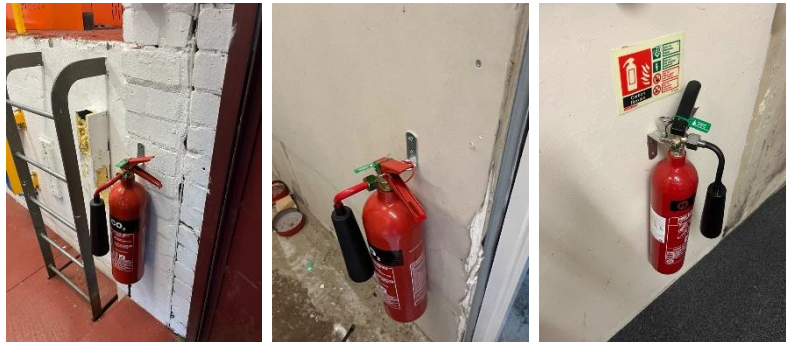
6) The CO2 extinguishers in the lift motor room and the PV system control room have no 'how to use' signage. An email has been sent to the Team Leader Fire Safety and Facilities to request suitable signage.

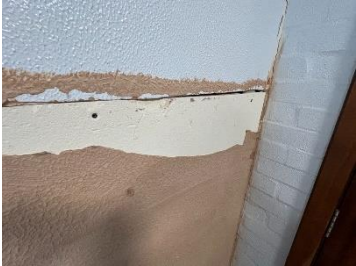
P3	Fire Rapid Response 3 – 6 months.	
10/06	<p>There is damage to the stairwell wall on the 3rd floor. This damage should be repaired. The repair should be done with materials that offer 60 minutes of fire resistance.</p>
