# Fire Risk Assessment

## Birchcroft

**Windmill Lane,  
Smethwick, B66 3LN**

**Date Completed: 13/08/2025**

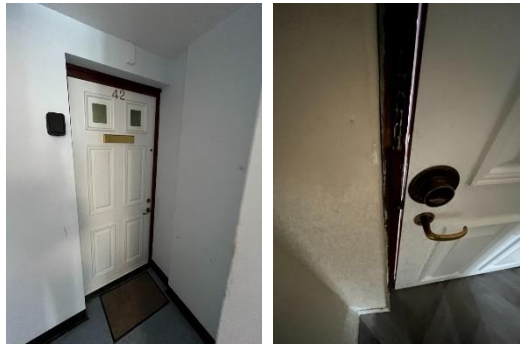
i) **Flat 42 - Door leaf fails to close into its frame from the open position correctly, adjustment required. See Action 07/20i.**

P2	Fire Rapid Response 1 – 3 months. JM17618192 JM 17824492 JM17866793 JM17989360 JM17824417	02/12/2025
07/20i	Flat 42 - Door leaf fails to close into its frame from the open position correctly, adjustment required.

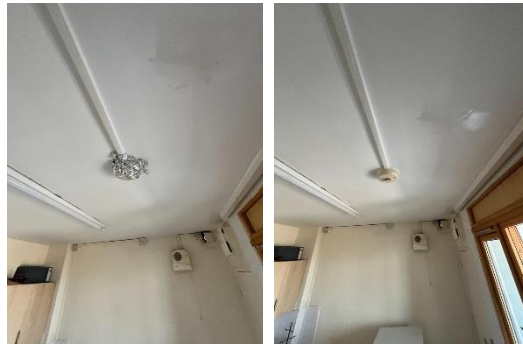
- 3) Flat 85 was accessed and it was noted that the resident had covered the smoke detectors with aluminium cooking foil. The assessor insisted that the covers were be immediately removed, the resident complied. An email was sent to the Operations Manager Housing services and the Housing Services Officer to request a spot check to ensure further compliance.

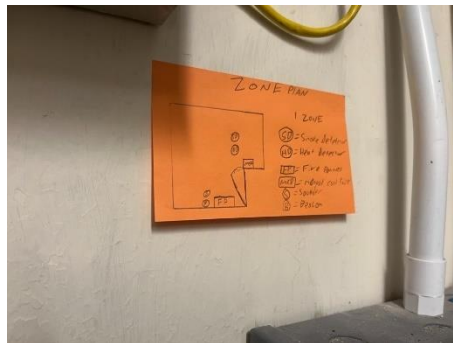
- 9) The zone map for the AFA panel in the CCTV/server room is of a temporary nature. A permanent zone map has been requested from the electrical department by email.

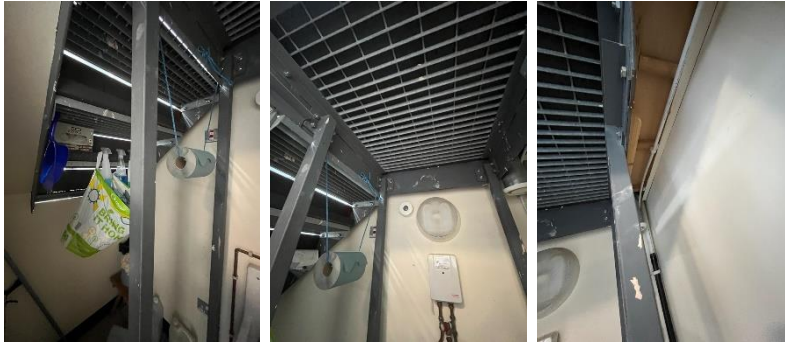
- 4) **The cleaners store under the metal access steps to the roof area is open at the ceiling level. This cupboard should have its ceiling, and the metal staircase legs covered with fire resistant plasterboard and sealed to prevent fire and smoke travel from the cupboard onto the stairwell landing. This cleaner's cupboard has sources of ignition, i.e. electrical fittings present. See Action 10/04.**

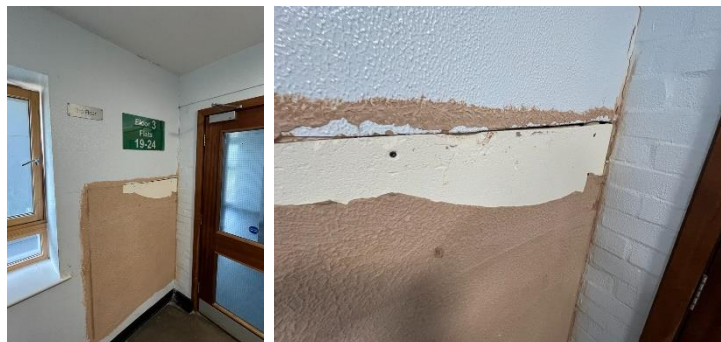
- 5) A variety of methods / materials have been used to achieve fire-stopping including Rockwool and intumescent pillows.
- 6) **There is damage to the stairwell wall on the 3<sup>rd</sup> floor landing. This damage should be repaired. The repair should be done with materials that offer 60 minutes of fire resistance. See Action 10/06.**

P3	Fire Rapid Response 3 – 6 months. JM17656888	05/09/2025
10/06	There is damage to the stairwell wall on the 3 <sup>rd</sup> floor. This damage should be repaired. The repair should be done with materials that offer 60 minutes of fire resistance.

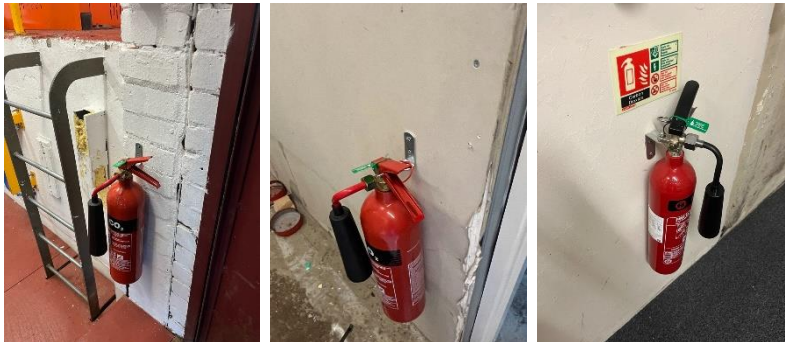
6) The CO2 extinguishers in the lift motor room and the PV system control room have no 'how to use' signage. An email has been sent to the Team Leader Fire Safety and Facilities to request suitable signage.
