# Fire Risk Assessment

## Elmcroft

**Windmill Lane,  
Smethwick, B66 3JN**

**Date Completed: 05/08/2025**

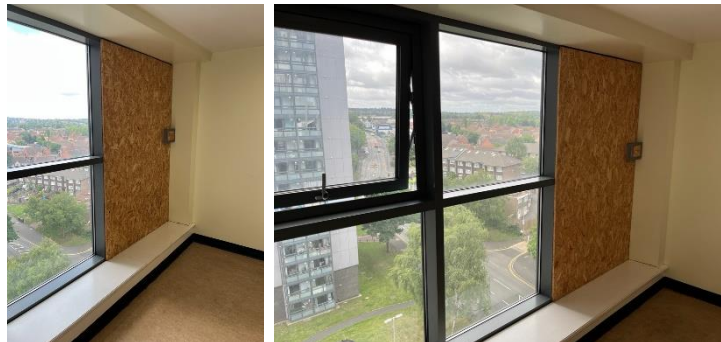
- 13) The stairwell lobby windows on floors 13 and 10 have chipboard panels covering the frames. Presumably these chipboard panels cover damage to the windows. This damage should be repaired, and the chipboard should be removed. See Action 07/13.

Question/ Ref No	Required Action	Supporting photograph	Priority	Timescale and Person Responsible	Date Completed
07/13	The stairwell lobby windows on floors 13 and 10 have chipboard panels covering the frames. Presumably these chipboard panels cover damage to the windows. This damage should be repaired, and the chipboard should be removed.

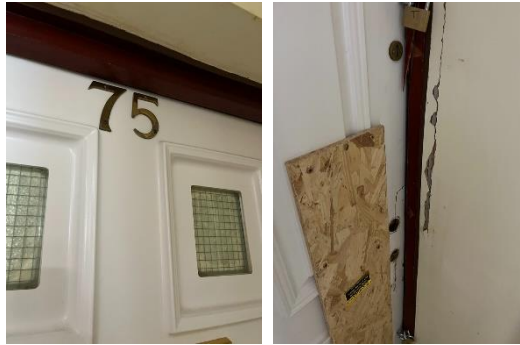
21) Flat 75 was not accessed but damage to the door leaf and door frame was noted. A new FD30s door has ordered.

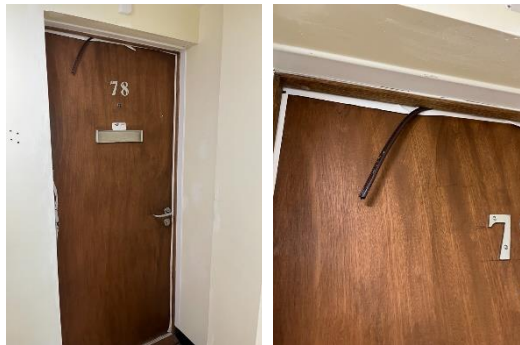
**22) Flat 78 was not accessed but damage to the smoke seal was noted. This damage should be repaired. See Action 07/22.**

P3	Repairs / Glazing 3 – 6 months.	
07/22	Flat 78 was not accessed but damage to the smoke seal was noted. This damage should be repaired.

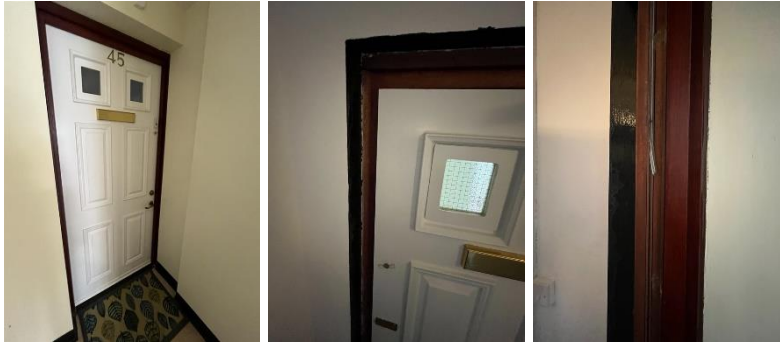
- e) Flat 45 - Door leaf fails to close into its frame from the open position correctly and the smoke seal is damaged. The issues require adjustment and repair. See Action 07/23e.

P2	Fire Rapid Response 1 – 3 months.	
07/23e	Flat 45 - Door leaf fails to close into its frame from the open position correctly and the smoke seal is damaged. These issues require adjustment and repair.

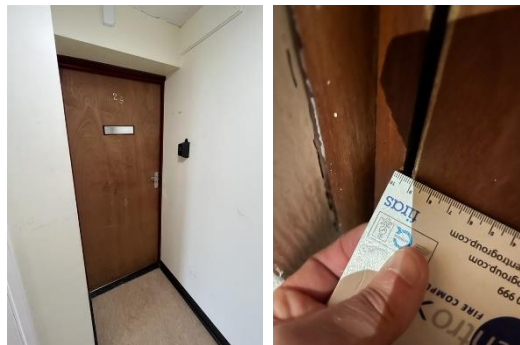
- f) Flat 29 - Door has an excessive latch side gap, requiring adjustment. See Action 07/23f.

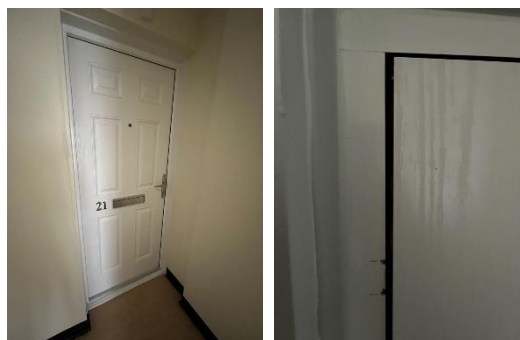
- g) Flat 21 – Door leaf fails to close into its frame from the open position correctly, adjustment required. See Action 07/23g.

07/23g	Flat 21 - Door leaf fails to close into its frame from the open position correctly, adjustment required.

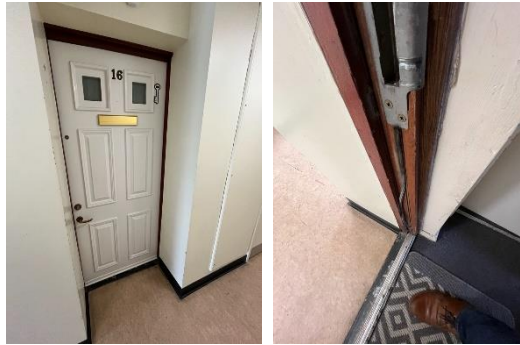
- h) Flat 16 – The frame latch side smoke seal is damaged, requiring repair. See Action 07/23h.**

P2	Fire Rapid Response 1 – 3 months.	
07/23h	Flat 16 – The frame latch side smoke seal is damaged, requiring repair.

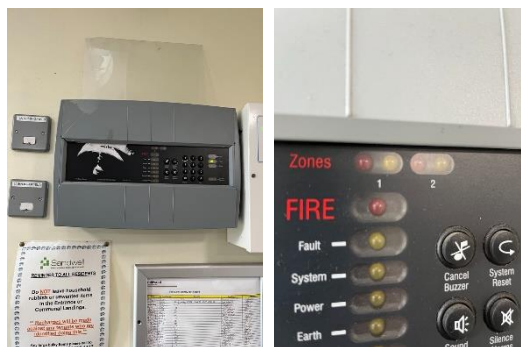
- 4) There is no effective means for detecting an outbreak of fire to the remaining communal areas. Automatic fire alarm systems are not normally required in the common areas of residential blocks.
- 5) There is an automatic fire alarm panel in the ground floor entrance foyer. This panel is showing two zones and has no zone map present. Emails were sent to the electrical department to investigate this issue. The panel is believed to serve the AOV detectors only present in the stairwell and lift shaft, and that following the refurbishment of the block the panel was labelled as such. Email confirmation was received stating that the panel will be investigated for system set up and new signs fixed to the panel.

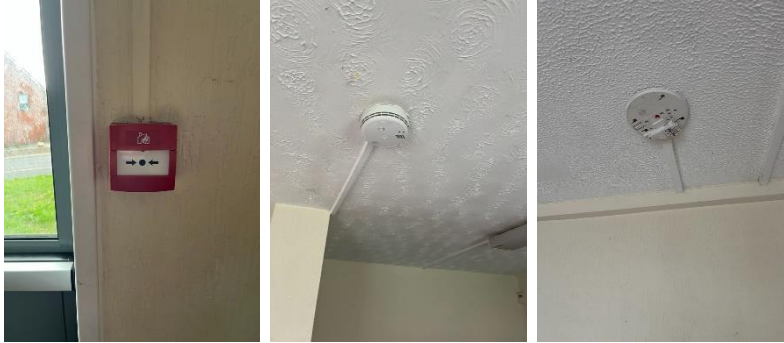
- 6) The flat that now contains the caretaker's facility has a common alarm system that appears to conform to BS 5839-6 with MCPs and smoke detectors. There is a detector head missing from the kitchen area. An email was sent to the Estates Services Manager to ensure this detector head is replaced.

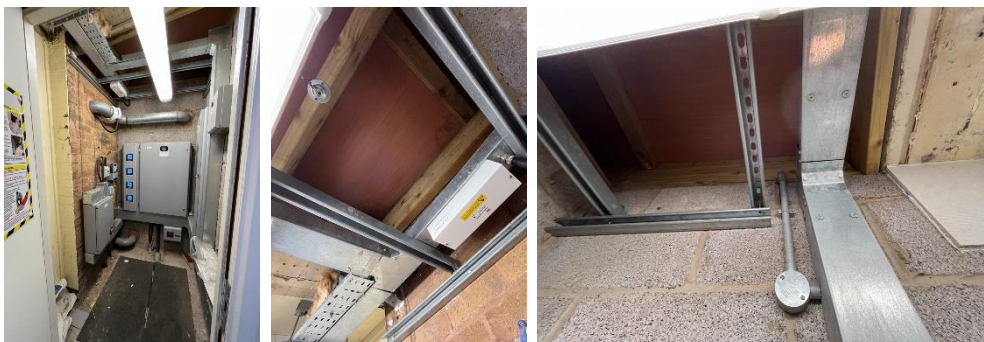
- 3) **The electrical cupboard opening on to the main entrance foyer has exposed timber panelling at the ceiling. The ceiling should be covered over with fire resistant plasterboard. See Action 10/03.**

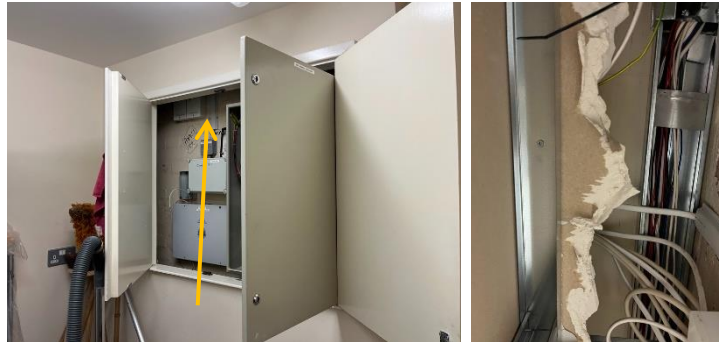
- 4) The cleaners room opening on to the main entrance foyer contains a recessed wall cabinet containing electrical equipment. This cabinet has no fire stopping at the top, where cabling enters the ceiling void. This a gap is required to be fire stopped. See Action 10/04.

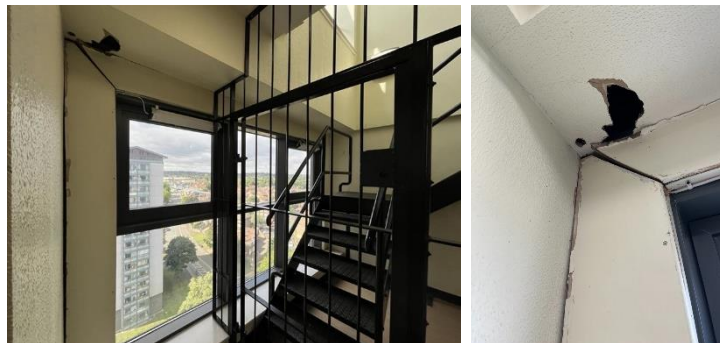
- 5) The 14<sup>th</sup> floor has damaged plaster around the AOV. This damage is required to be repaired. See Action 10/05

P3	Fire Rapid Response 3 – 6 months.	
10/05	The 14 <sup>th</sup> floor has damaged plaster around the AOV. This damage is required to be repaired.

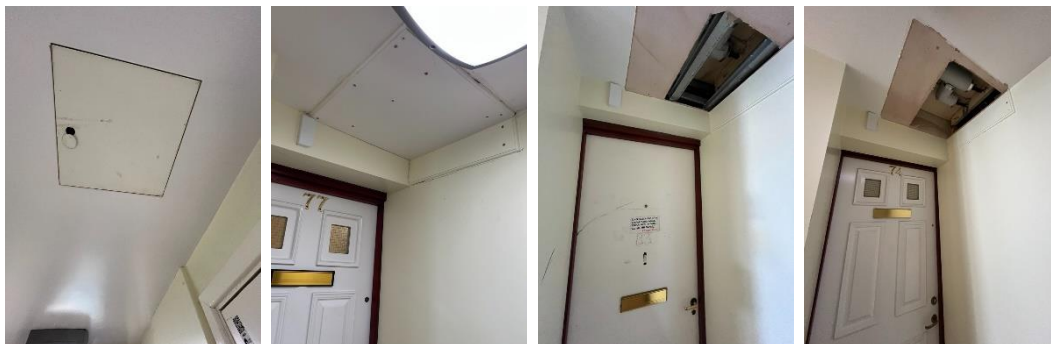
- 7) **Service access panels are fixed to masonry in the ceilings of corridors. The service access panels for flats 83 and 74 have been removed. These panels are required to be replaced. See Action 10/07.**

P3	Repairs / Plasterer 3 – 6 months.	
10/07	The service access panels for flats 83 and 74 have been removed. Reinstall panels.

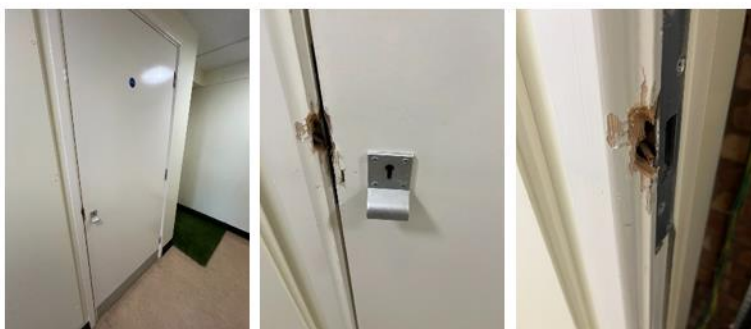
- 8) All communal doors are fitted with automatic closing devices that are checked on a regular basis by Caretaking Teams as part of their checks. Defective closing devices are replaced either by the Caretaking Team(s) or the in-house repairs team(s).
- 9) Electrical service cupboards have FD30s rated doors, secured with a suited lock. Residents have been provided with a key for access to their electricity meters. It is recommended that all service cupboard doors are uprated to FD30s during future building refurbishment works.
- 10) **The 11th floor electrical service cupboard near flats 70, 71 and 72 has damage. This damage should be repaired. See Action 10/10.**

10/10	The 11th floor electrical service cupboard near flats 70, 71 and 72 has damage. This damage should be repaired.

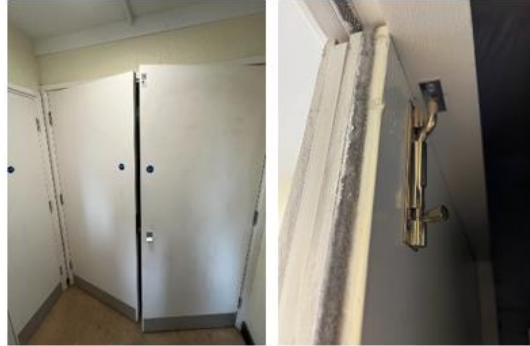
- 11) **The ground floor service cupboard double doors in the bin chute compartment are unsecure due to a loose shoot bolt, adjustment is required. See Action 10/11.**

P3	Fire Rapid Response 3 – 6 months.	
10/11	The ground floor service cupboard double doors in the bin chute compartment are unsecure due to a loose shoot bolt, adjustment is required.

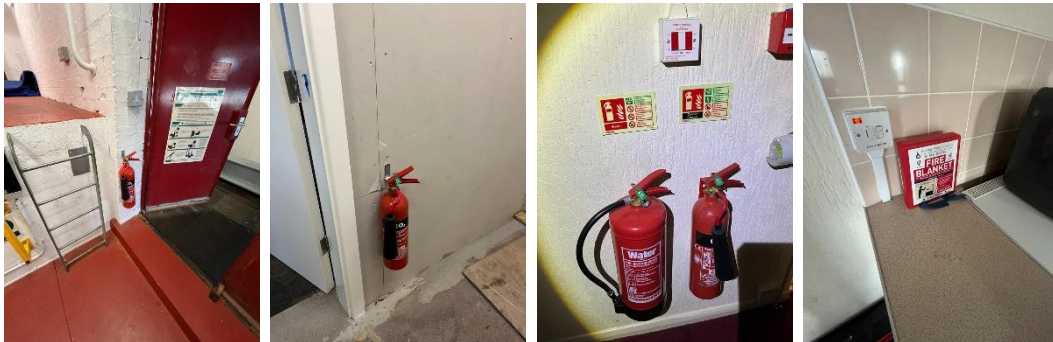
6) The CO2 extinguishers in the lift motor room and the PV system control room have no 'how to use' signage. The fire blanket is required to be fixed to the wall in the caretakers room (formerly Flat 5). These deficiencies are required to be resolved. An email has been sent to the Team Leader Fire Safety and Facilities to request suitable signage.
