Fire Risk Assessment

Elmcroft

**Windmill Lane,
Smethwick, B66 3JN**

Date Completed: 05/08/2025

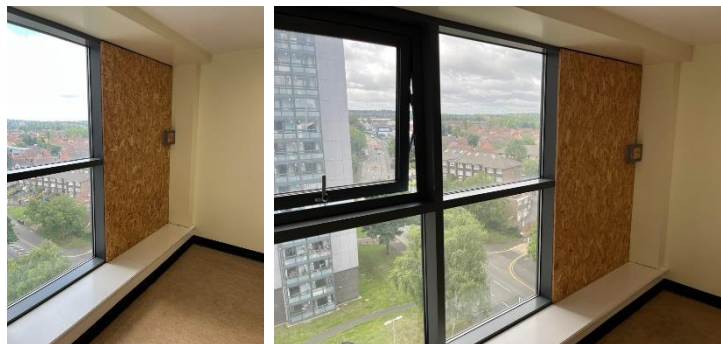
- 13) The stairwell lobby windows on floors 13 and 10 have chipboard panels covering the frames. Presumably these chipboard panels cover damage to the windows. This damage should be repaired, and the chipboard should be removed. See Action 07/13.

Question/ Ref No	Required Action	Supporting photograph	Priority	Timescale and Person Responsible	Date Completed
07/13	The stairwell lobby windows on floors 13 and 10 have chipboard panels covering the frames. Presumably these chipboard panels cover damage to the windows. This damage should be repaired, and the chipboard should be removed.

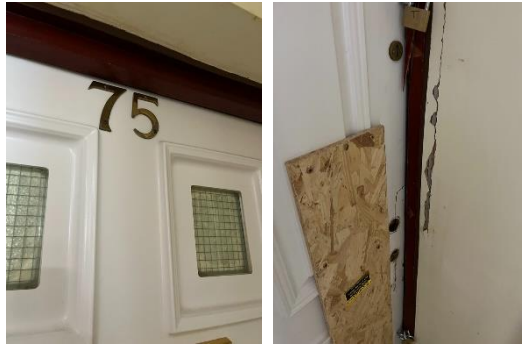
21) Flat 75 was not accessed but damage to the door leaf and door frame was noted. A new FD30s door has ordered.

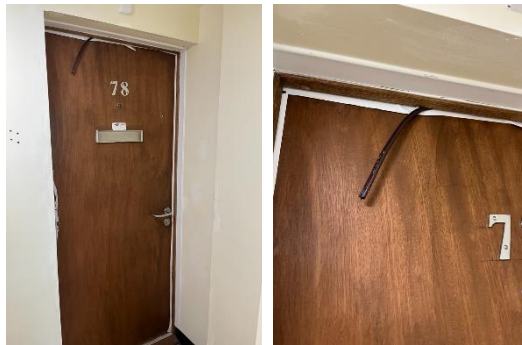
22) Flat 78 was not accessed but damage to the smoke seal was noted. This damage should be repaired. See Action 07/22.

P3	Repairs / Glazing 3 – 6 months. JM17633101 This work forms part of the cladding works being undertaken via Equians	13/10/2025
07/22	Flat 78 was not accessed but damage to the smoke seal was noted. This damage should be repaired.

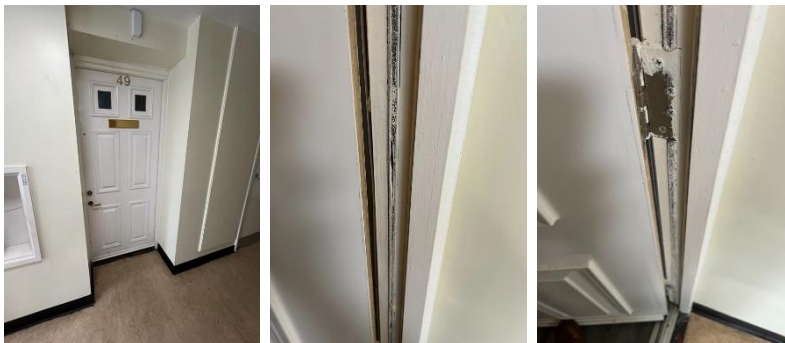
d) Flat 49 - Door frame has a paint contaminated cold smoke brush on the hinge side, requiring replacement. See Action 07/23d.

07/23d	Flat 49 - Door frame has a paint contaminated cold smoke brush on the hinge side, requiring replacement.

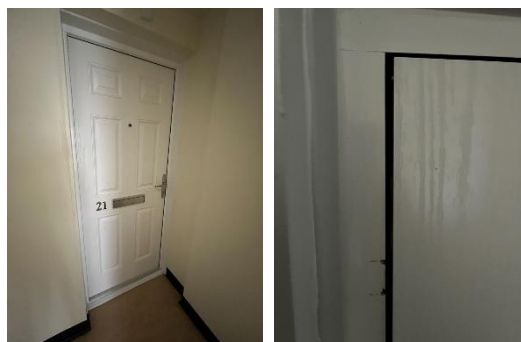
- g) Flat 21 – Door leaf fails to close into its frame from the open position correctly, adjustment required. See Action 07/23g.

07/23g	Flat 21 - Door leaf fails to close into its frame from the open position correctly, adjustment required.

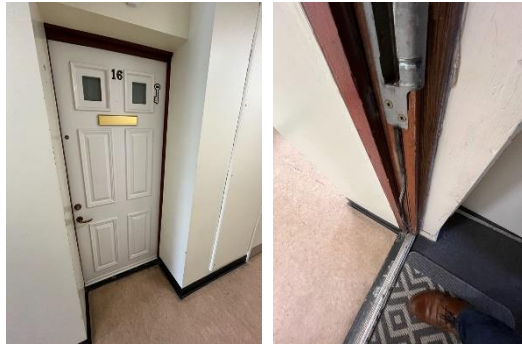
- h) Flat 16 – The frame latch side smoke seal is damaged, requiring repair. See Action 07/23h.**

P2	Fire Rapid Response 1 – 3 months. JM17552129	20/08/2025
07/23h	Flat 16 – The frame latch side smoke seal is damaged, requiring repair.

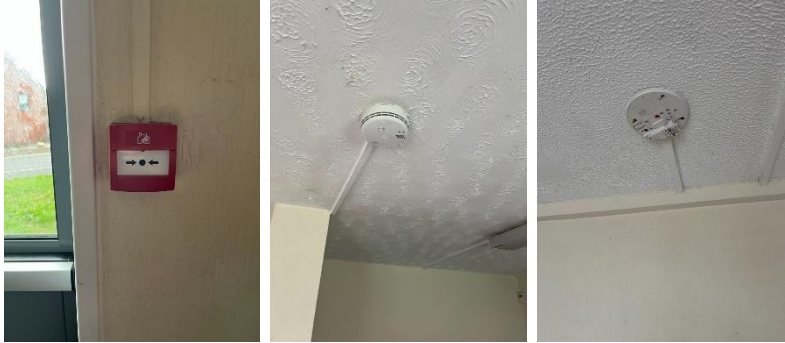
- 6) The flat that now contains the caretaker's facility has a common alarm system that appears to conform to BS 5839-6 with MCPs and smoke detectors. There is a detector head missing from the kitchen area. An email was sent to the Estates Services Manager to ensure this detector head is replaced.

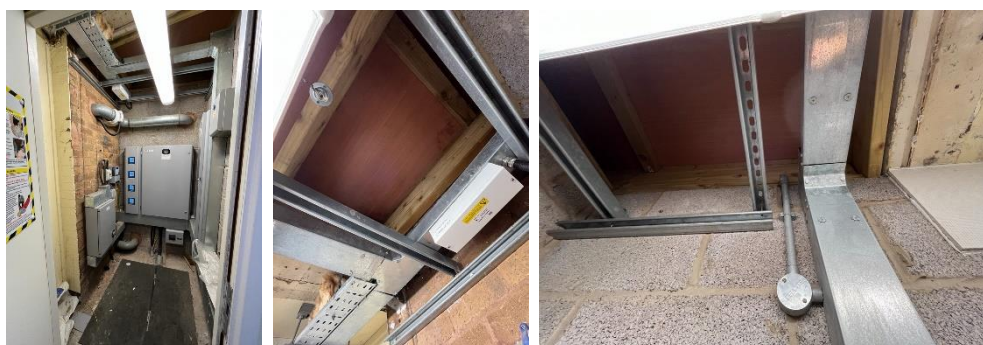
- 3) **The electrical cupboard opening on to the main entrance foyer has exposed timber panelling at the ceiling. The ceiling should be covered over with fire resistant plasterboard. See Action 10/03.**

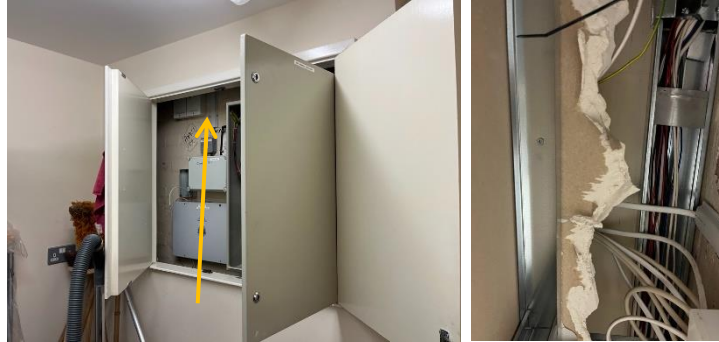
- 4) The cleaners room opening on to the main entrance foyer contains a recessed wall cabinet containing electrical equipment. This cabinet has no fire stopping at the top, where cabling enters the ceiling void. This a gap is required to be fire stopped. See Action 10/04.

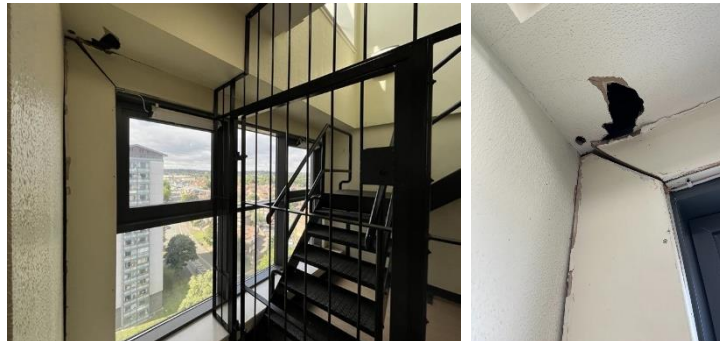
- 5) The 14th floor has damaged plaster around the AOV. This damage is required to be repaired. See Action 10/05

<p>P3</p>	<p>Fire Rapid Response 3 – 6 months. JM17552265</p>	<p>18/08/2025</p>
<p>10/05</p>	<p>The 14th floor has damaged plaster around the AOV. This damage is required to be repaired.</p>

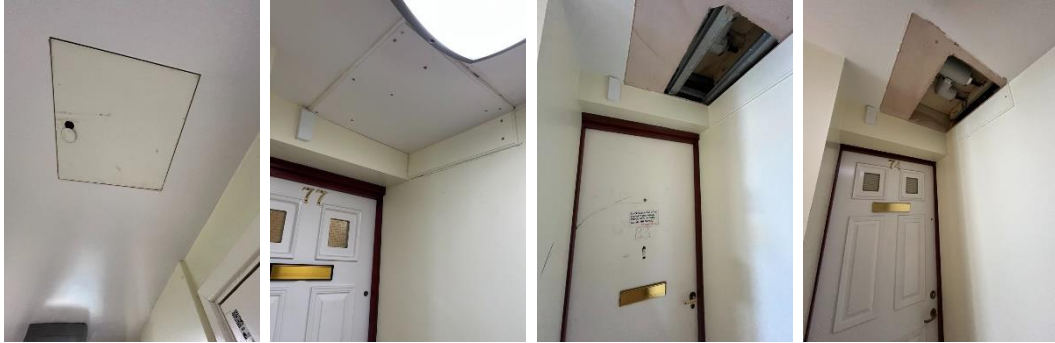
- 7) **Service access panels are fixed to masonry in the ceilings of corridors. The service access panels for flats 83 and 74 have been removed. These panels are required to be replaced. See Action 10/07.**

<p>P3</p>	<p>Repairs / Plasterer 3 – 6 months.</p>	<p>19/08/2025</p>
<p>10/07</p>	<p>The service access panels for flats 83 and 74 have been removed. Reinstall panels.</p>

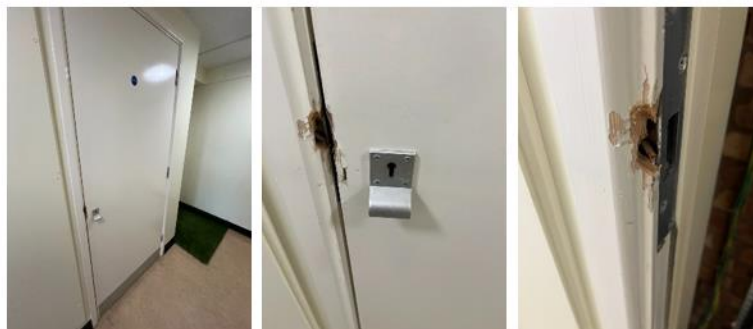
- 8) All communal doors are fitted with automatic closing devices that are checked on a regular basis by Caretaking Teams as part of their checks. Defective closing devices are replaced either by the Caretaking Team(s) or the in-house repairs team(s).
- 9) Electrical service cupboards have FD30s rated doors, secured with a suited lock. Residents have been provided with a key for access to their electricity meters. It is recommended that all service cupboard doors are uprated to FD30s during future building refurbishment works.
- 10) **The 11th floor electrical service cupboard near flats 70, 71 and 72 has damage. This damage should be repaired. See Action 10/10.**

10/10	The 11th floor electrical service cupboard near flats 70, 71 and 72 has damage. This damage should be repaired.

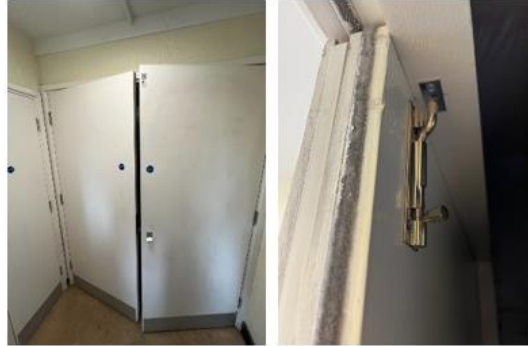
- 11) The ground floor service cupboard double doors in the bin chute compartment are unsecure due to a loose shoot bolt, adjustment is required. See Action 10/11.

P3	Fire Rapid Response 3 – 6 months. JM17552349	18/08/2025
10/11	The ground floor service cupboard double doors in the bin chute compartment are unsecure due to a loose shoot bolt, adjustment is required.
